Fairfax House, York

Conservation Management Plan

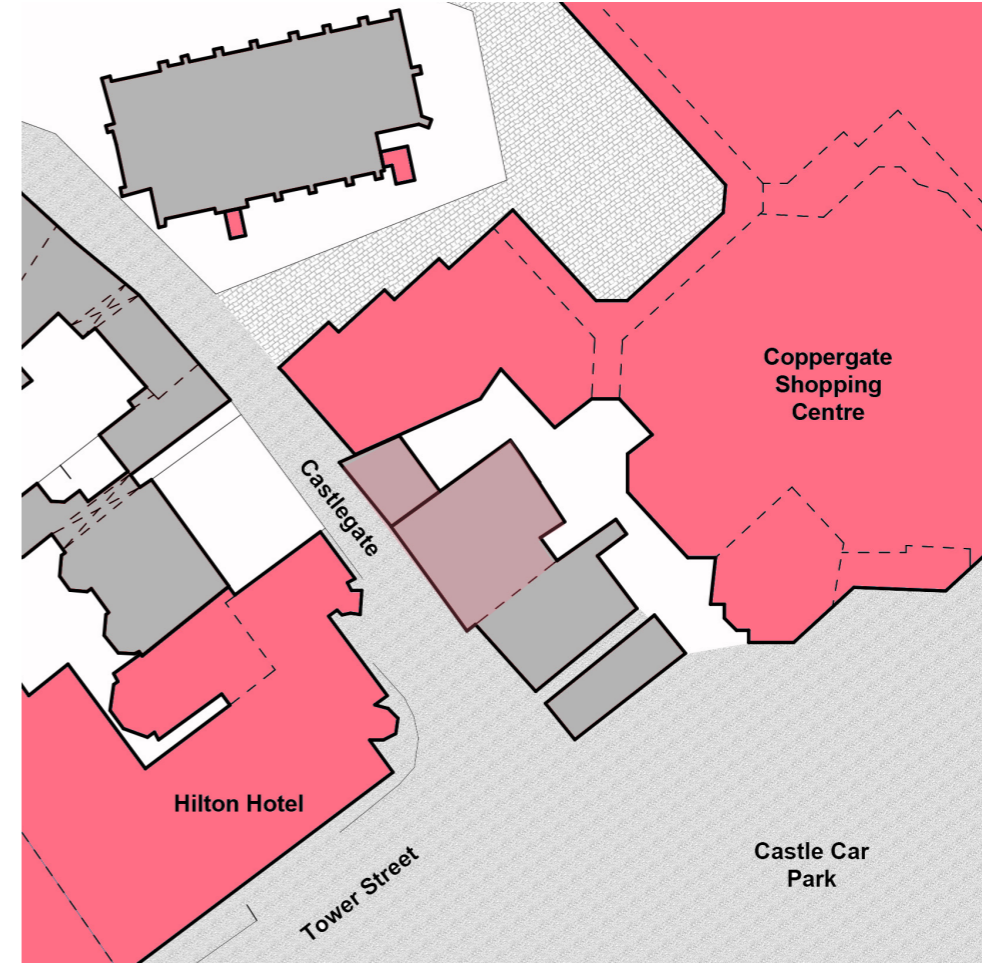
Present Day Site Context, Diagram Page\Park.

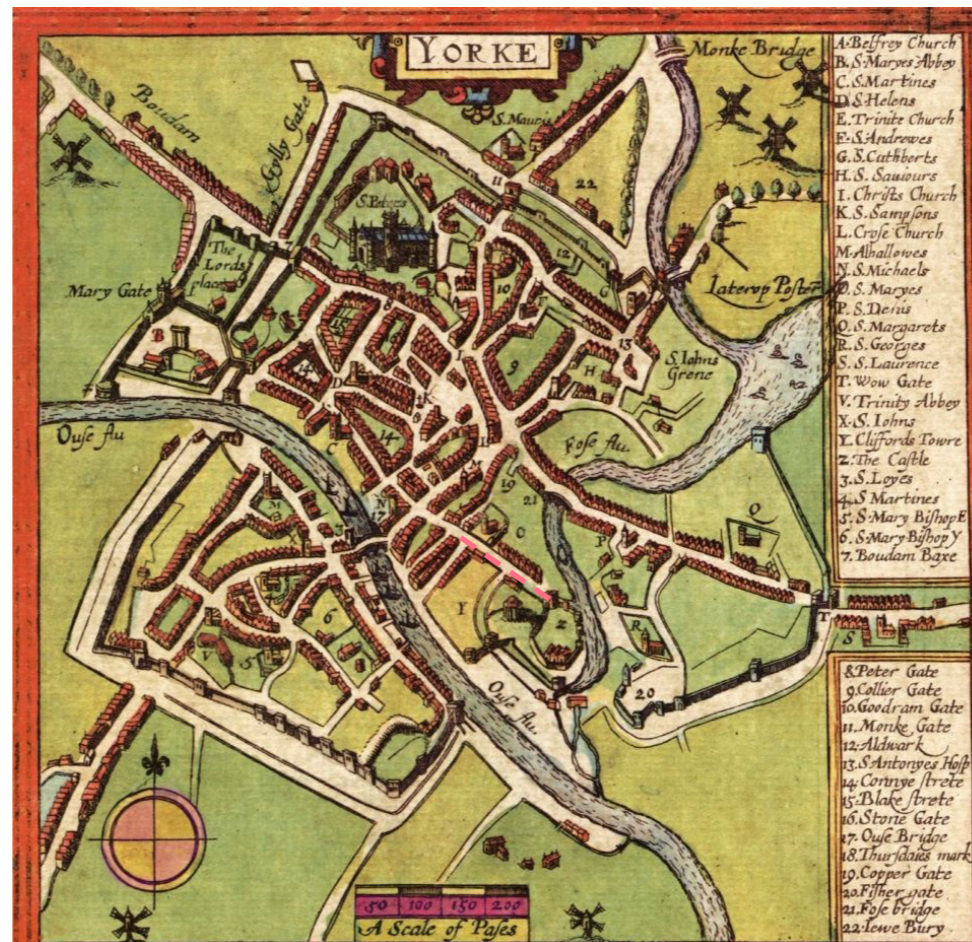
1611 Map of York, John Speed.

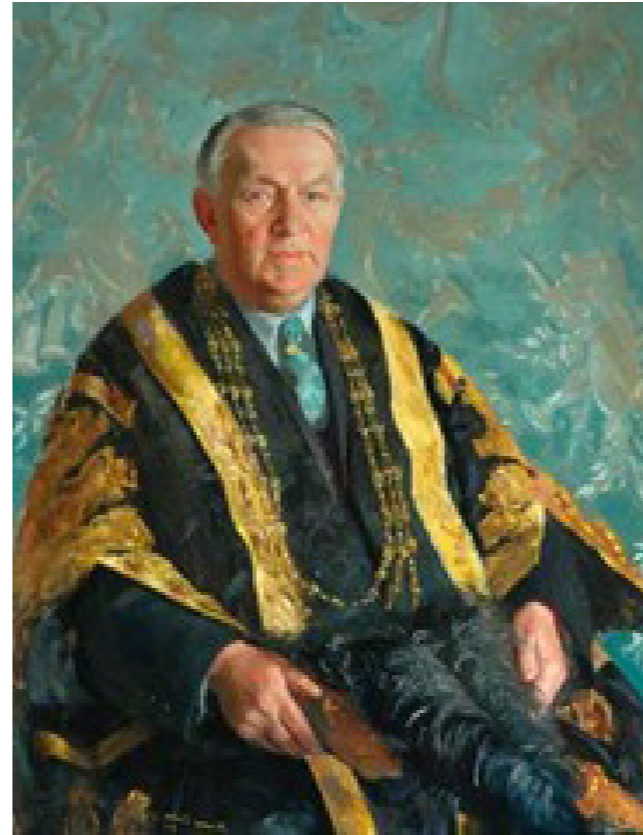
Painting of Dr John Bowes Morrell. Source: York Conservation Trust.

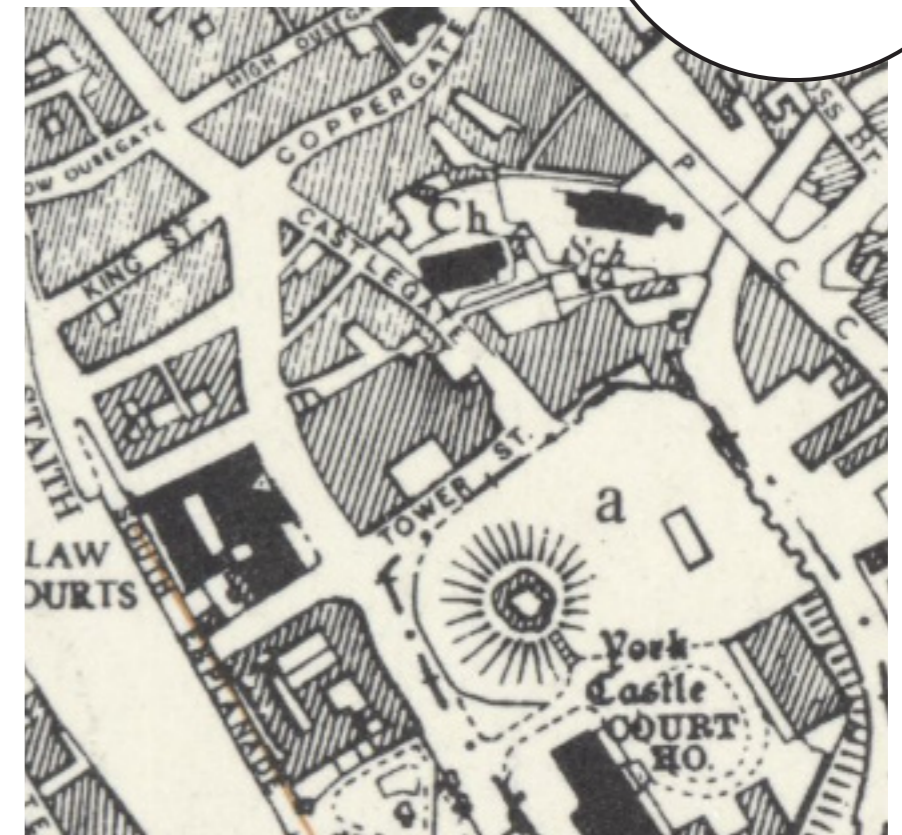
1958 OS National grid map SE65SW A (1944-1970). Source: National Library of Scotland.

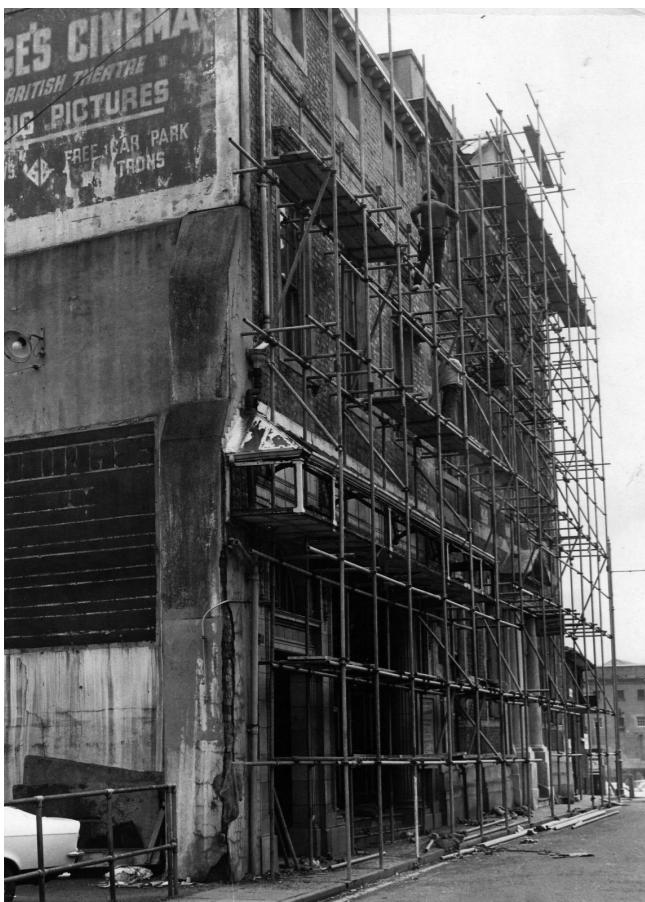
May 1972, Source: York Press.

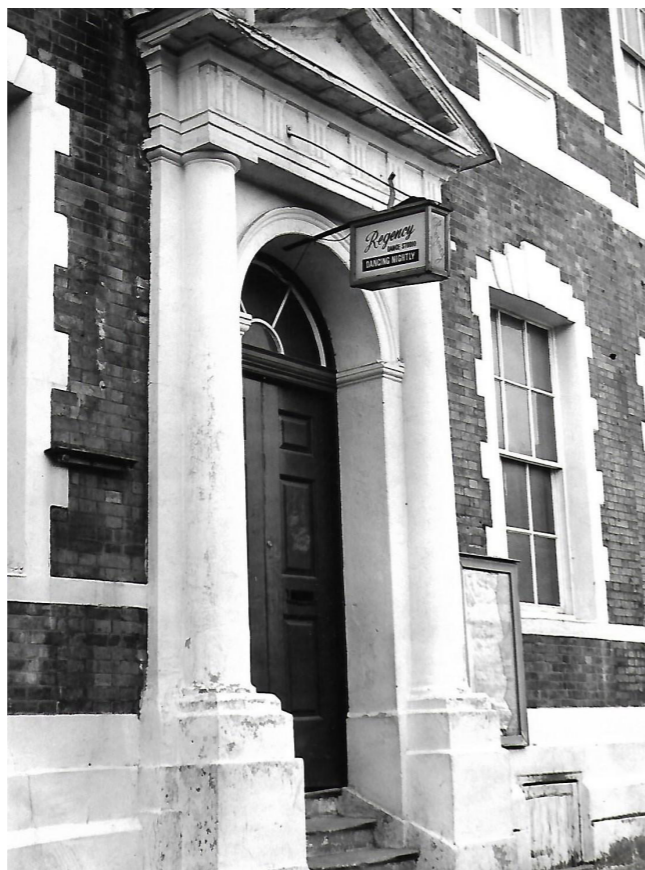
Main entrance door during the Dance School's tenancy. Note the deteriorating condition of the building. Source: York Press.

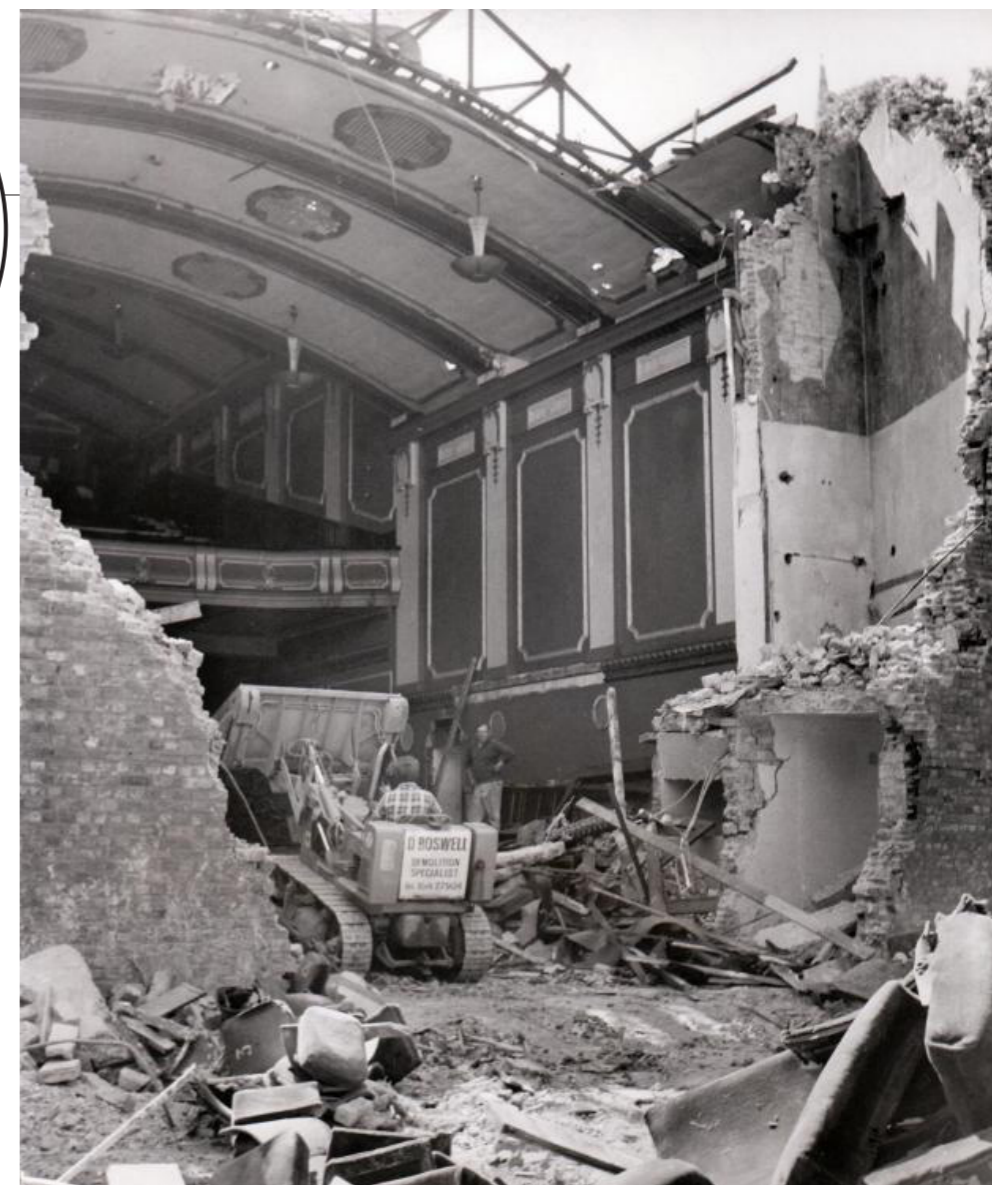
St George's Hall being demolished by contractor, Dennis Boswell. Source: York Press.

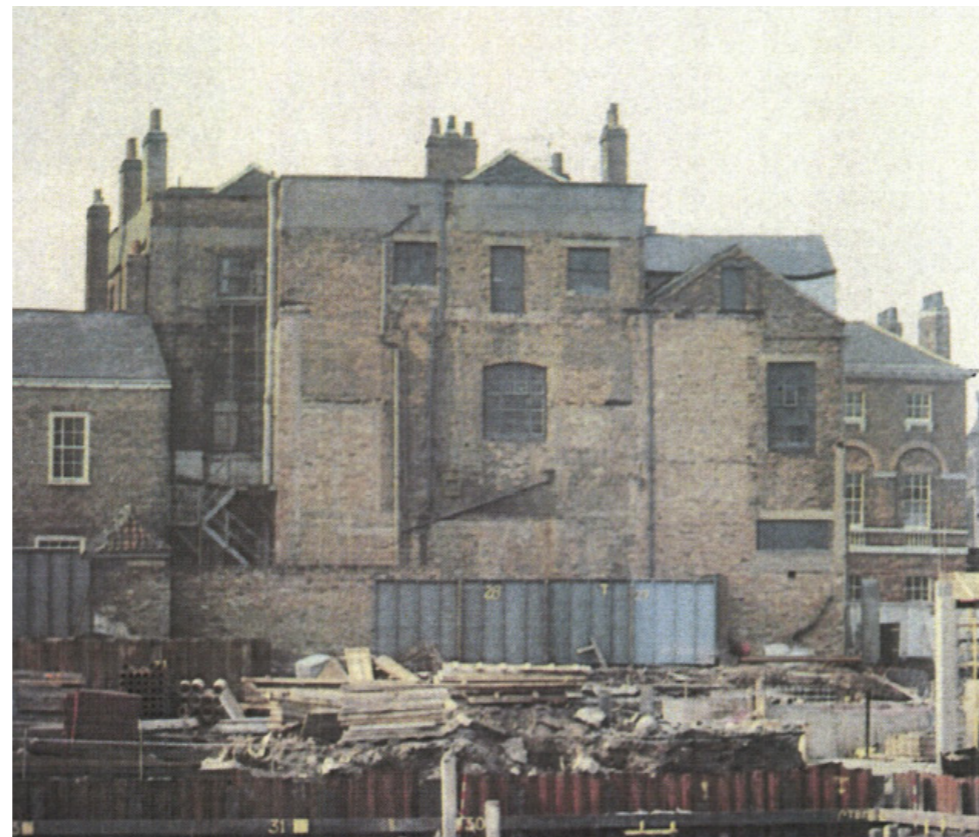
The rear facade before restoration, c.1981. Source: York Civic Trust.

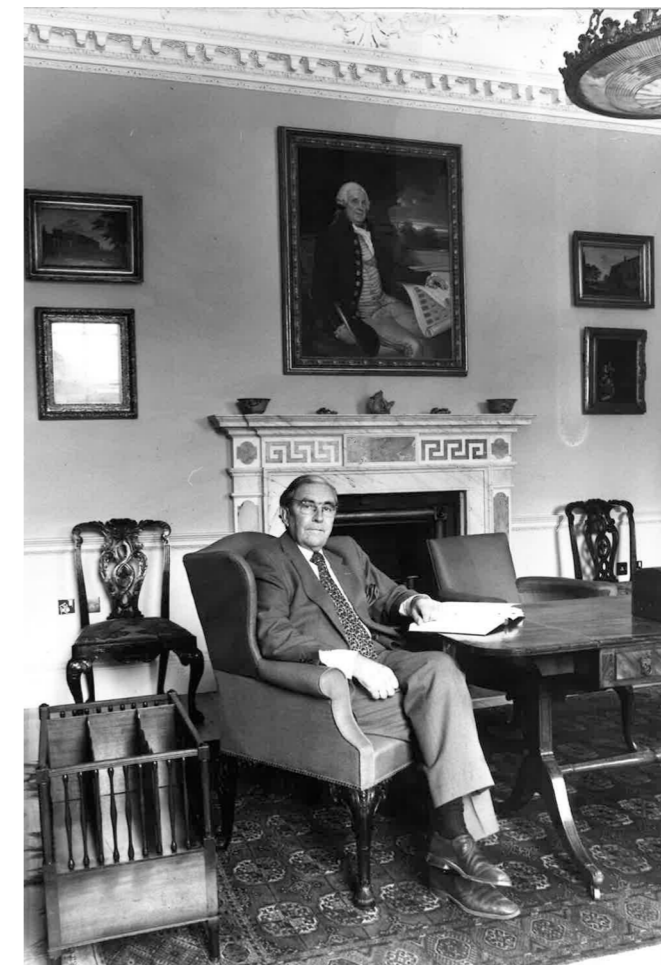
Chairman John Shannon, pictured in the restored Fairfax House.

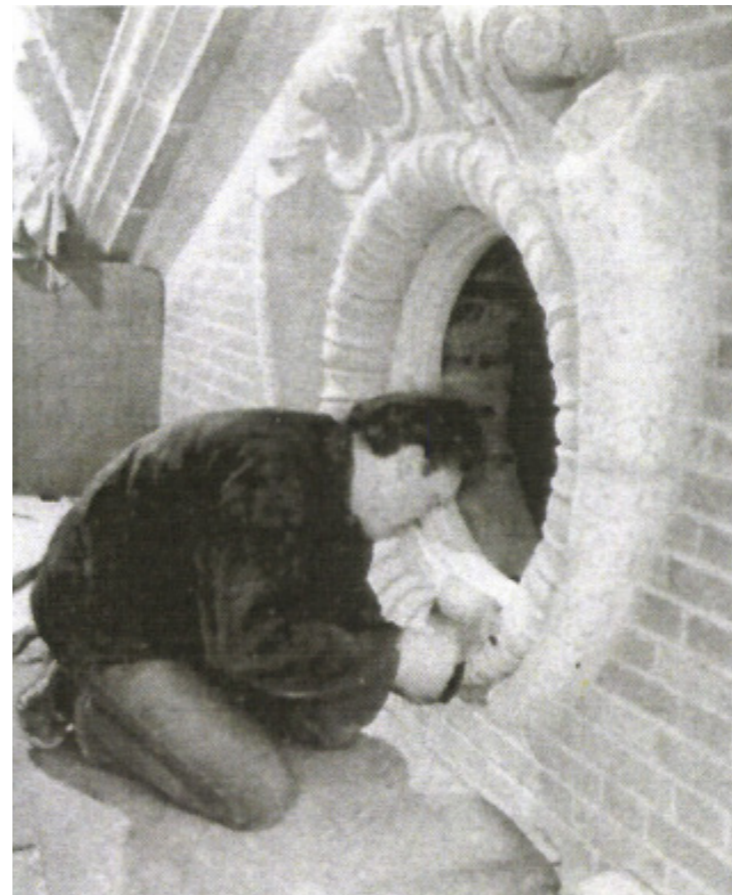
Charles Gurney carving the stone oculus on site, 1982-4. York Civic Trust Archive.

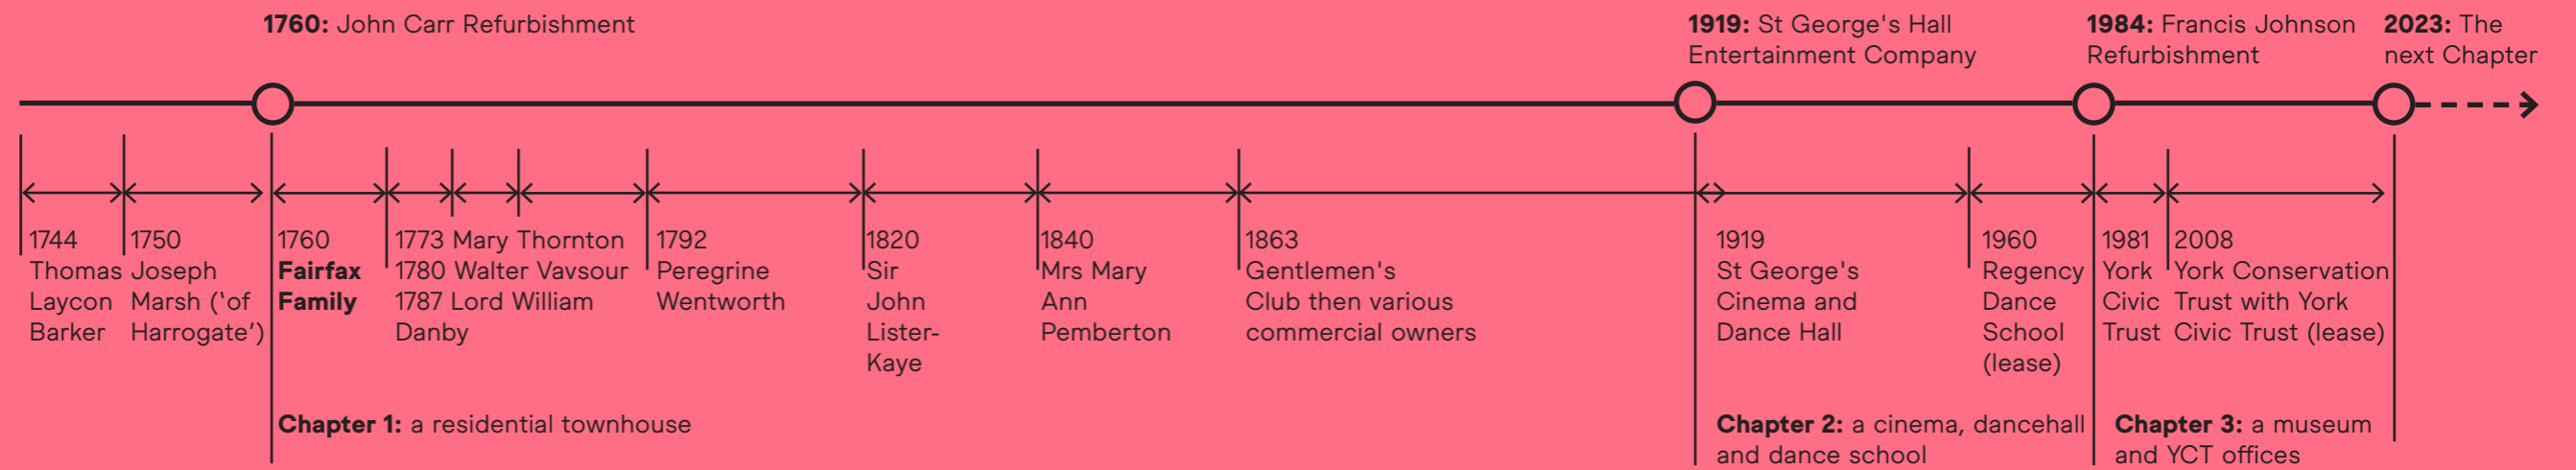
3.6 John Carr Refurbishment

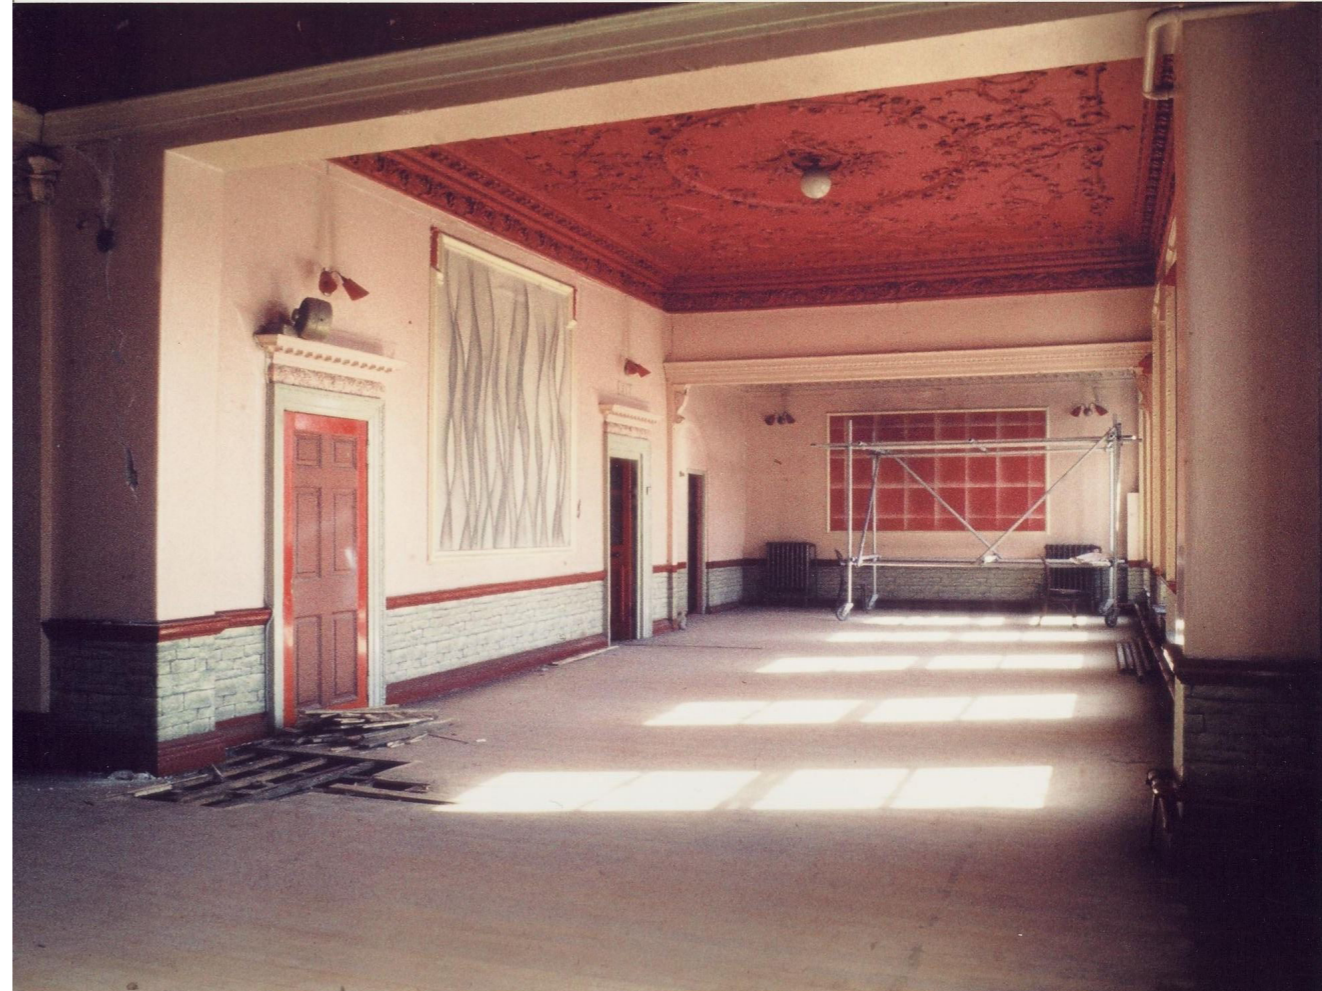
c.1980; Interior of Dance School before refurbishment. Source; York Civic Trust Archive.

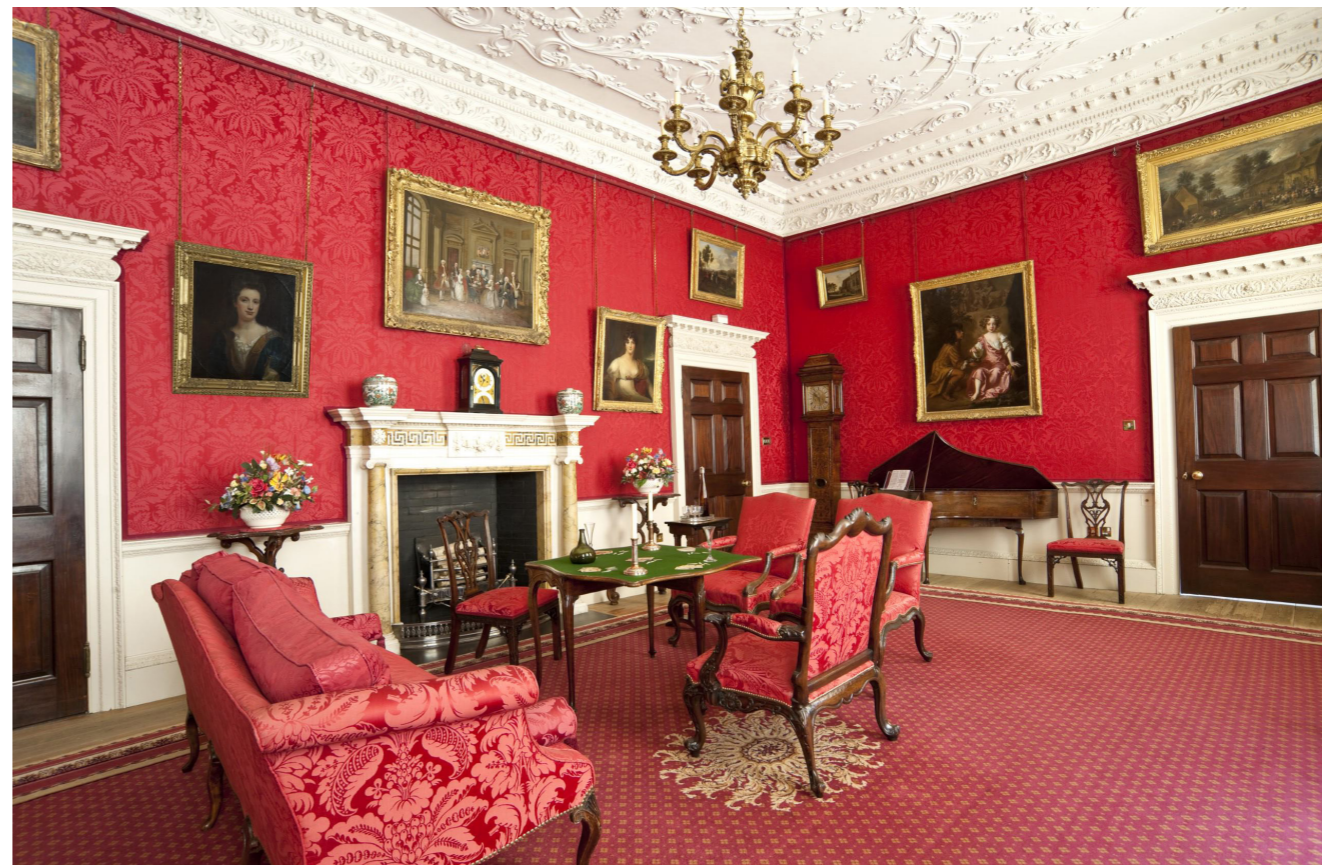
c.1989; Restored Saloon (first floor). Source: York Civic Trust Archive.

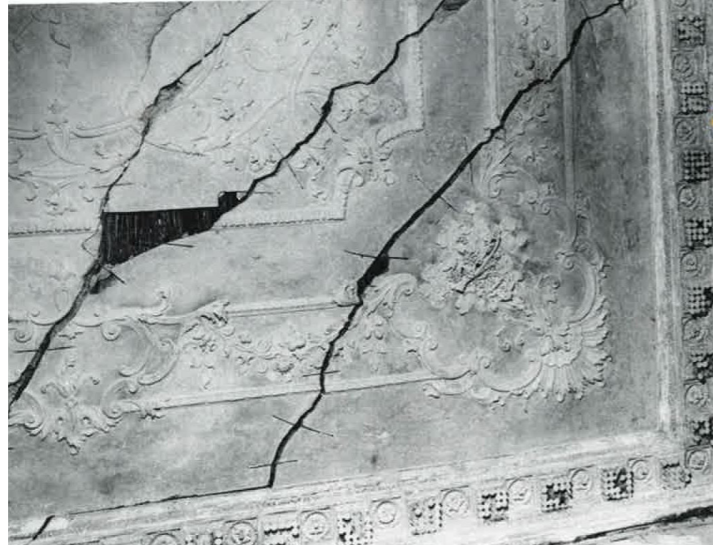
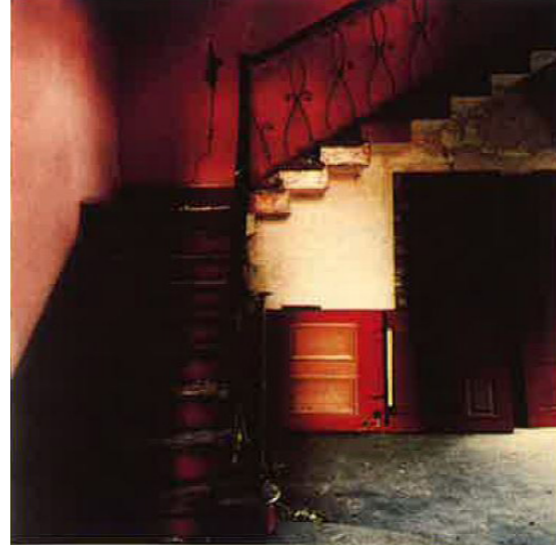
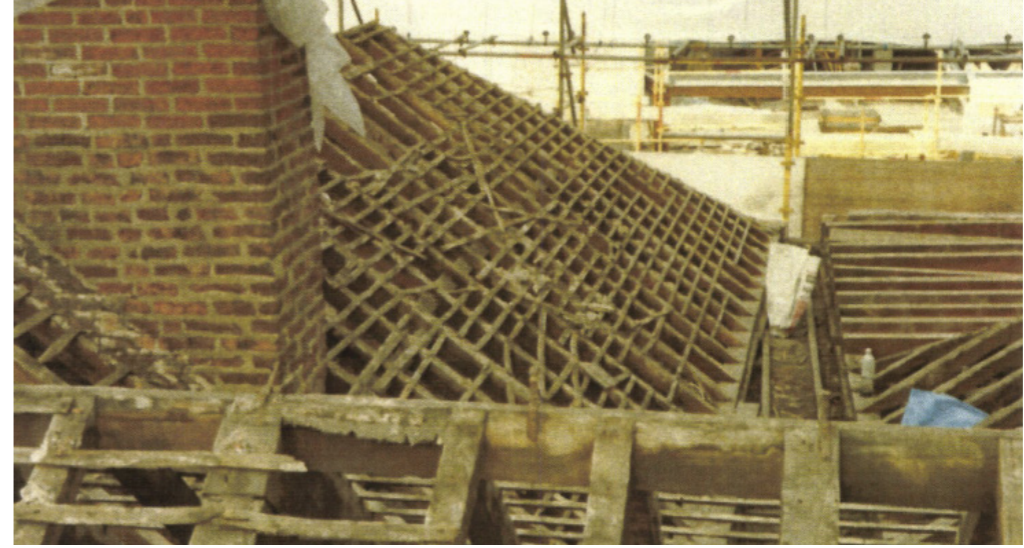
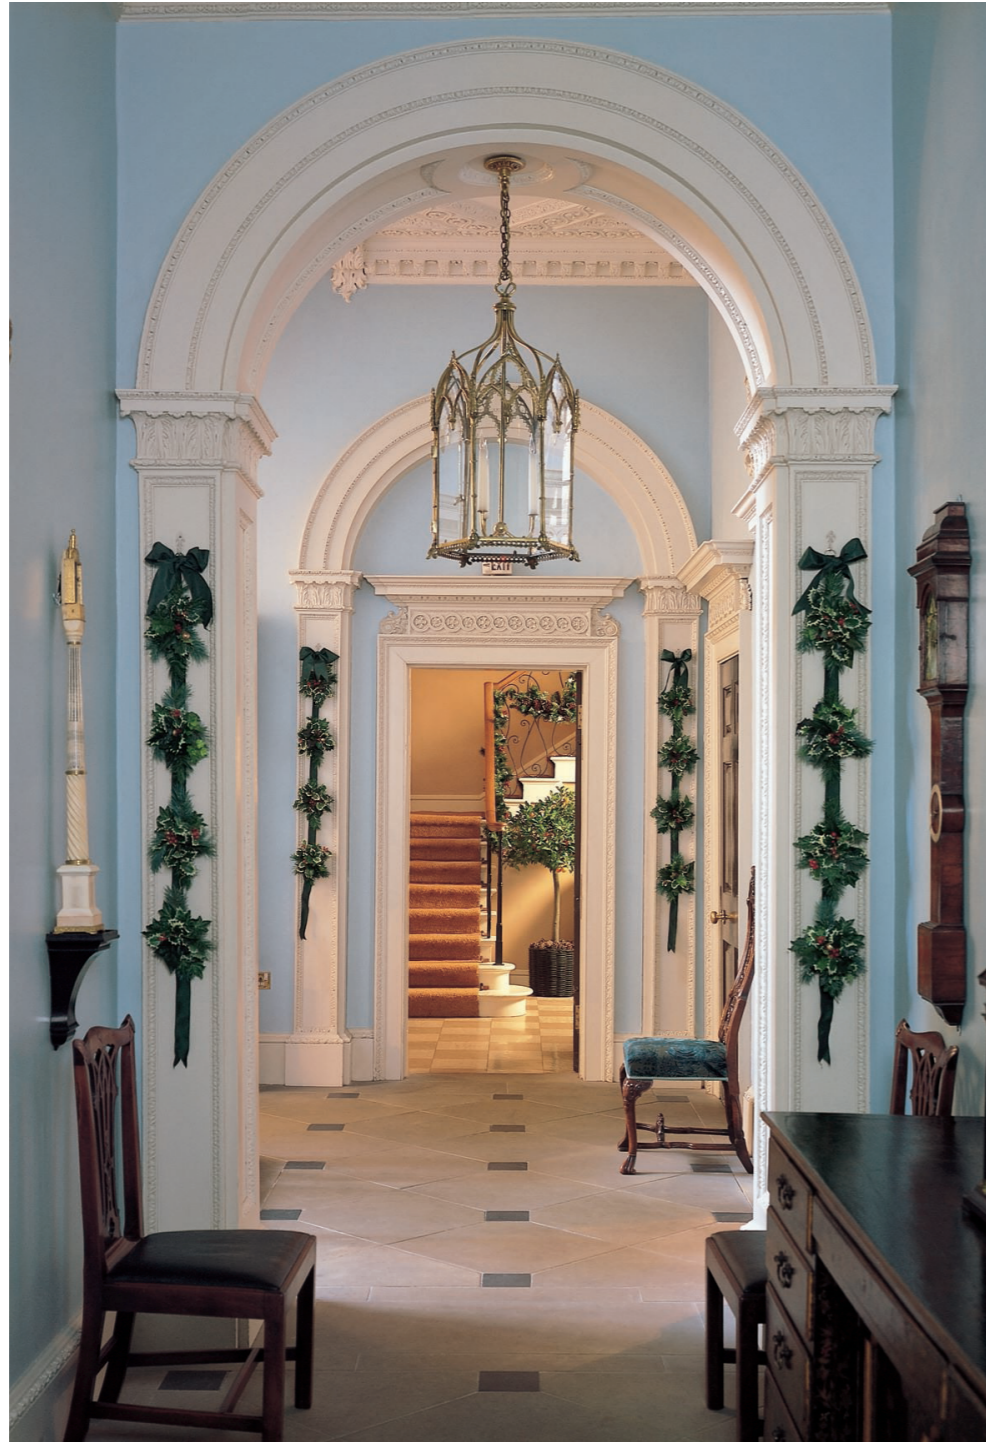
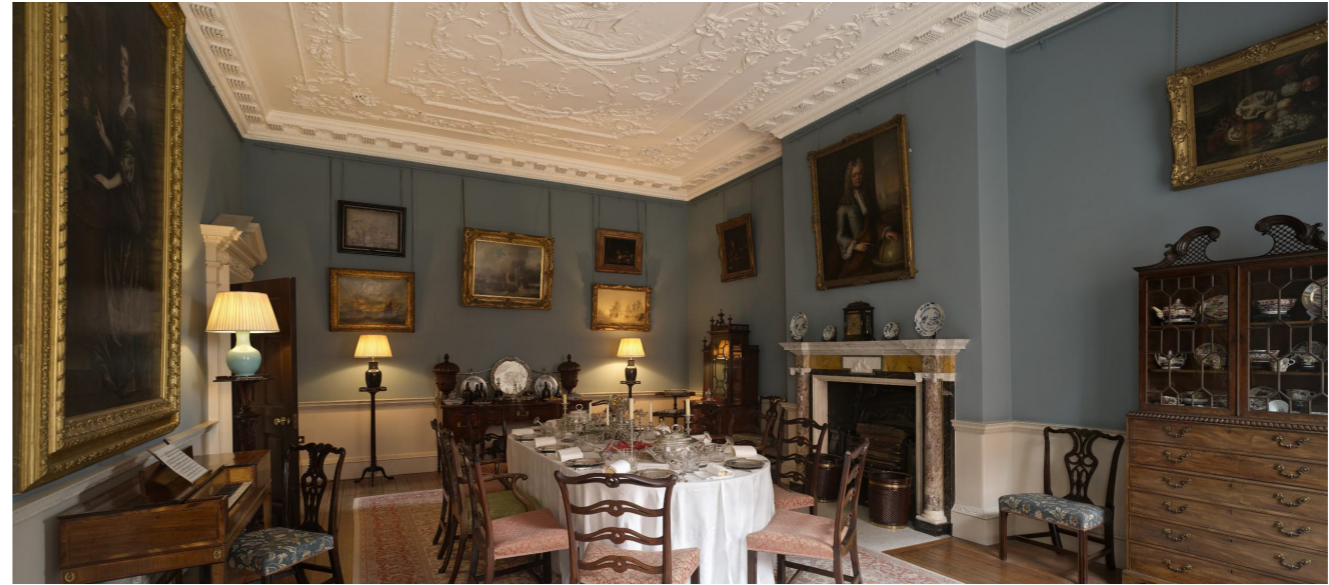
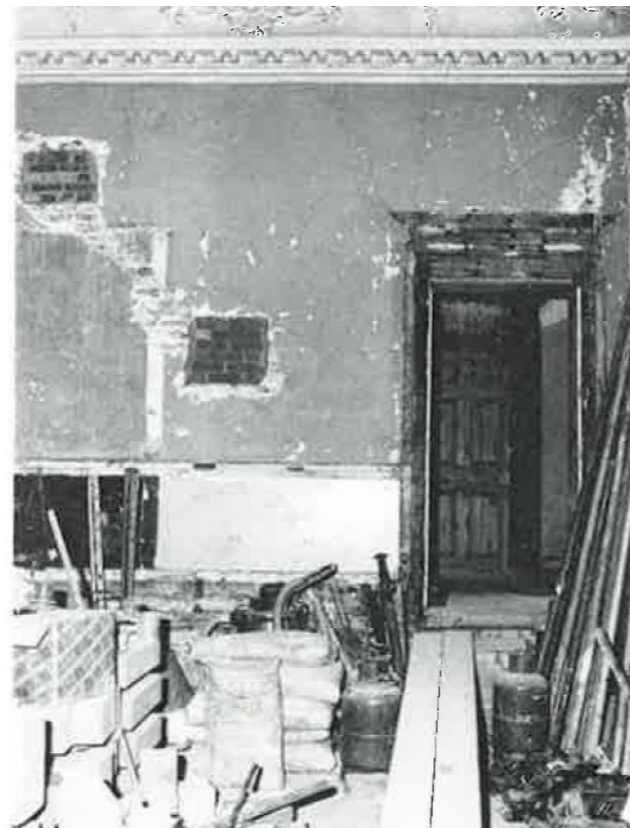
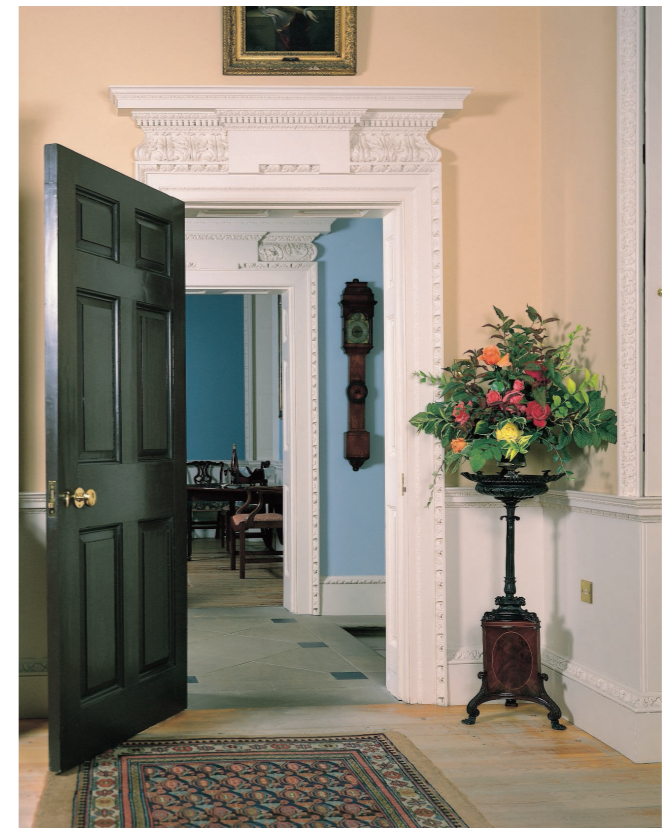
Entrance Hall view through
 to Grand Stair Hall shows
 the succession of arches;
 Restored Dining Room Interior;
 Before and After Restoration
 1980 - 1984, York Civic Trust
 Archive.

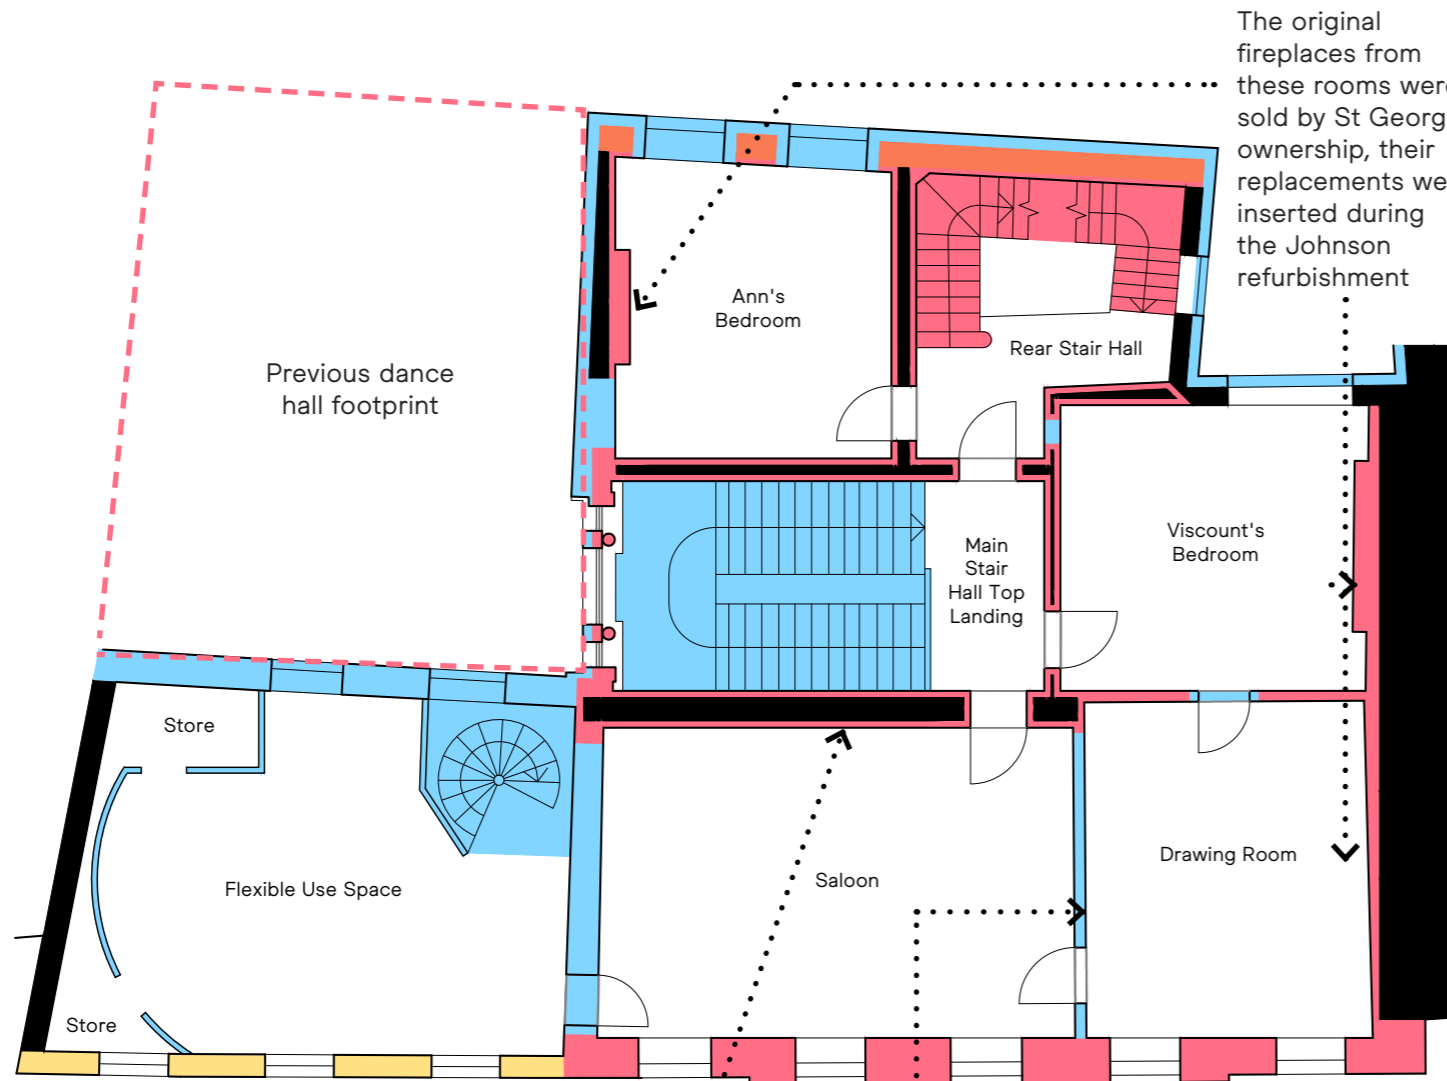
The original fireplaces from these rooms were sold by St George's ownership, their replacements were inserted during the Johnson refurbishment

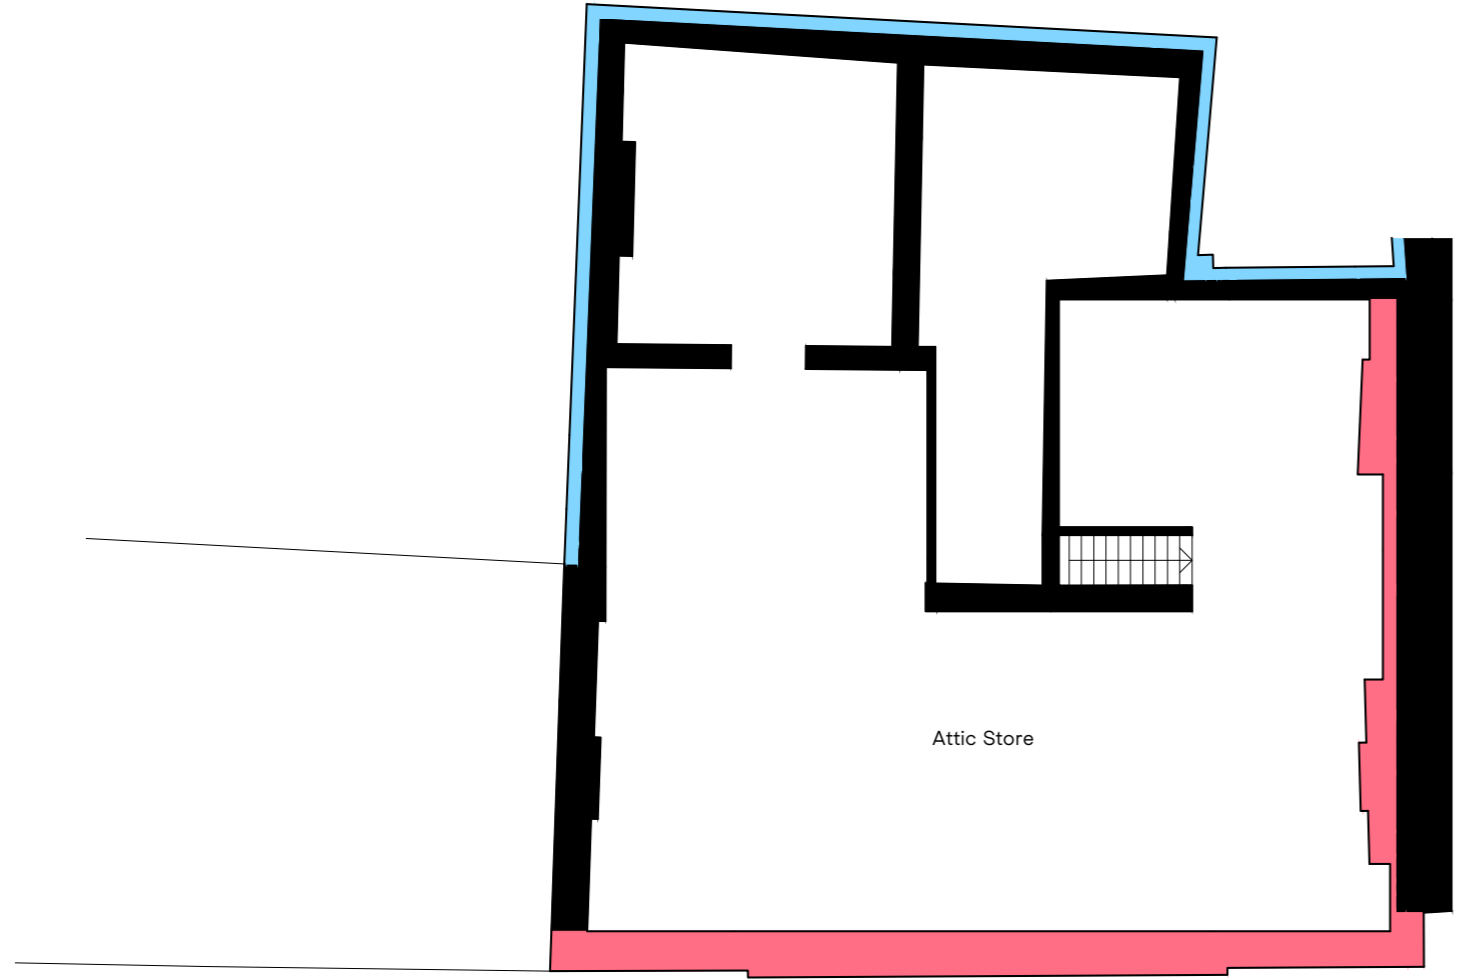
- KEY:**
- Suspected Original Pre 1760
 - Carr Refurbishment 1760
 - Cinema / Dance 1919-1980
 - Johnson Restoration 1984
 - Unknown

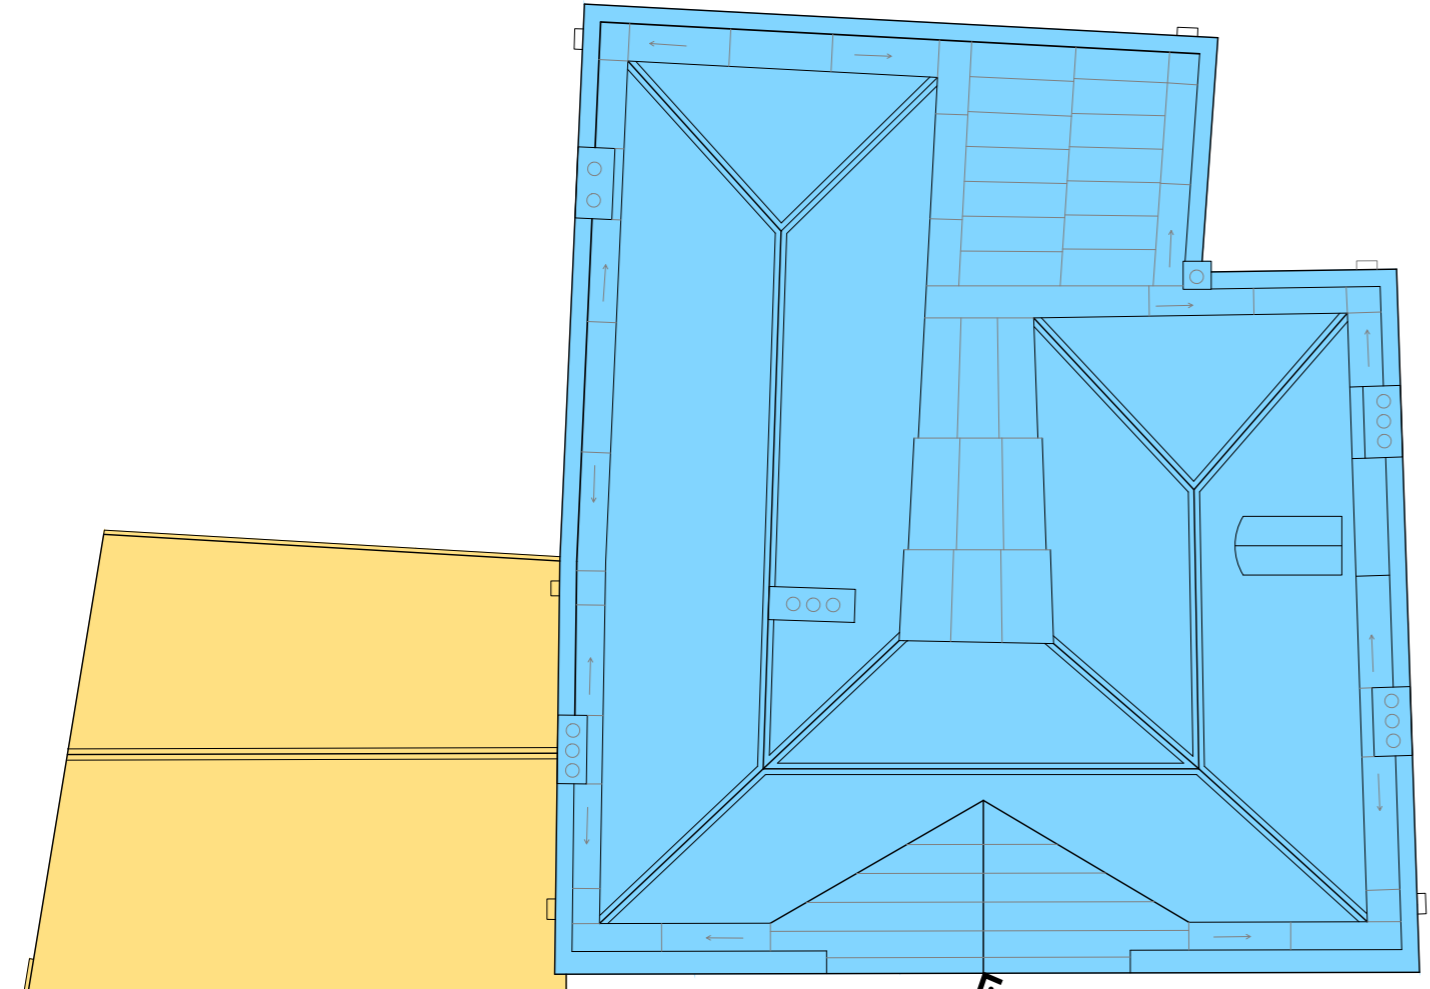
• Pediment replaced in the Johnson restoration.

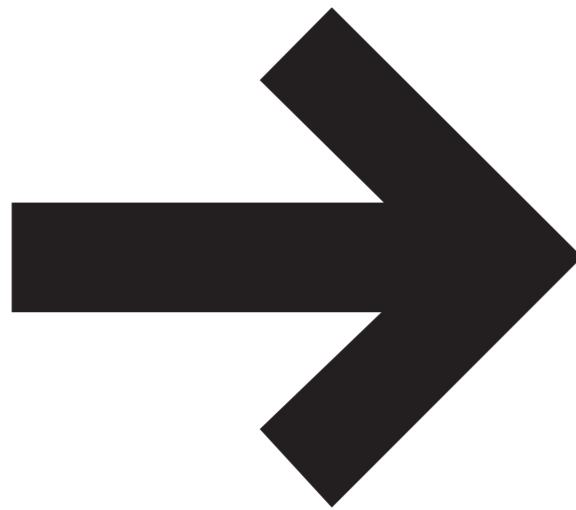
Today, Fairfax House is an Accredited Historic House Museum and the base for York Civic Trust. Owned by York Conservation Trust, the House is generally in good condition as a consequence of the custodians recognising and prioritising emergency works since its restoration. There are still areas which require improvement and significant upheaval is required to bring the building up to modern standards befitting a museum and workplace.
