Fairfax House, York

Conservation Management Plan

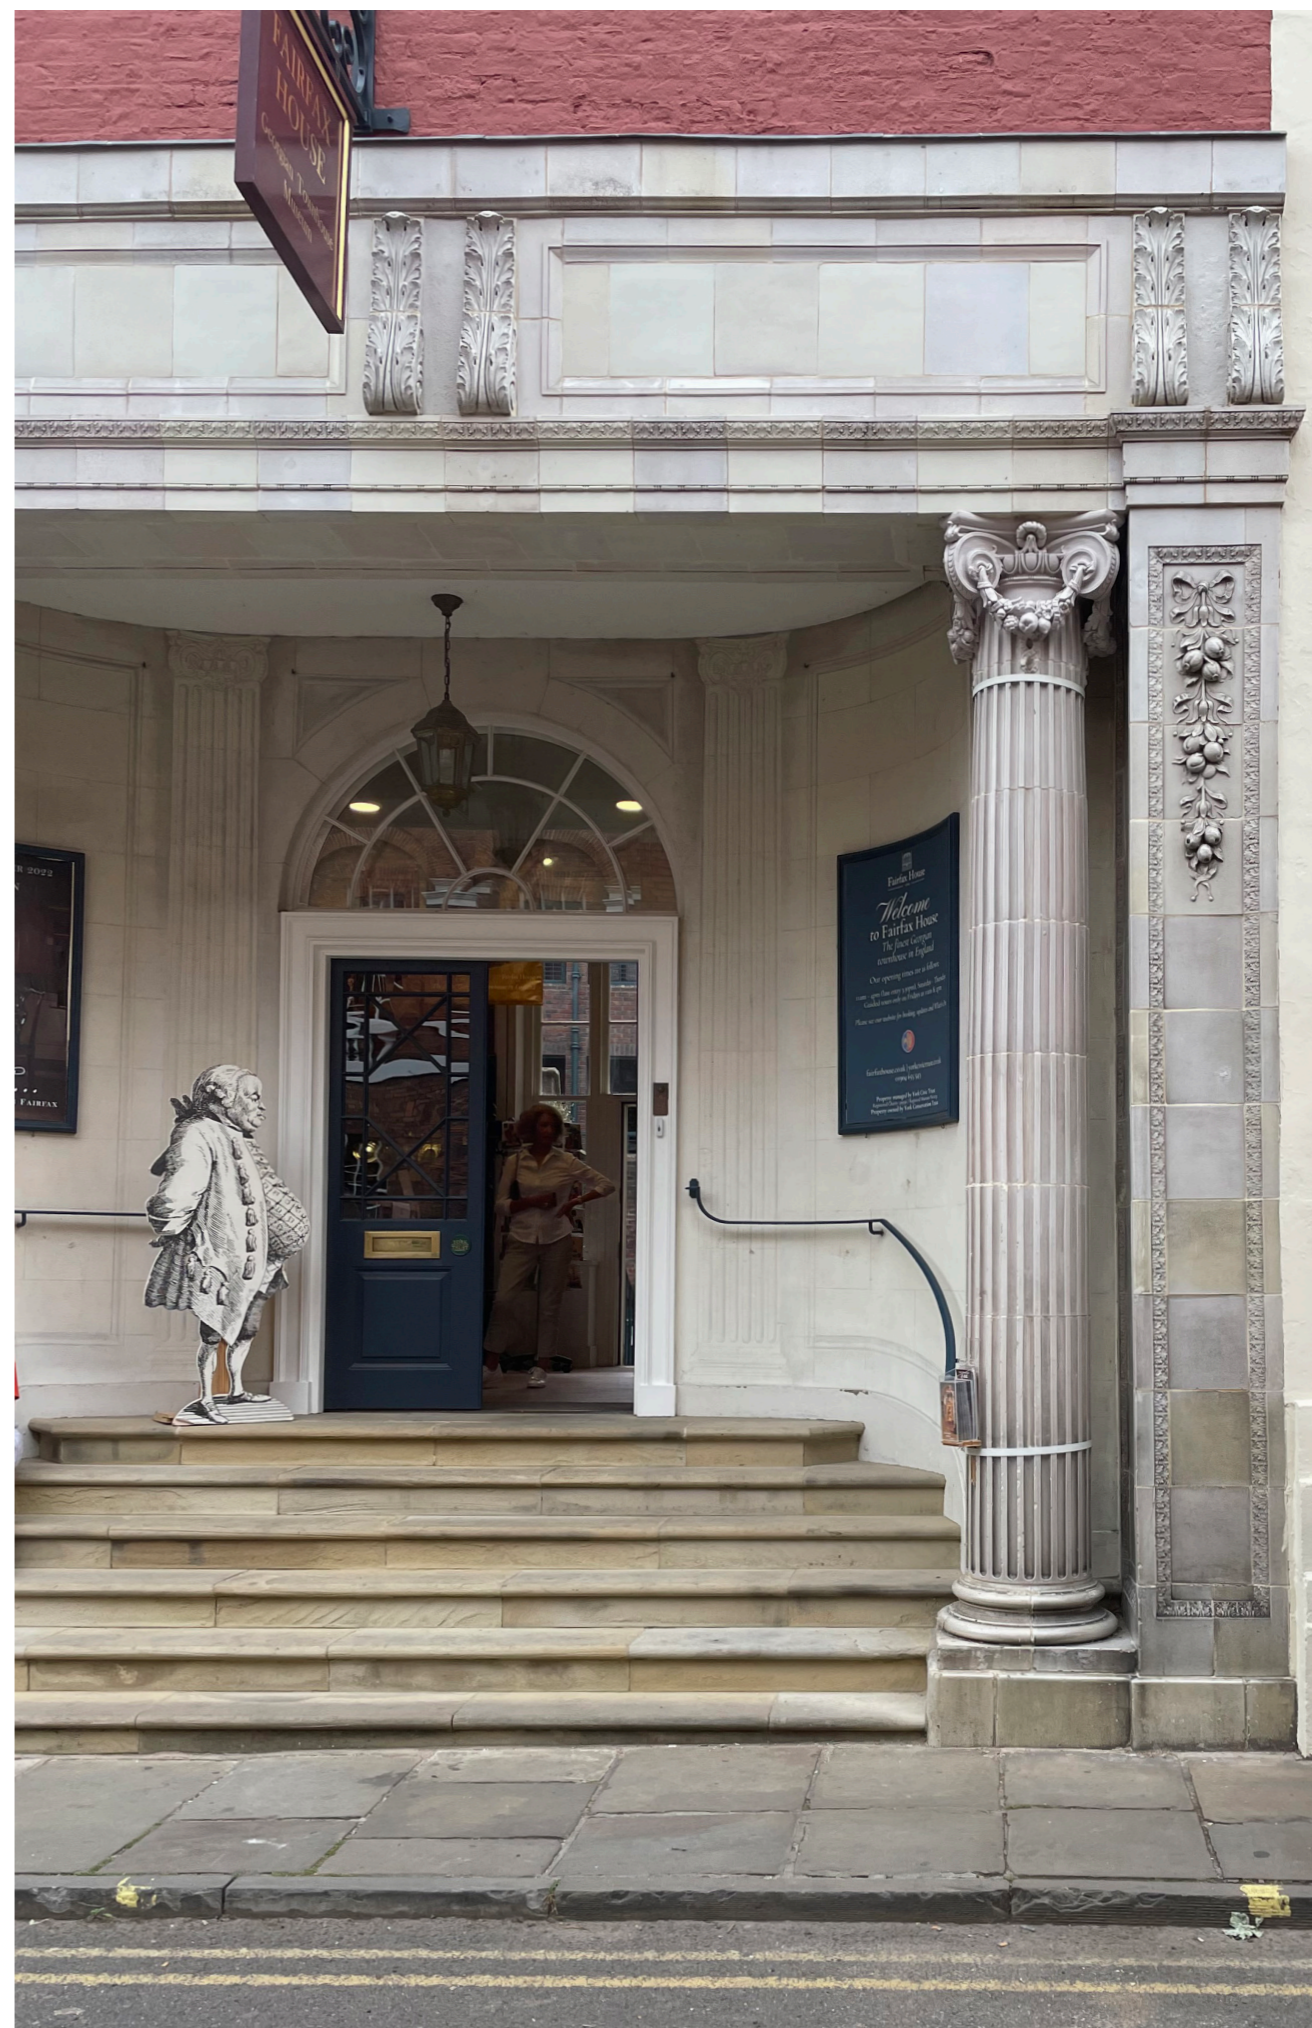
Right: Stepped access to the Museum entrance presents a physical and psychological barrier to visitors and staff.

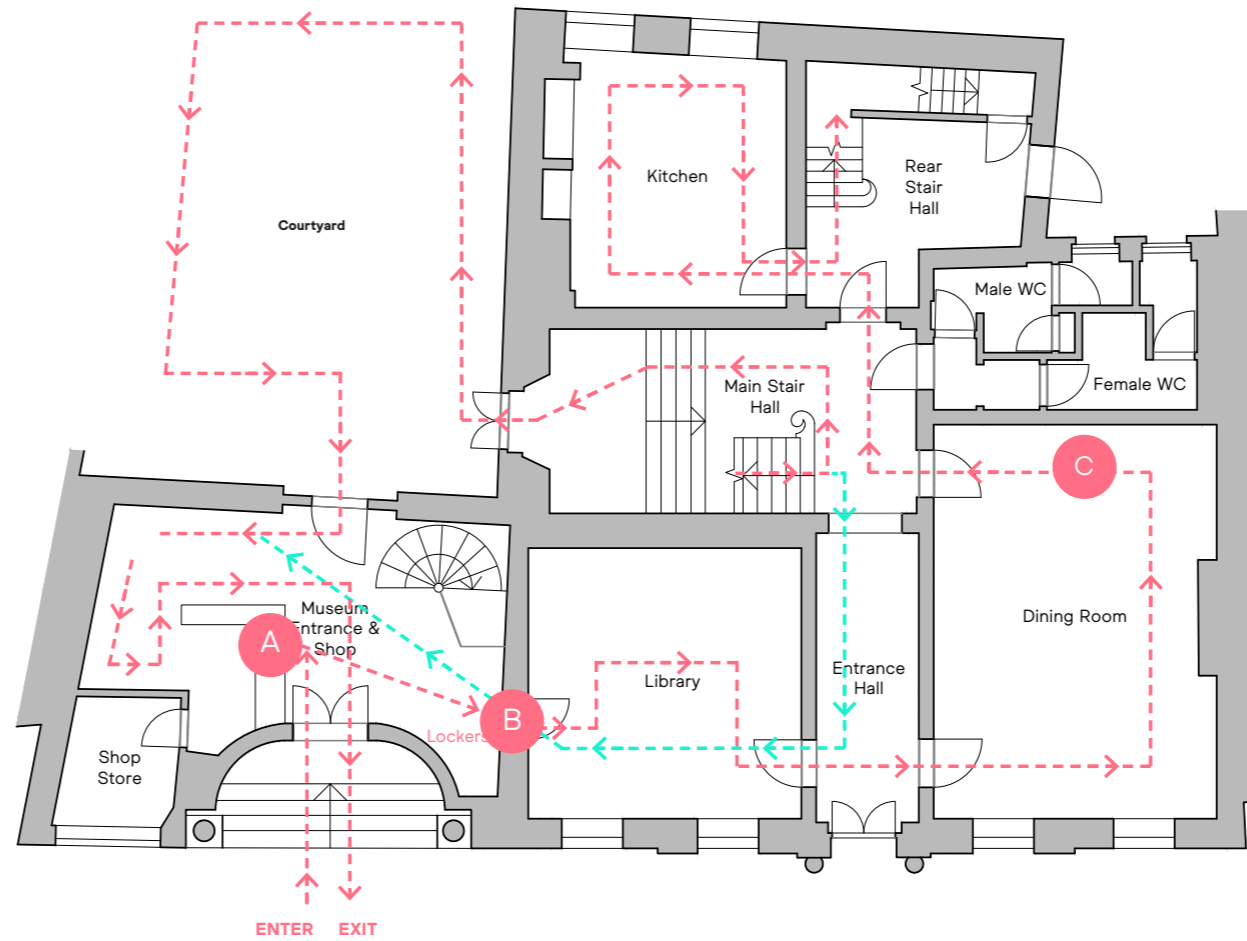
Existing First Floor Plan

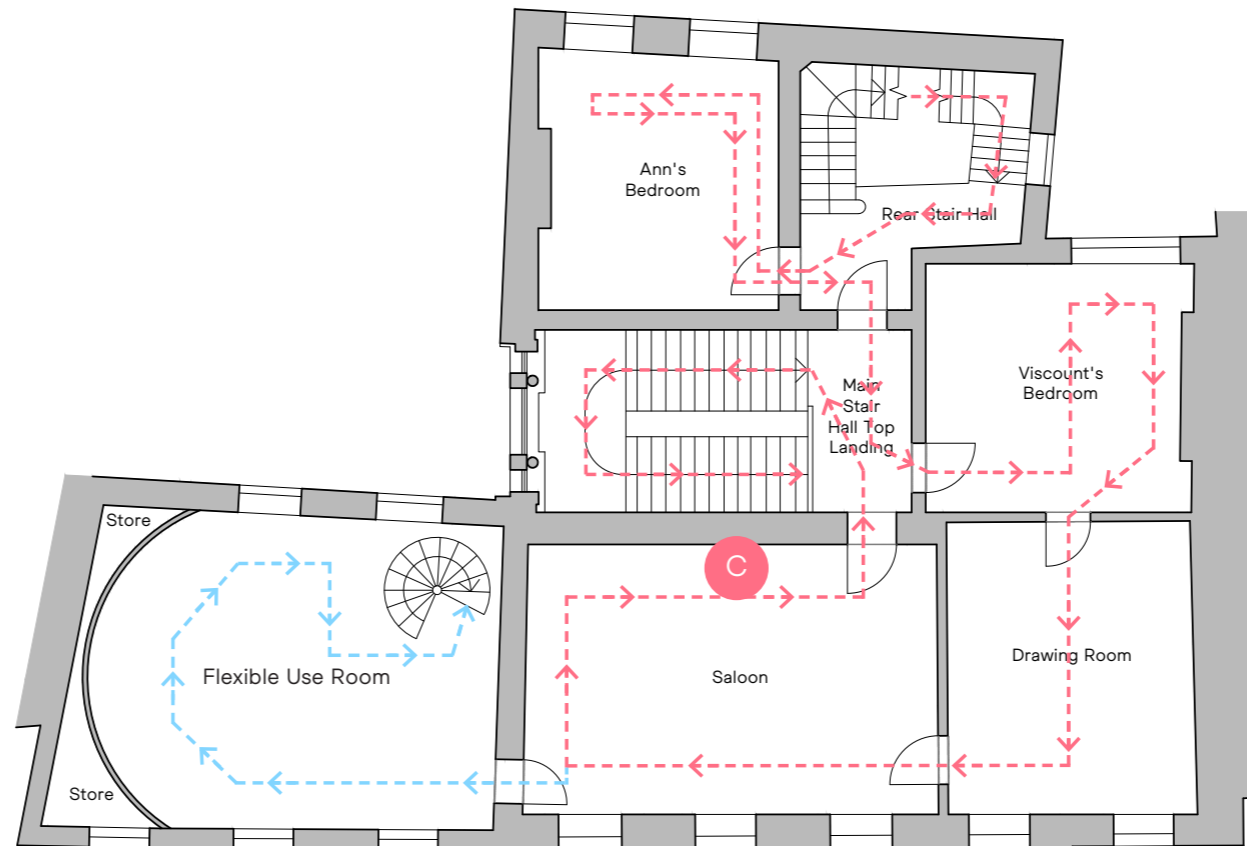
3.10.3 Building Structural Appraisal Mason Clark Associates

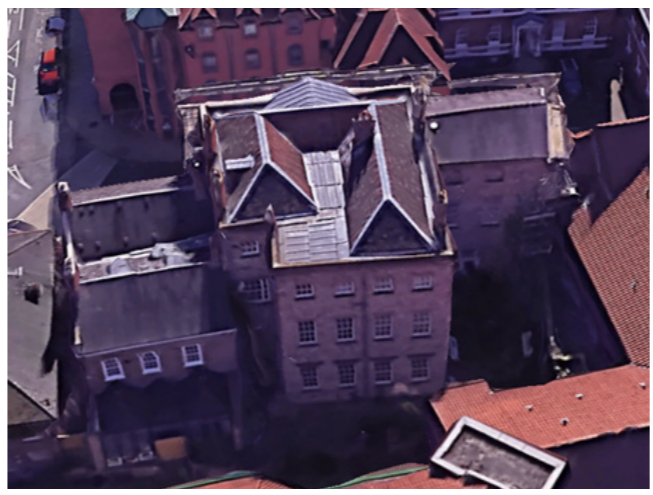
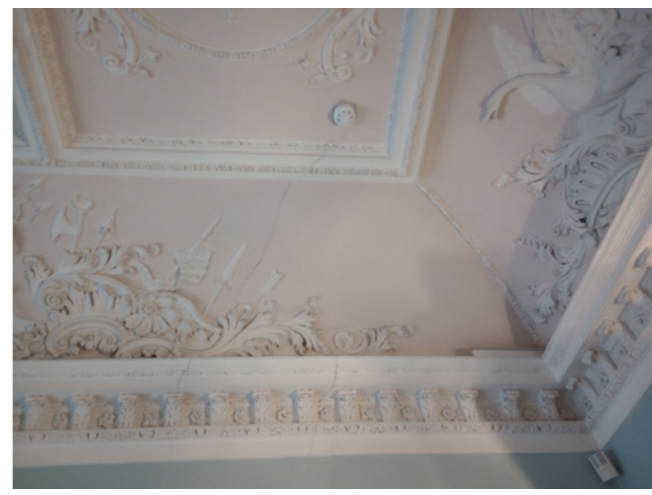
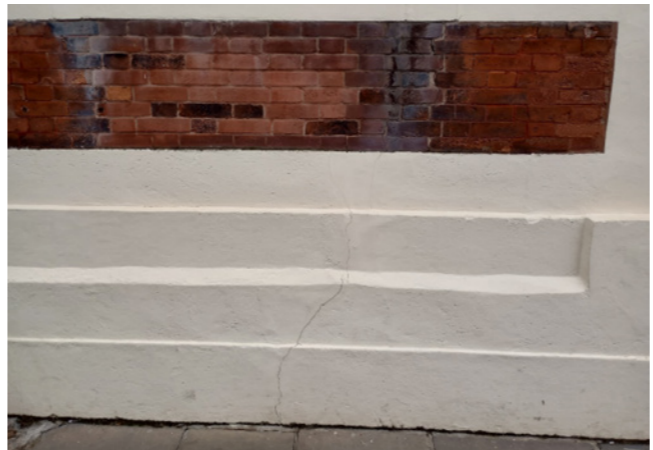
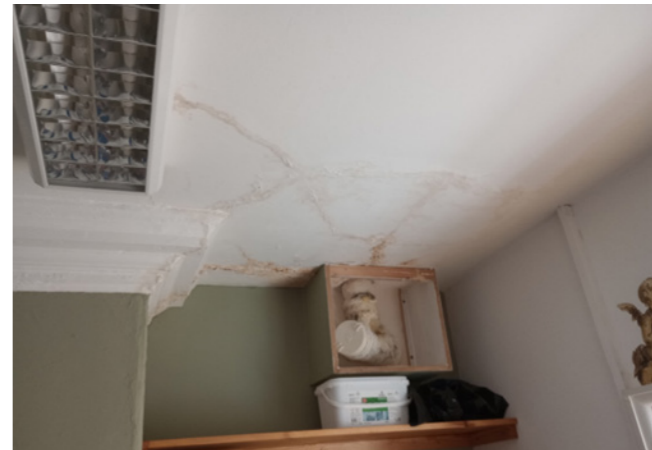
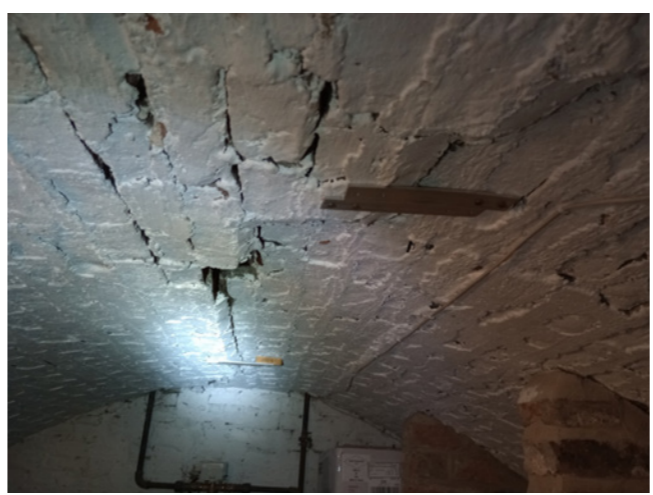
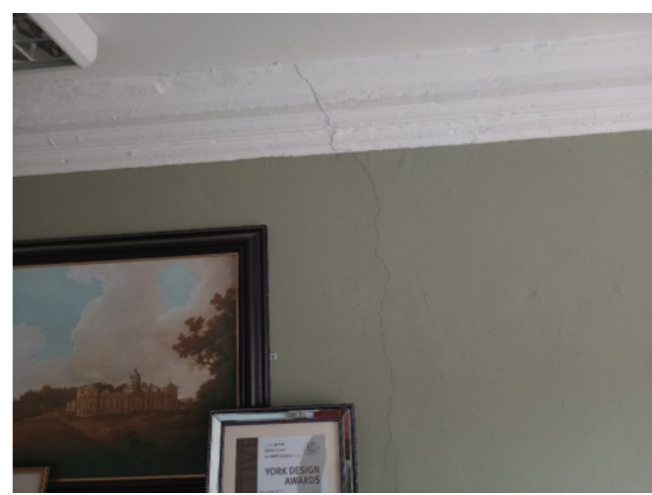
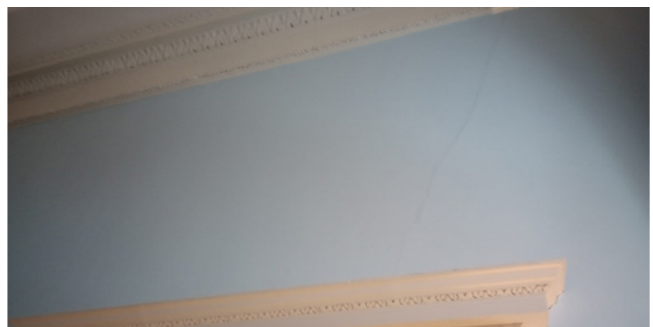
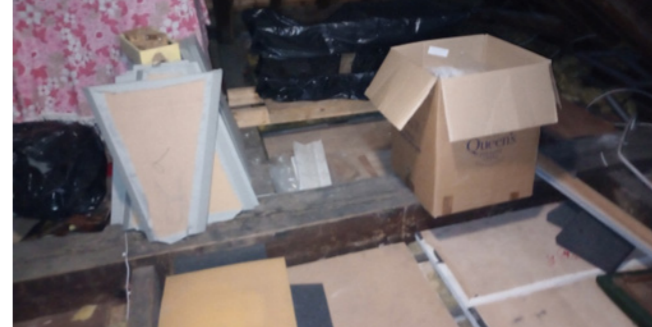
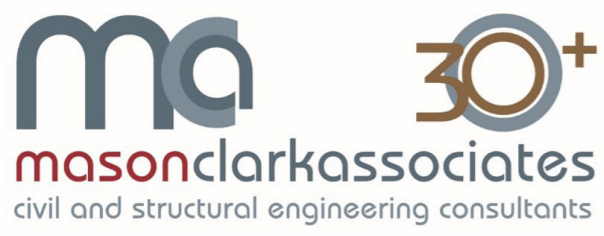
Varying image extracts taken from Mason Clark Report, March 2023.

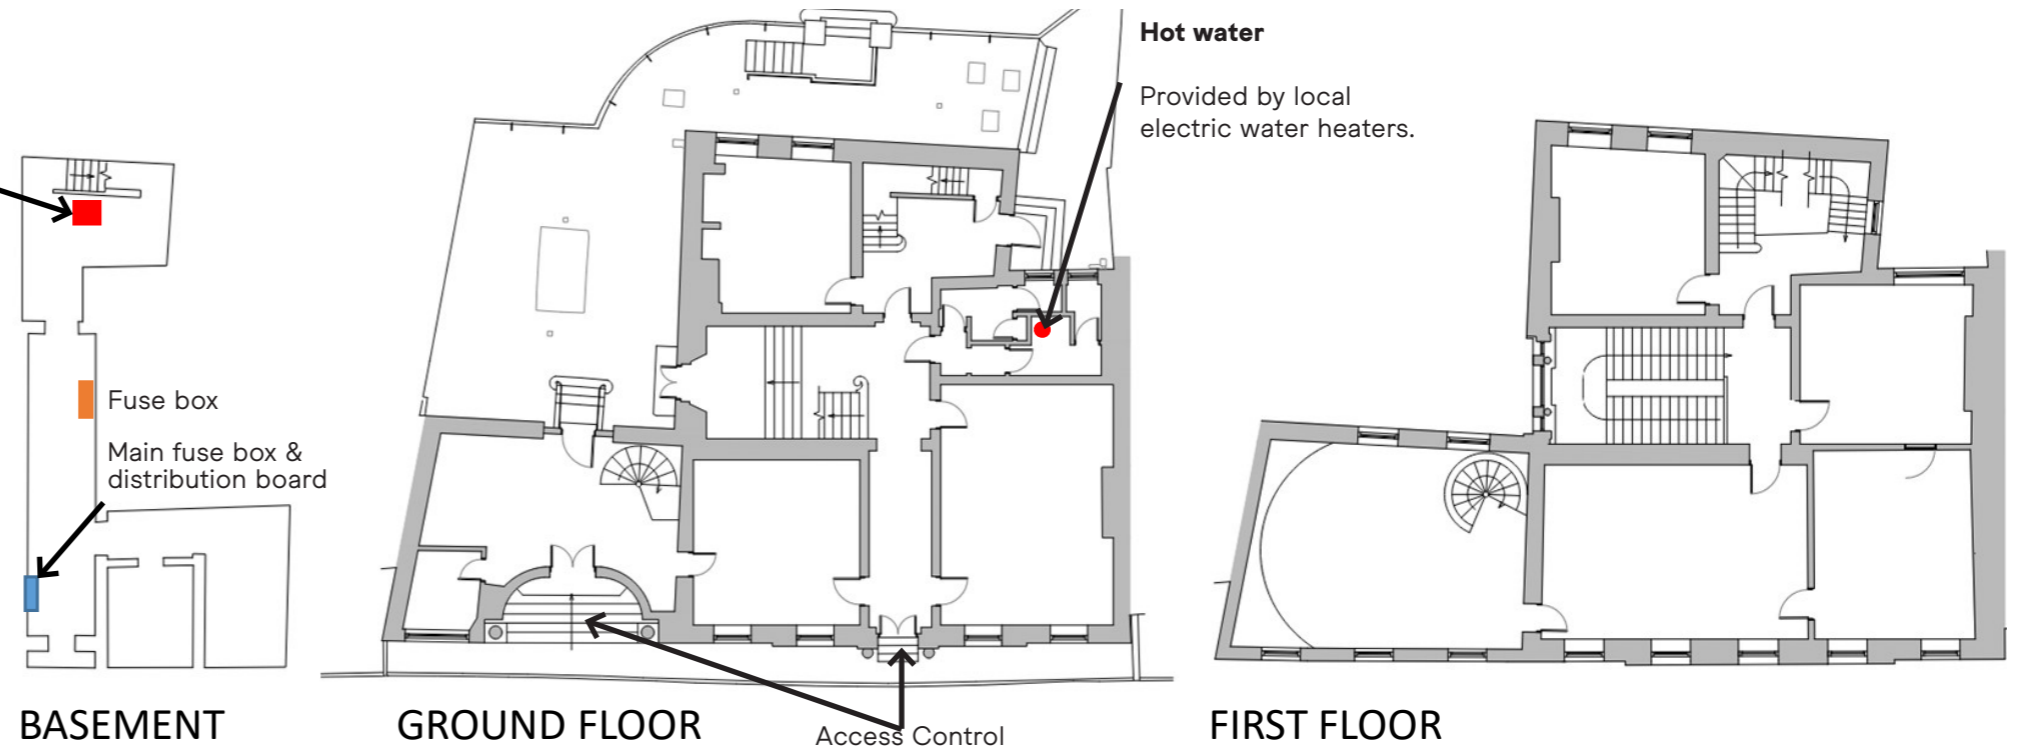
Some sensors and sounders are old and faulty and require replacement with new units with longer lifespan and lower energy costs.

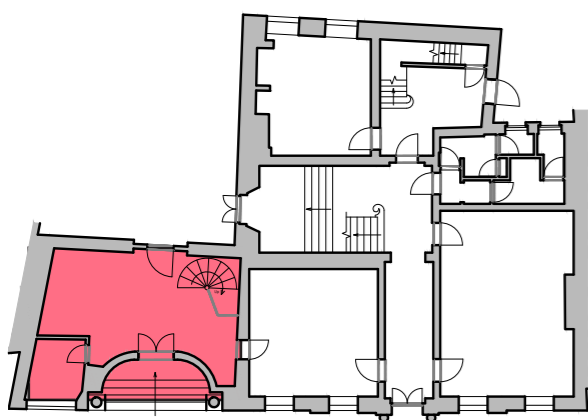
KEY - Ground Floor Plan, NTS. Area identified in pink.

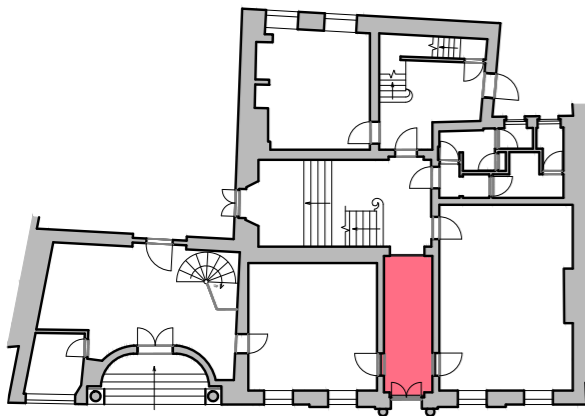
KEY - Ground Floor Plan, NTS. Area identified in pink.

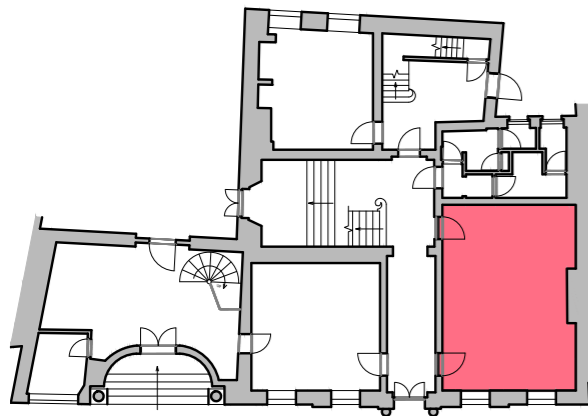
KEY - Ground Floor Plan, NTS. Area identified in pink.

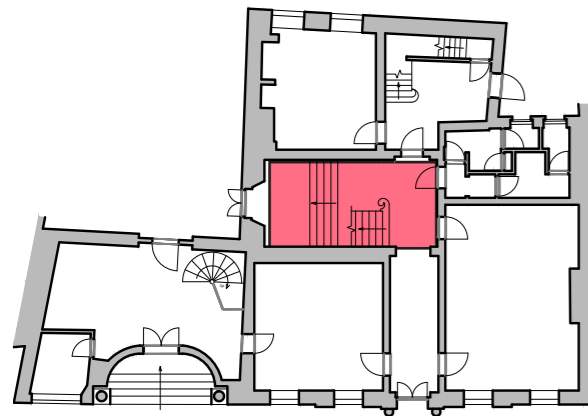
KEY - Ground Floor Plan, NTS. Area identified in pink.

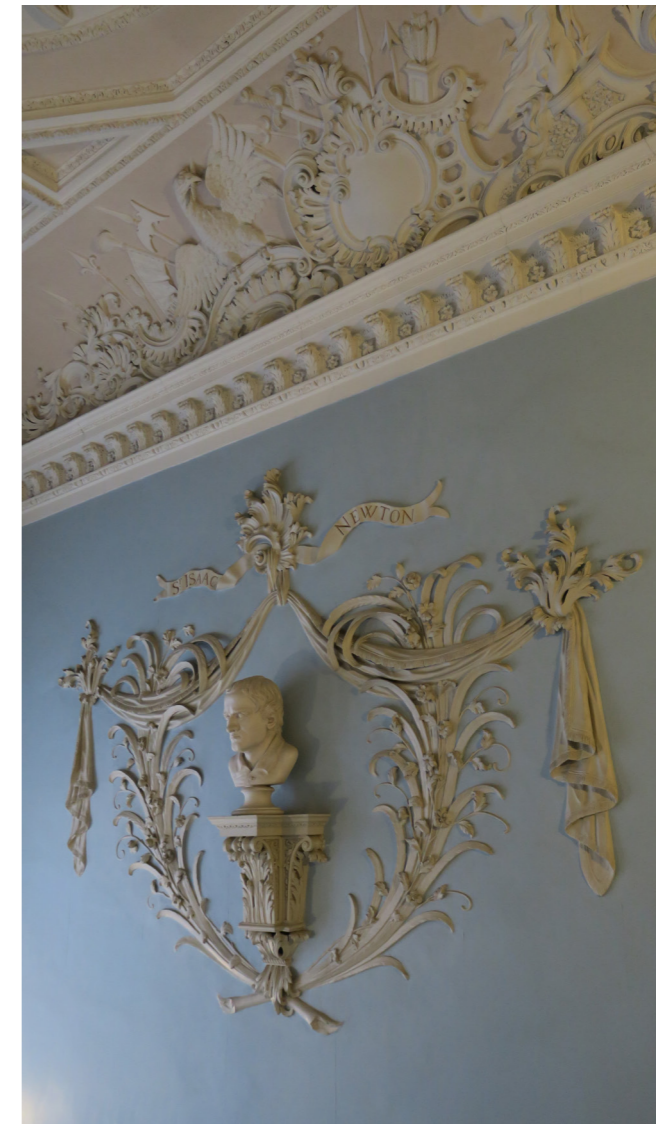
North elevation decorative detail shows stucco cartouche with crossed palm leaves and drapery. With replica Sir Isaac Newton bust.

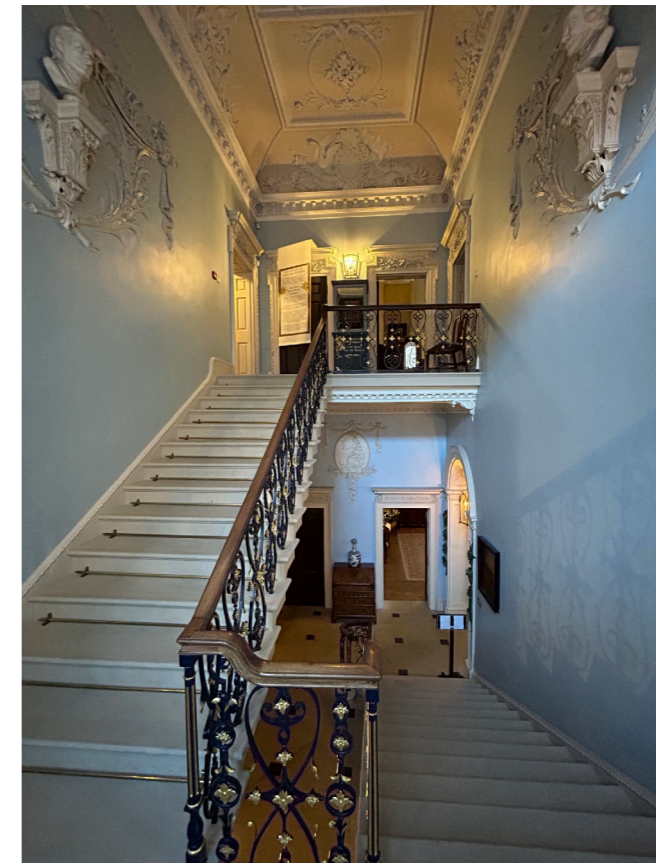
East view of room from stair landing.

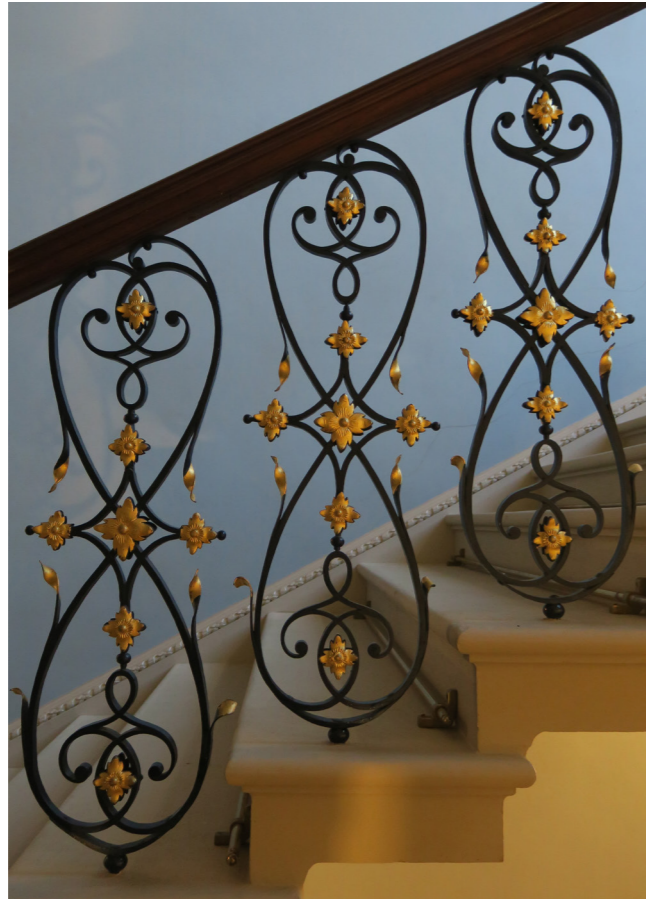
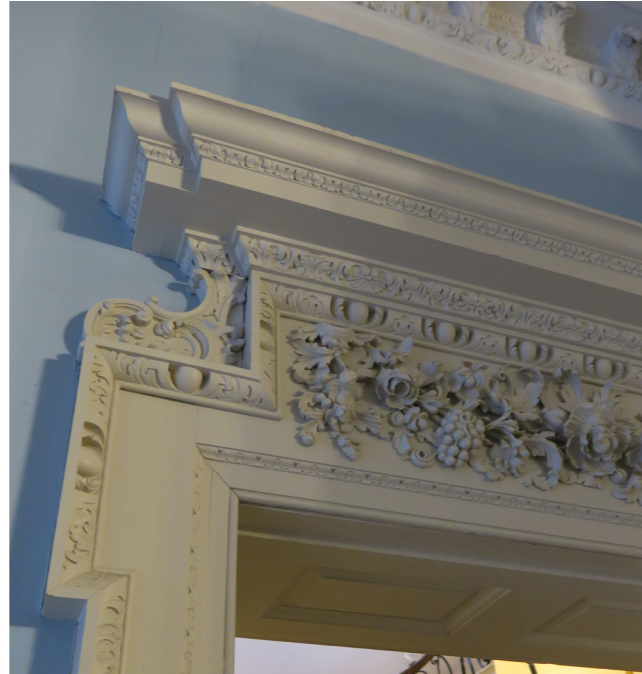
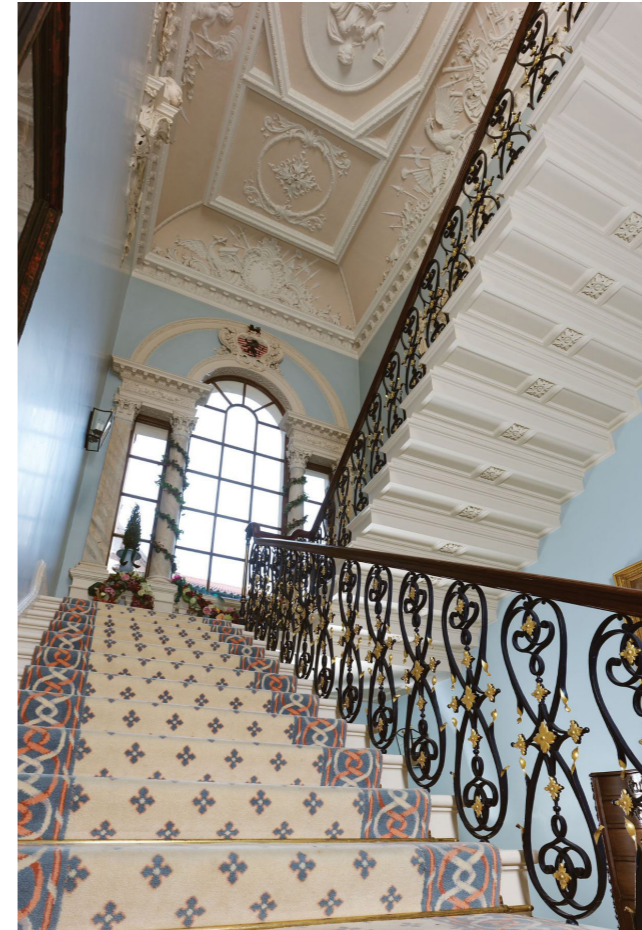
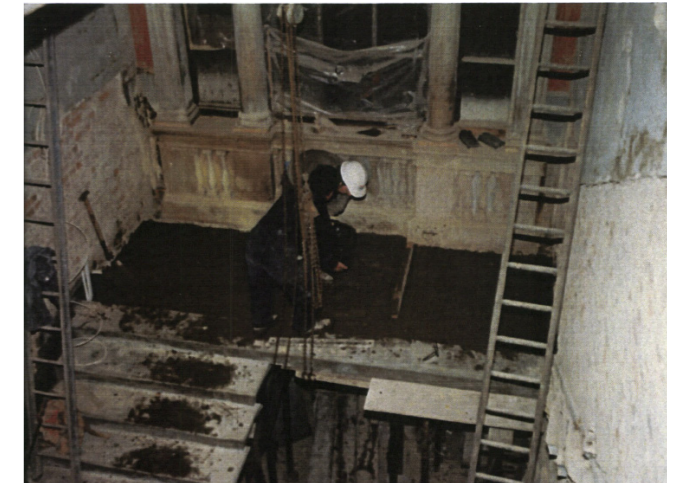
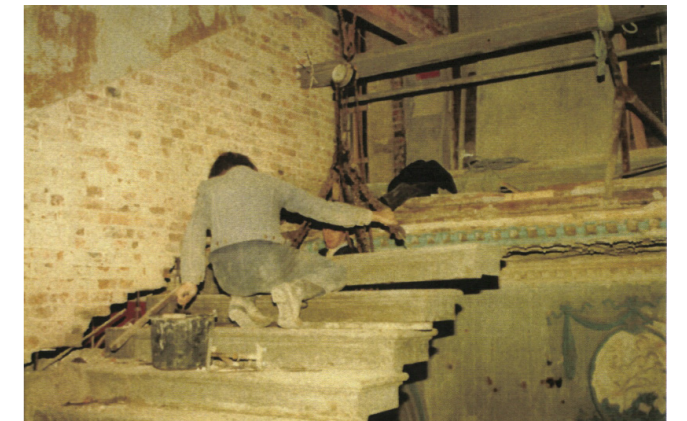
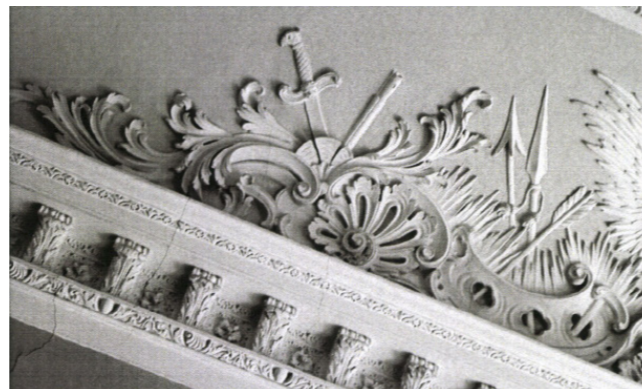
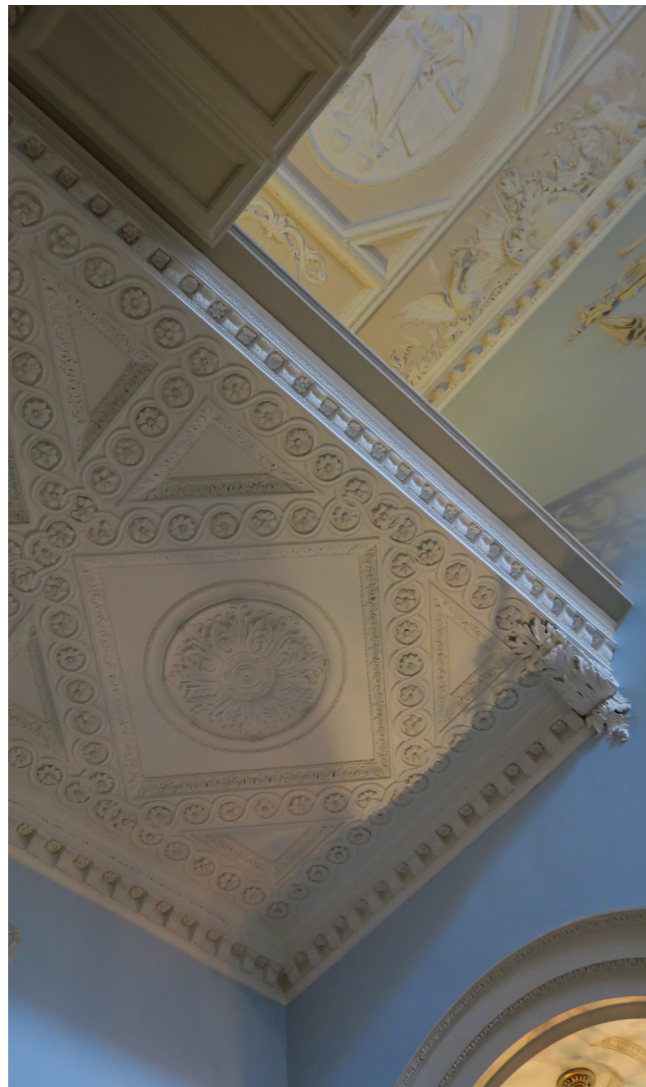
Left to Right -
First floor landing ceiling detail; Architecture Militaire stuccowork detail to centre of ceiling; c. 1980 following cinema redecoration and extension, note the bricked up window before restoration; c.1982-3 Work in progress throughout restoration; Stair underside plasterwork detail.

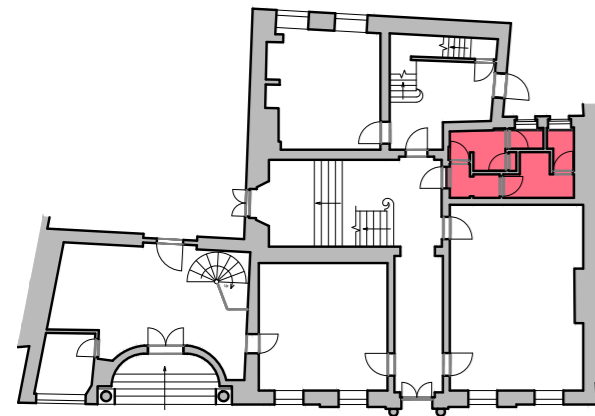
KEY - Ground Floor Plan, NTS. Area identified in pink.

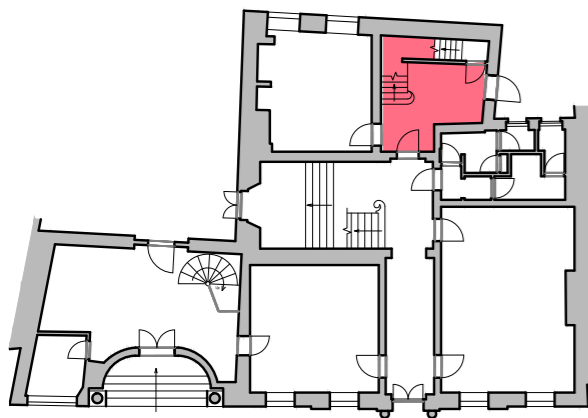
KEY - Ground Floor Plan, NTS. Area identified in pink.

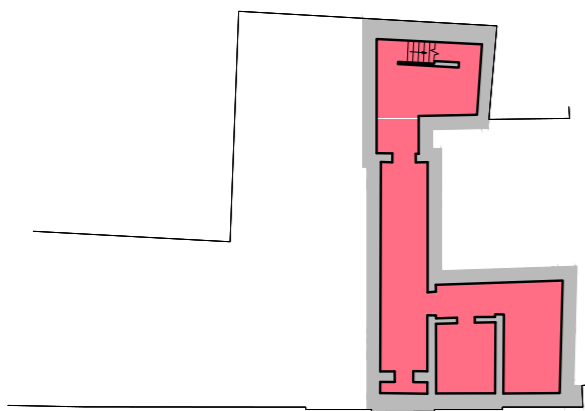
KEY - Basement Floor Plan, NTS. Area identified in pink.

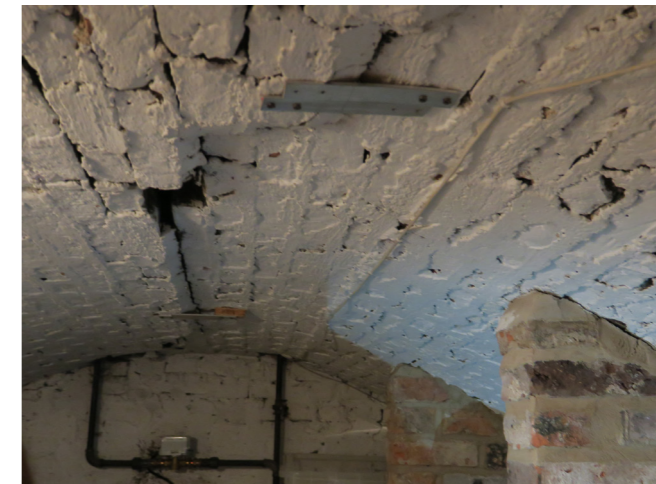
East Cellar, Structural Crack to Ceiling.

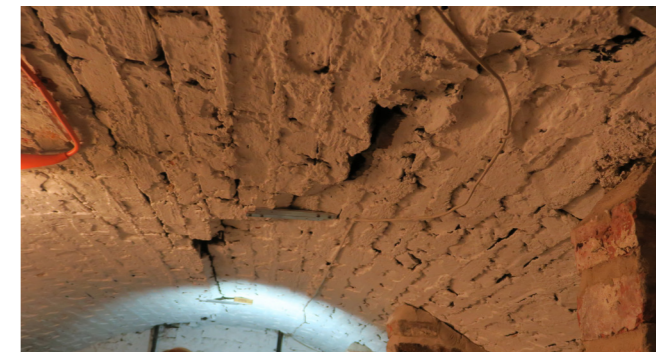
East Cellar, Structural Crack to Ceiling.

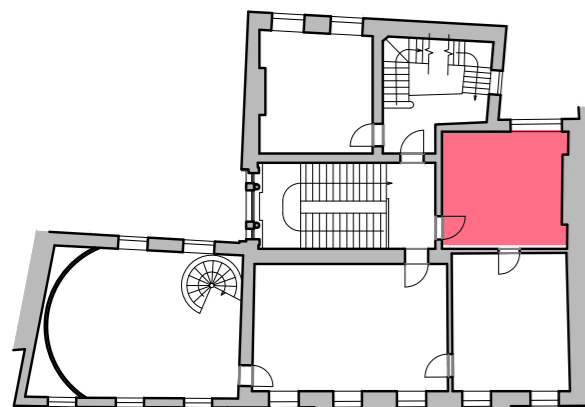
KEY - First Floor Plan, NTS. Area identified in pink.

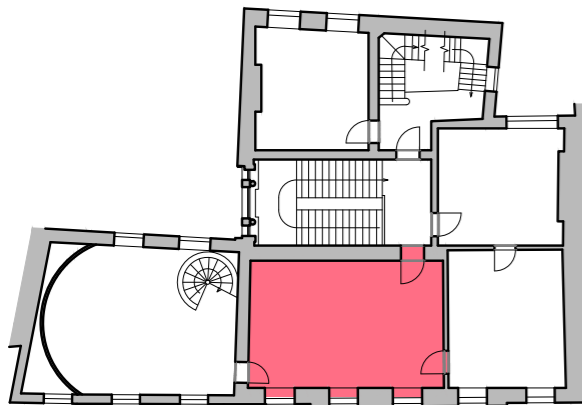
KEY - First Floor Plan, NTS. Area identified in pink.

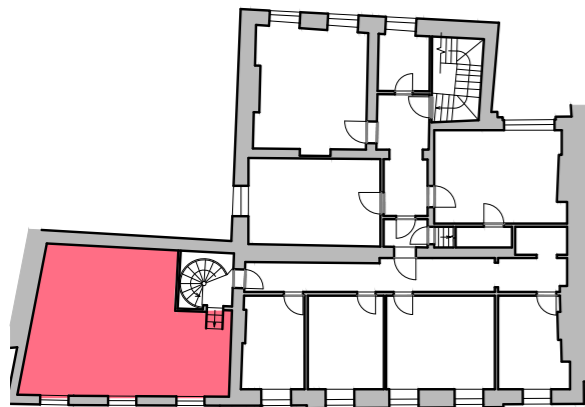
KEY - Second Floor Plan, NTS. Area identified in pink.

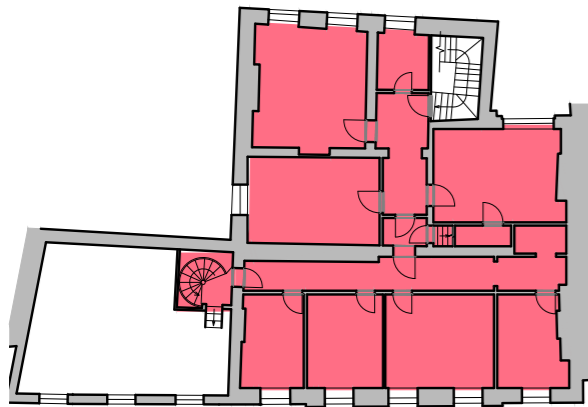
KEY - Attic above Second Floor, NTS. Area identified in pink.

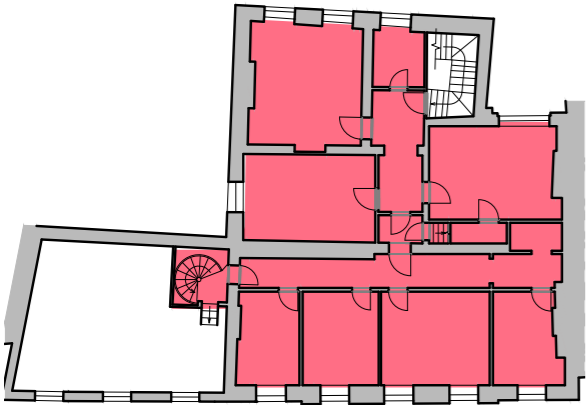
KEY - Second Floor Plan, NTS. Area identified in pink.

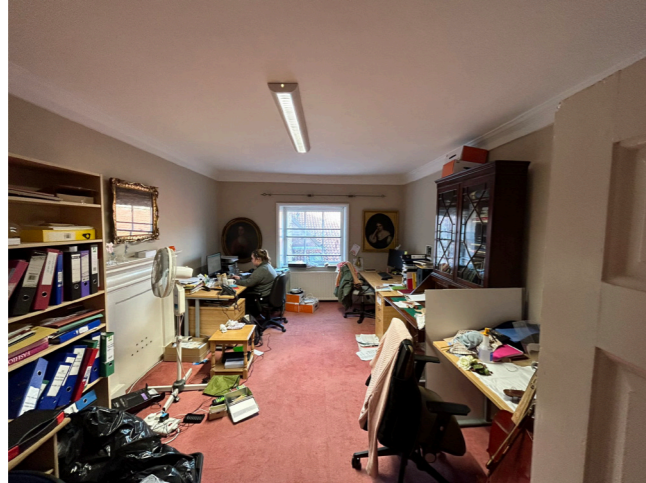
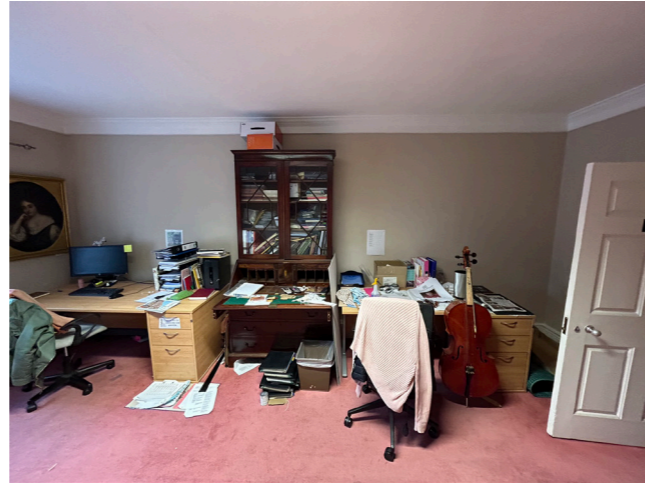
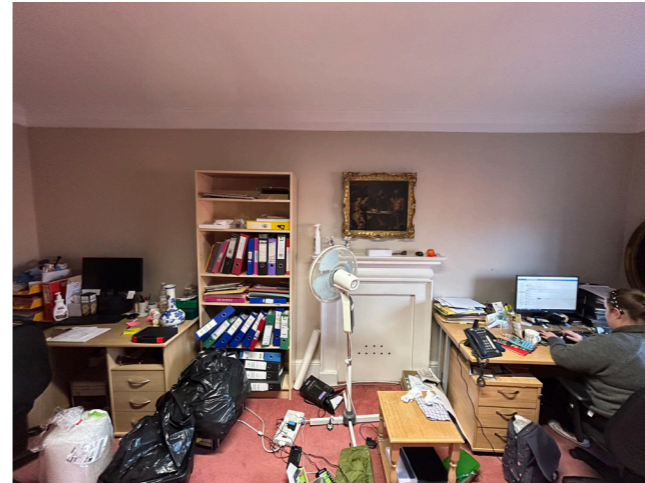
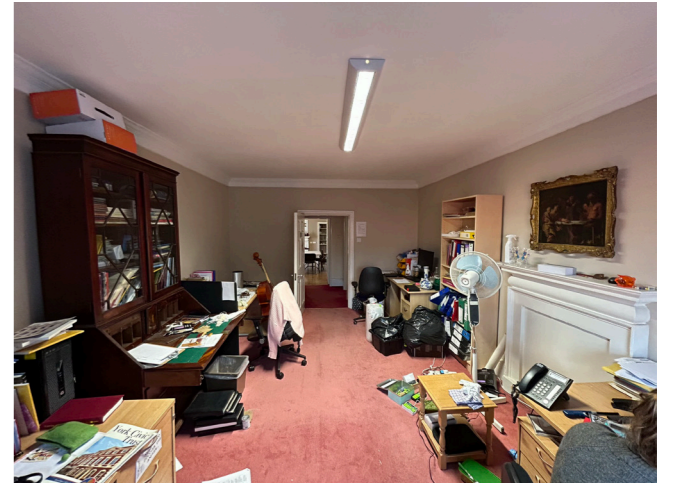
Kitchen - East Elevation; North
Elevation; West Elevation;
Hairline Fractures to Ceiling.

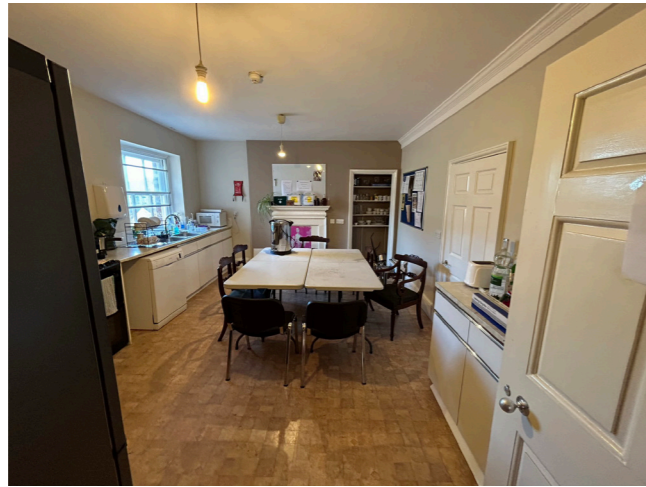
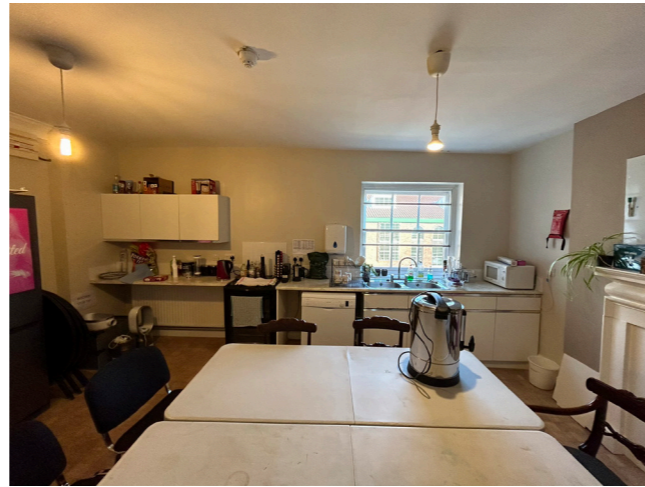
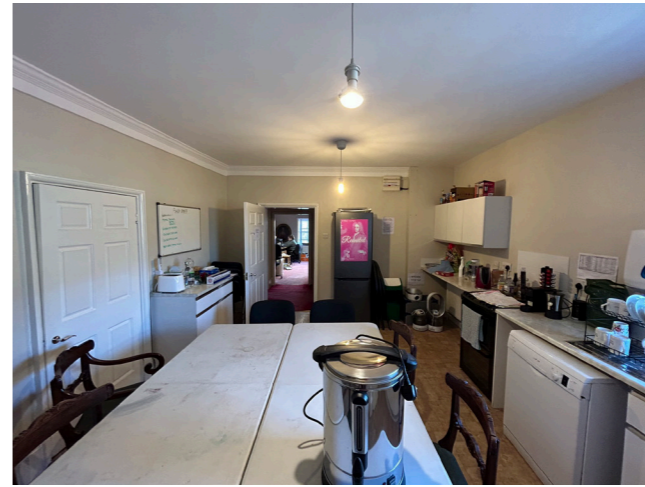
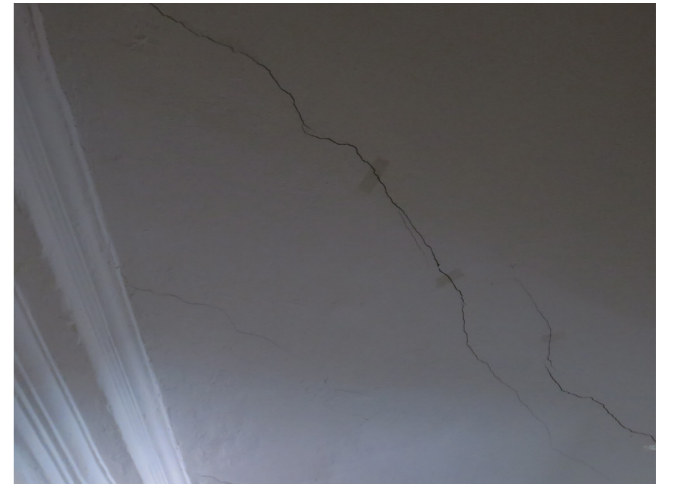
East Archive Room, Leak to
South-East Corner of Room;
Cracking to Ceiling near door;
Bathroom - West Elevation;
East Elevation.

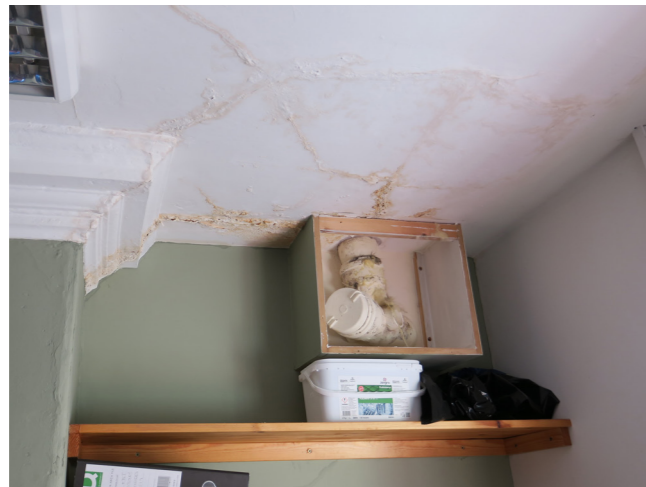
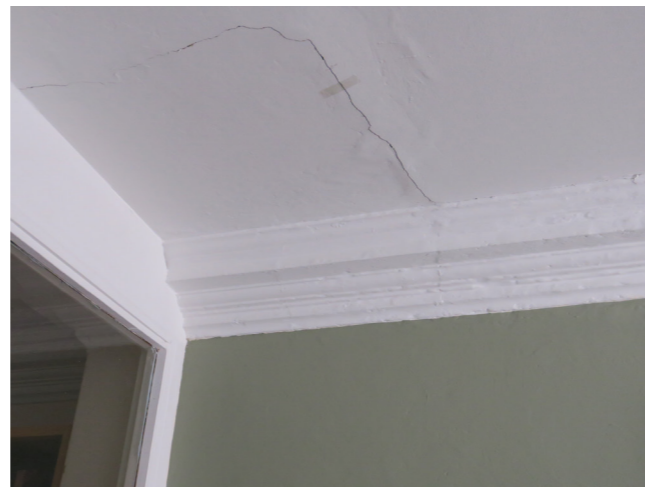
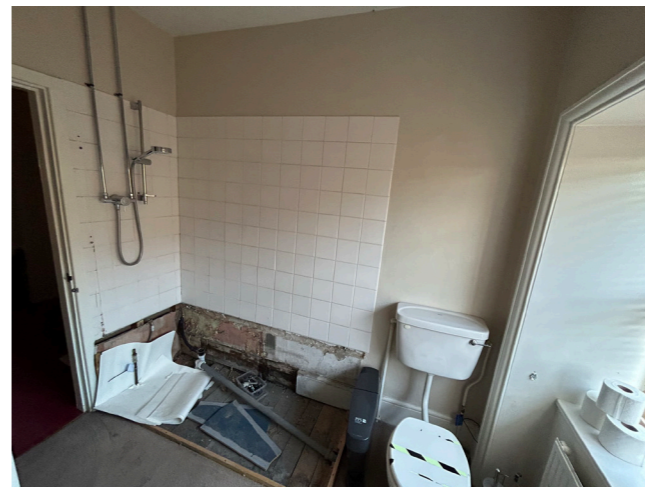
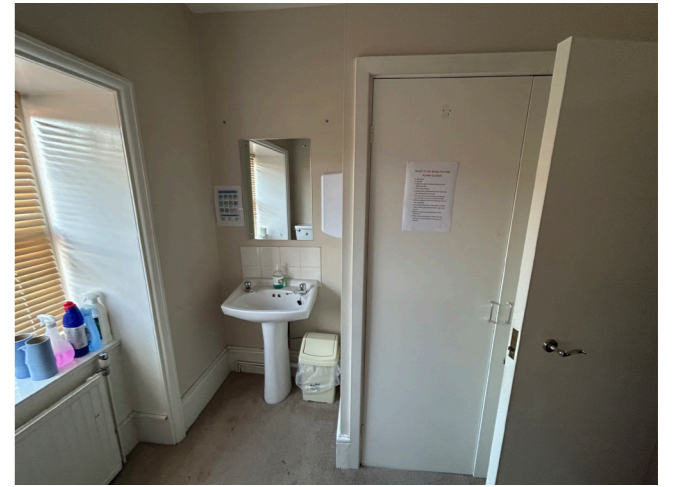
5.17 Rear Facade, Elevations & Courtyard

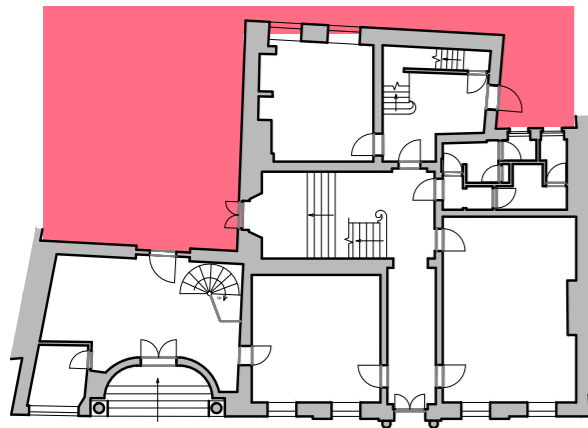
KEY - Ground Floor Plan, NTS. Area identified in pink.

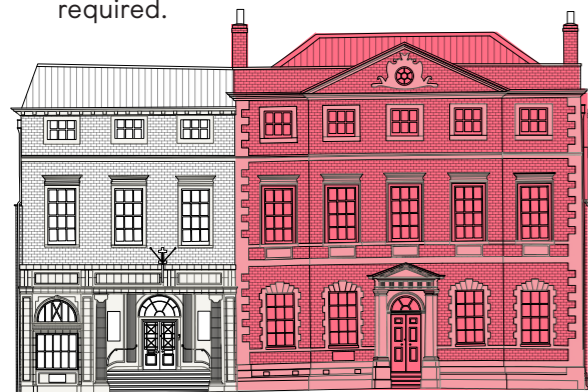
KEY - South Elevation, NTS. Area identified in pink.

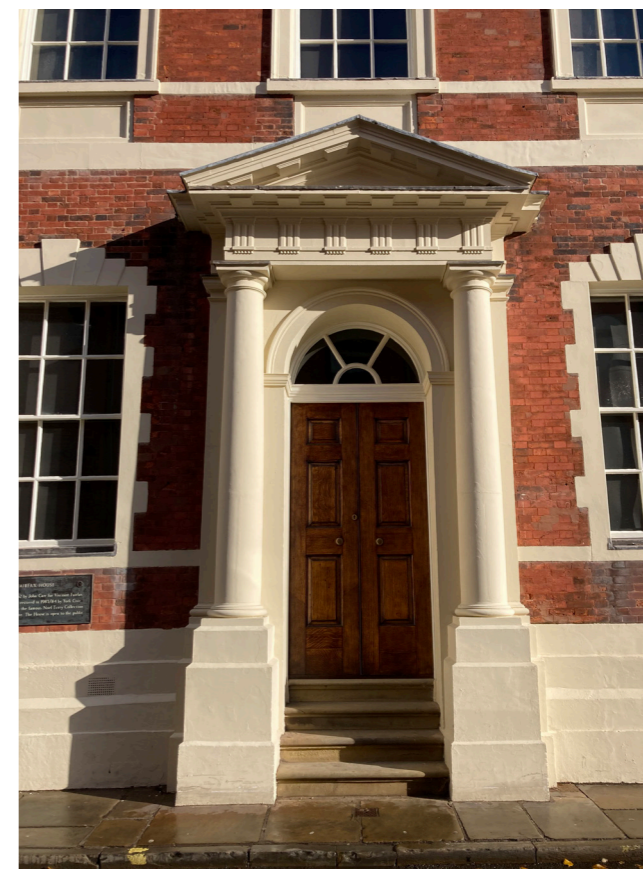
South Elevation, main entrance door off Castlegate

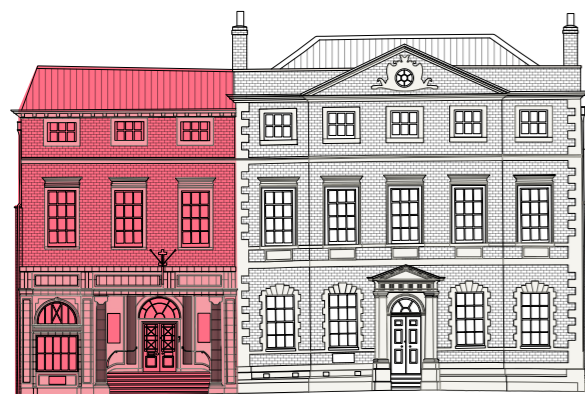
KEY - South Elevation, NTS. Area identified in pink.

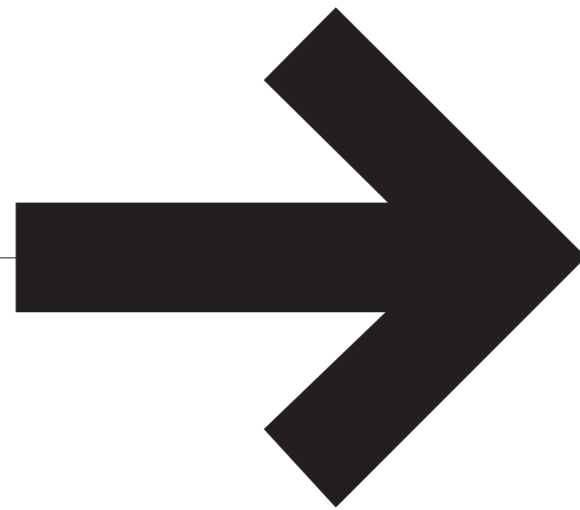
The following policies are relevant to the ongoing management of maintenance and repair at Fairfax House. It should be noted that, as a responsible custodian client, both York Conservation Trust and York Civic Trust are already acting within the parameters of the policies identified in this section. That said, the following should be continually adhered to:
