Fairfax House, York

Conservation Management Plan

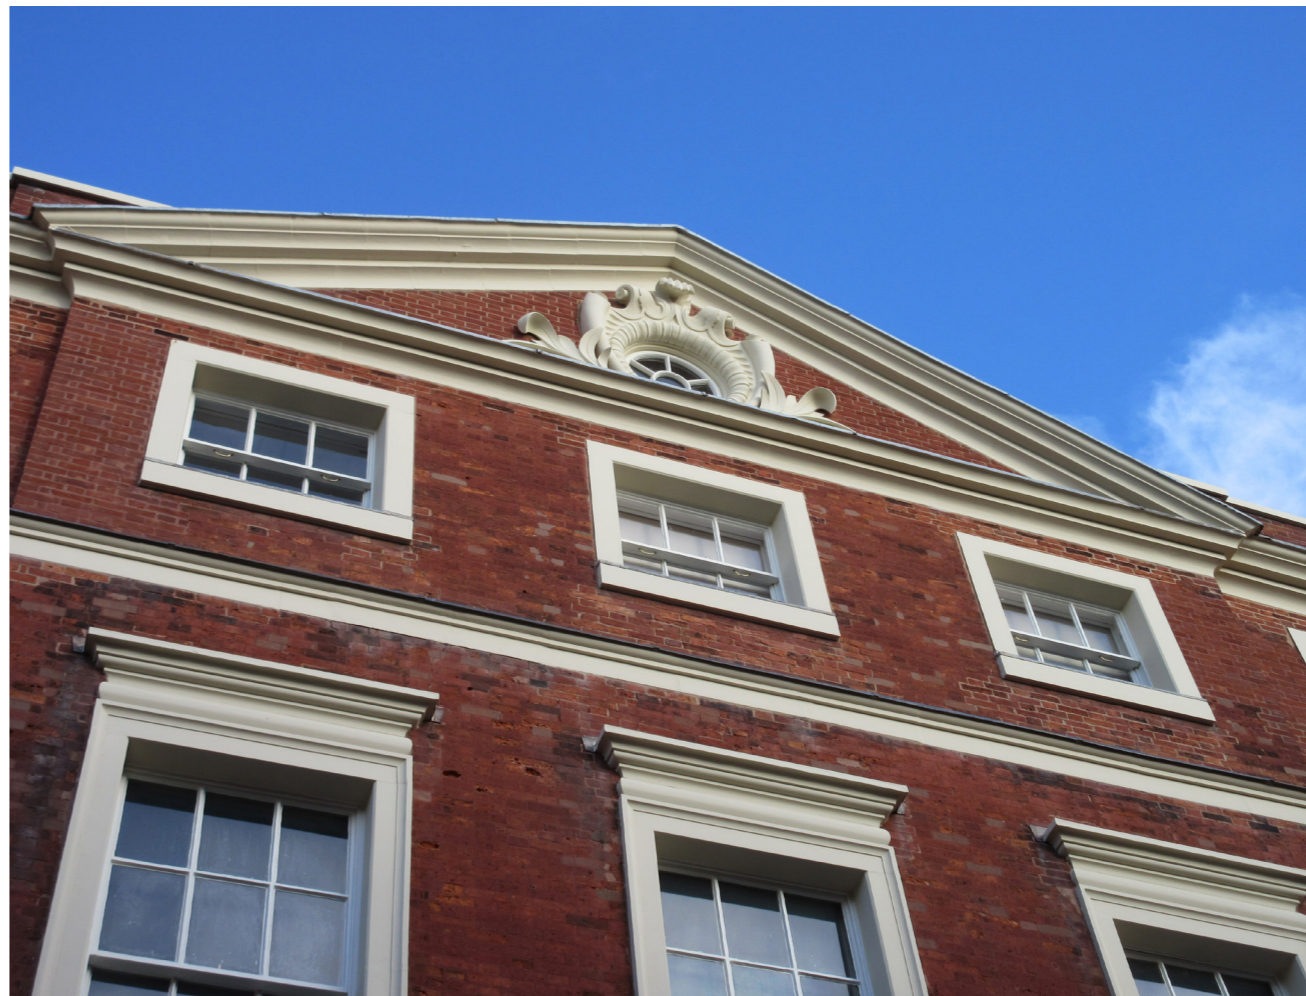
Looking up to existing frontage from Castlegate Street below.

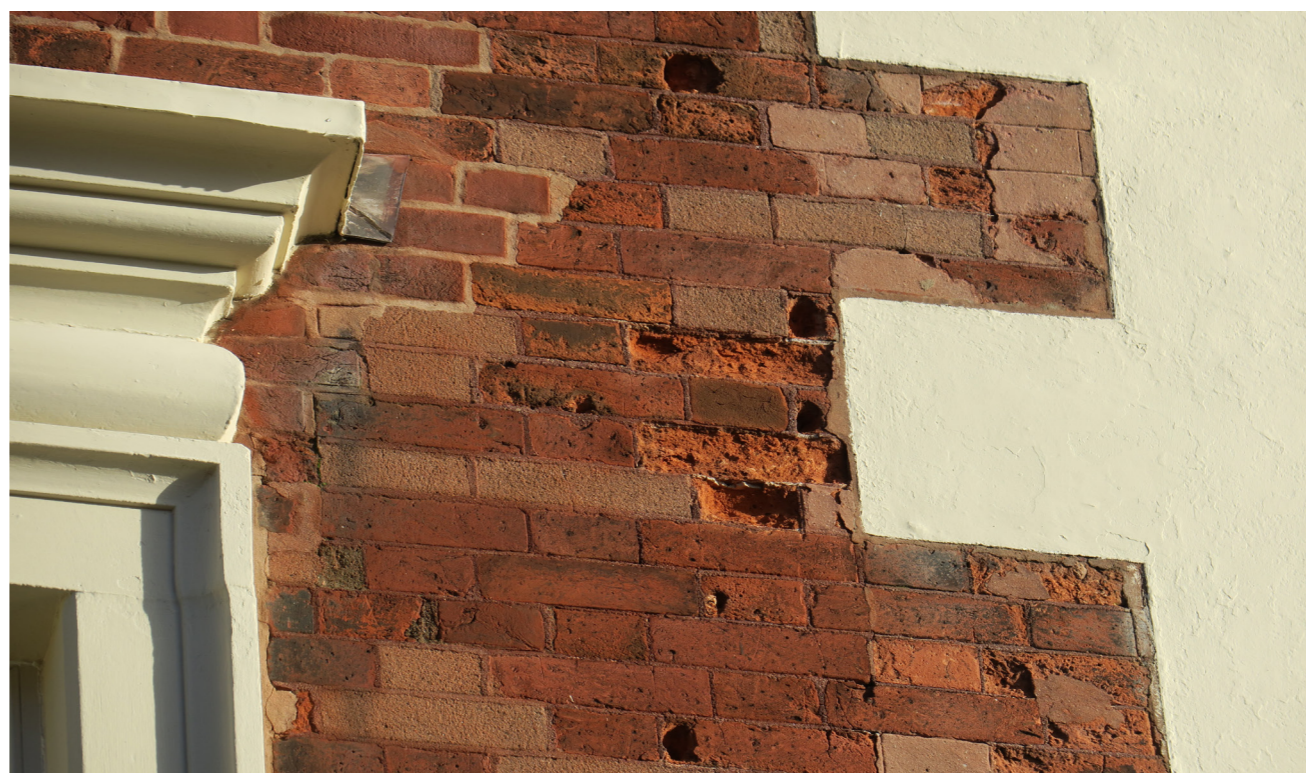
View of decay to existing frontage.

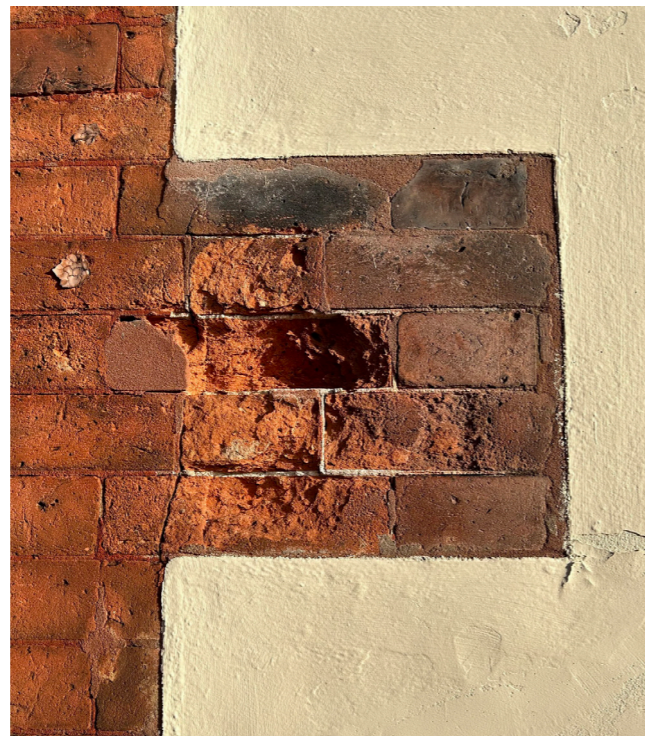
of time. This is visible at a granular level on the front façade, where multiple phases of brick repairs and re-pointing are visible. There are some clear areas of concern alongside some problematic work in cementitious material that require consideration and possible action in coming years.

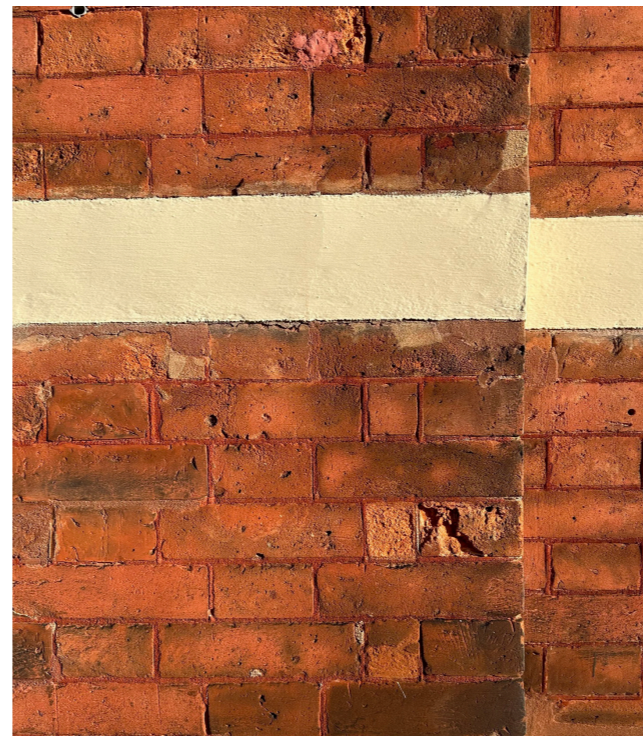
Using 3D software, a detailed brick by brick model could be built, with photographic information overlaid. The 3D model can become a home for all test data, embedded into the model elements. This process can also be carried out in 2D.

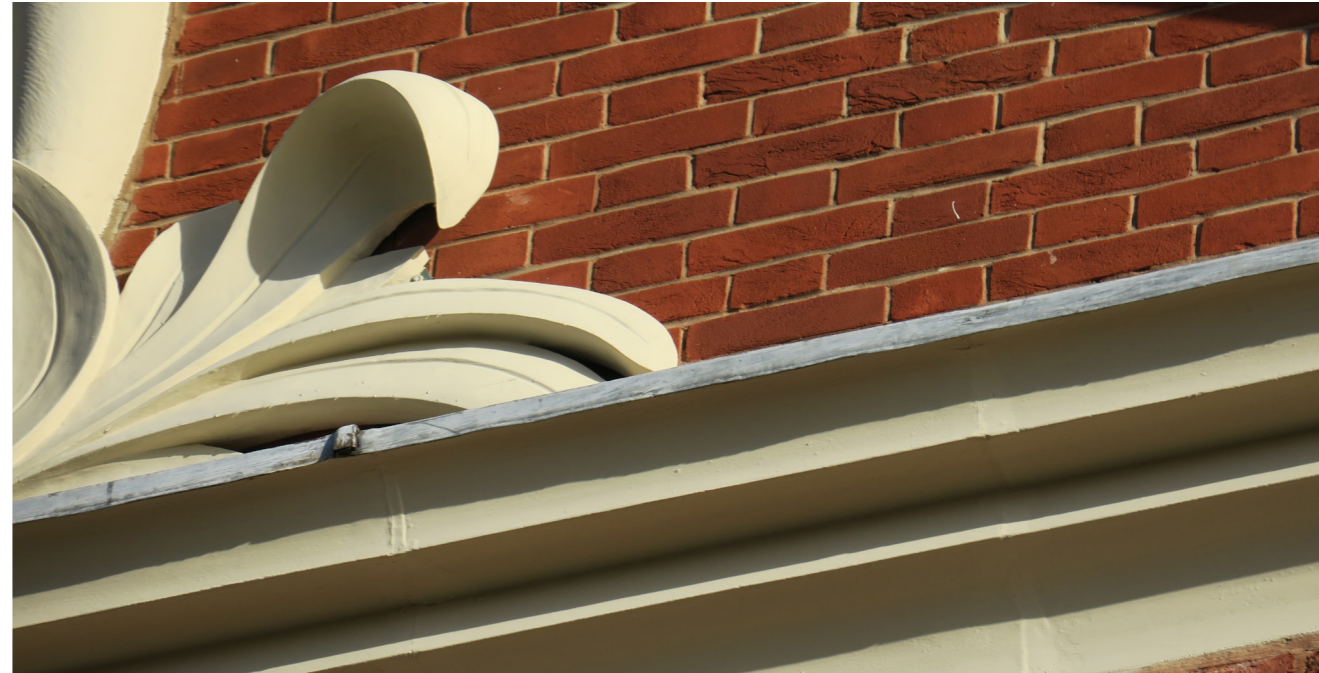
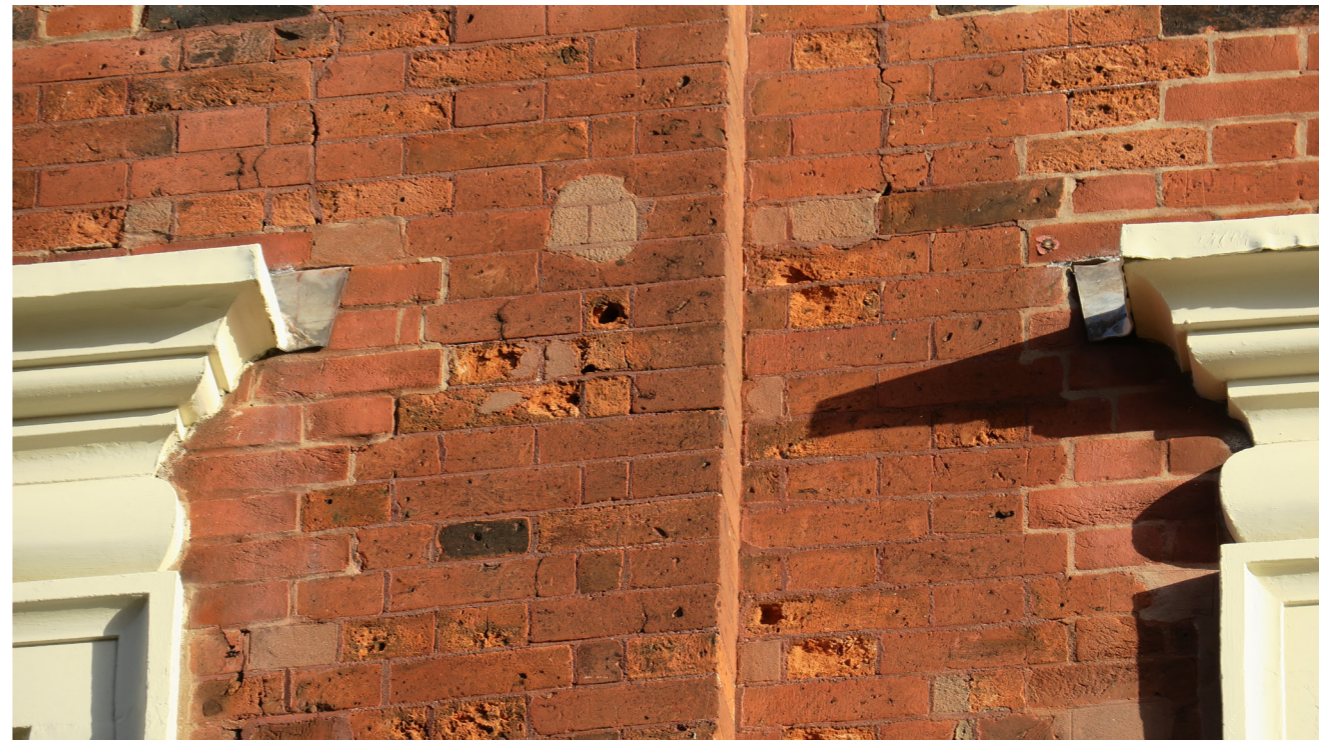
All works should be carried out by skilled operatives with prior experience of conservation brick repair. Sample repairs must be carried out and agreed, particularly with respect to pointing styles, joint widths, and the set colour of mortar (allowing sufficient time for full cure).

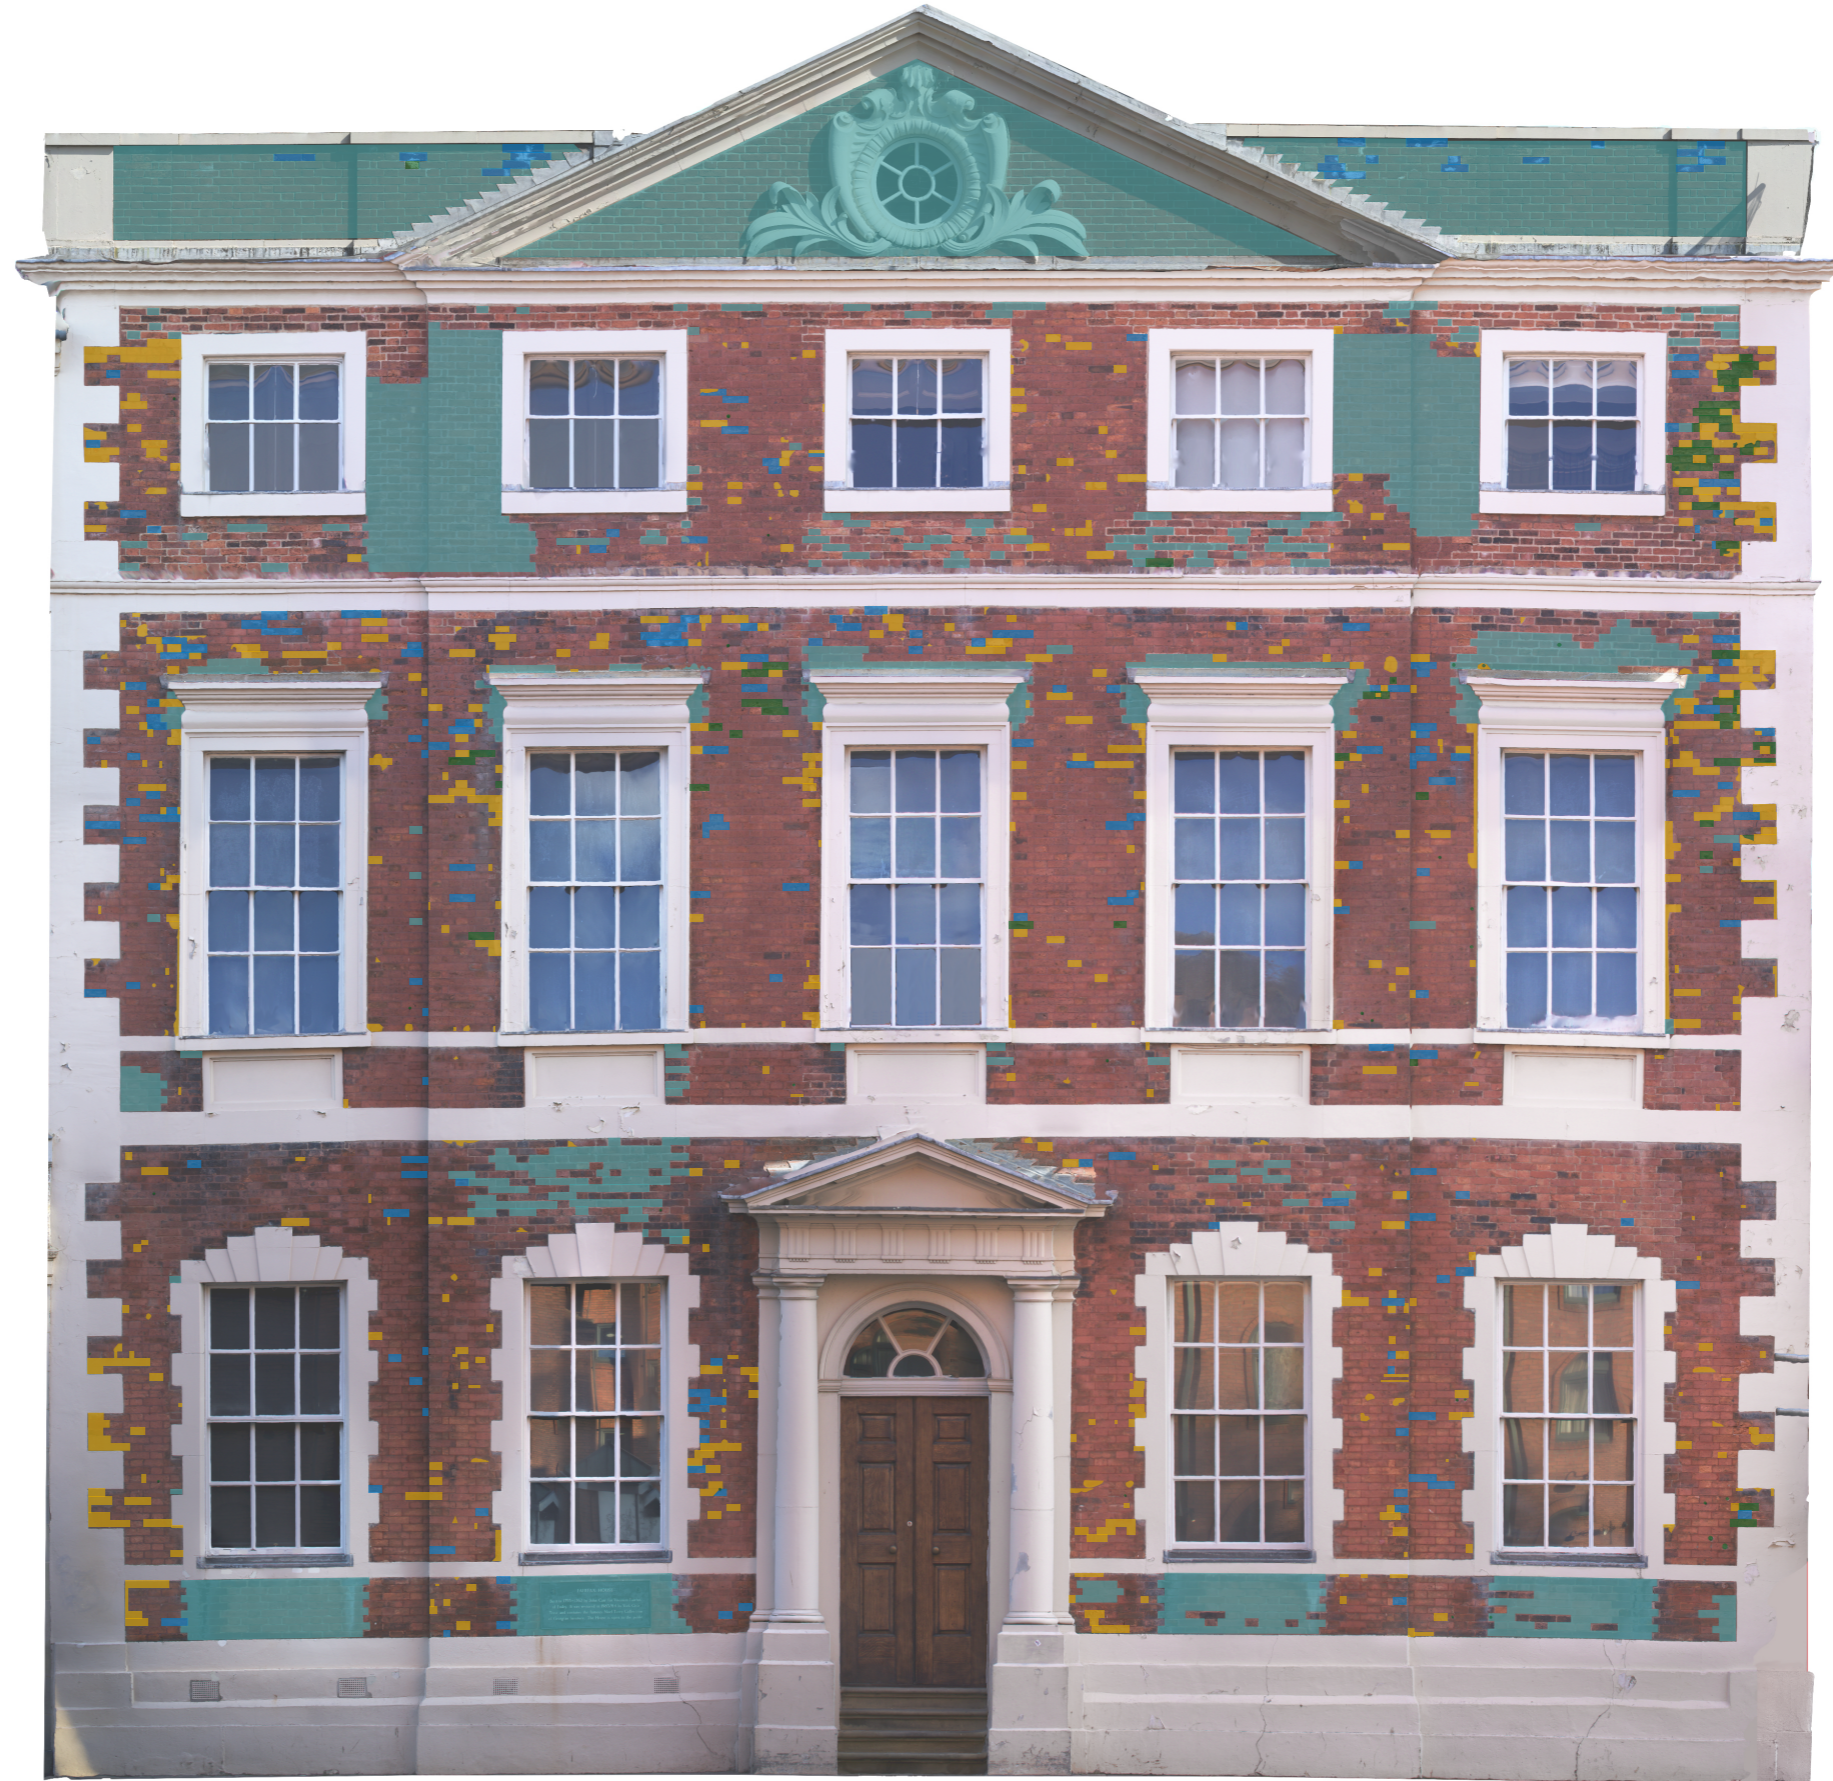
- Light spalling
- Heavy spalling / hole
- Cementitious repair
- Replacement brickwork

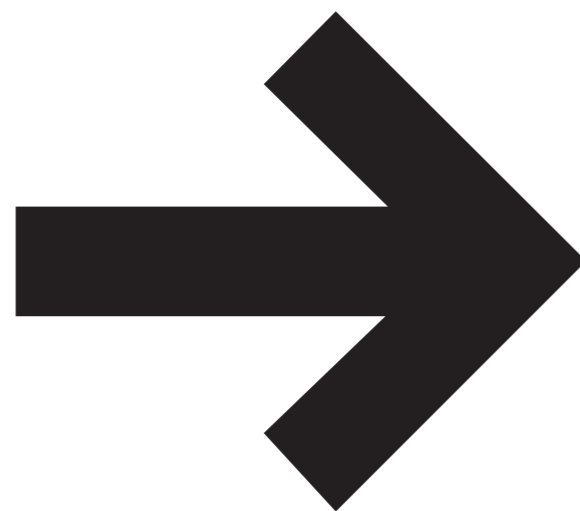
Should capital development works be brought forward at any stage, design works should be commissioned in accordance with the policies identified in this document. The following policies relate to the design and implementation of new work, and should be the starting point for any design development to improve access and visitor facilities at Fairfax House:

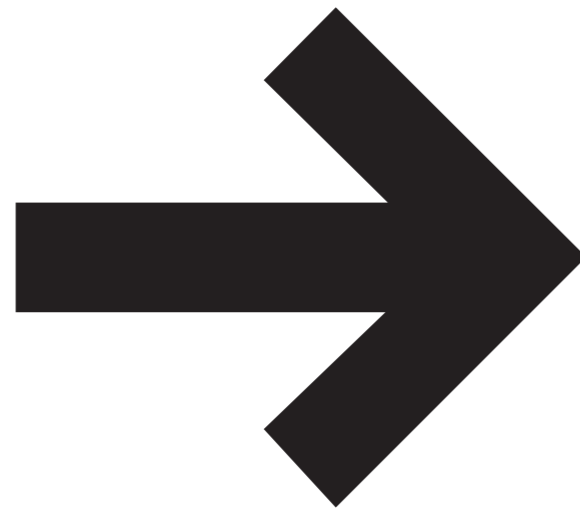
York Conservation Trust and York Civic Trust are already committed to the most sustainable form of urban development. The most sustainable buildings are the ones we already have. That said, yearly operational carbon emissions from existing building stock can be much higher than new buildings, due to poor thermal performance. The following policies are recommended for adoption relative climate change and the environment:
