45 Goodramgate, York

Statement of Significance

File: 3191-2021-001

Maybank Building Conservation LLP

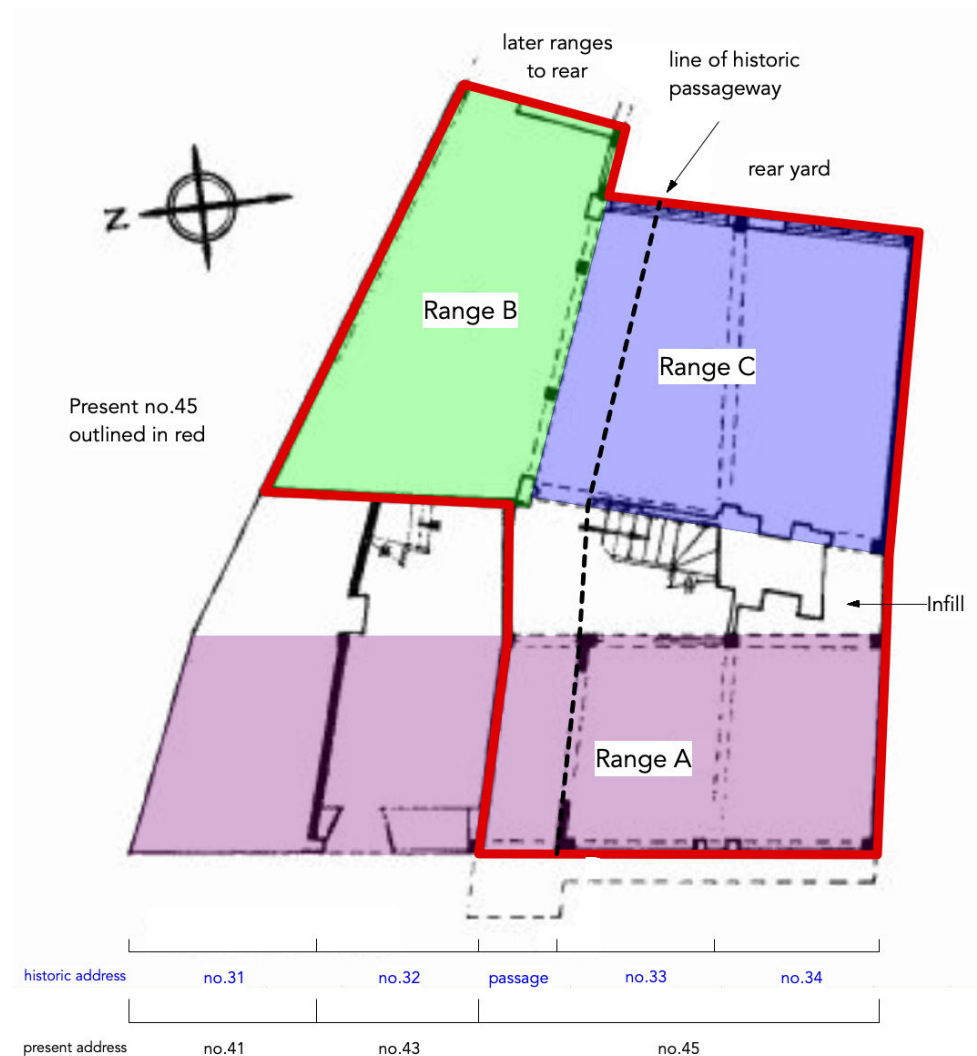
Fig. 5.1 Annotated and labelled ground floor plan (after RCHME 1981)

- No. 45 Goodramgate comprises three distinct timber-framed ranges with an infilled space between them (fig. 5.1). A rear courtyard incorporates ranges of predominantly C20th brick structures.

- The two-storey front range (A), runs parallel to Goodramgate and stylistically dates from the late C15th or early C16th. This double-jettied timber-framed range was built as five bays with a central passage, of which no. 45 represents the southern half and passageway. The northern portion of the frame survives, but cut back and re-fronted in brick as nos. 41 and 43 Goodramgate (fig. 5.2).

- The (presently) double-height single-storey Range B, sits behind nos. 41-43 and parallel to the central passageway, and is roughly contemporary with Range A.
- The two-storey Range C, which lies behind no.45, dates from early C17th. This was constructed as single rooms on both ground and first floors, with the original attic surviving above.
- An irregular 6-10 foot gap between Range A and Ranges B & C was likely infilled at an early date, and contains a large brick chimney of similar date to Range C.
- The present doorway to no.45 sits within the original passageway that connected Goodramgate to the yard behind.

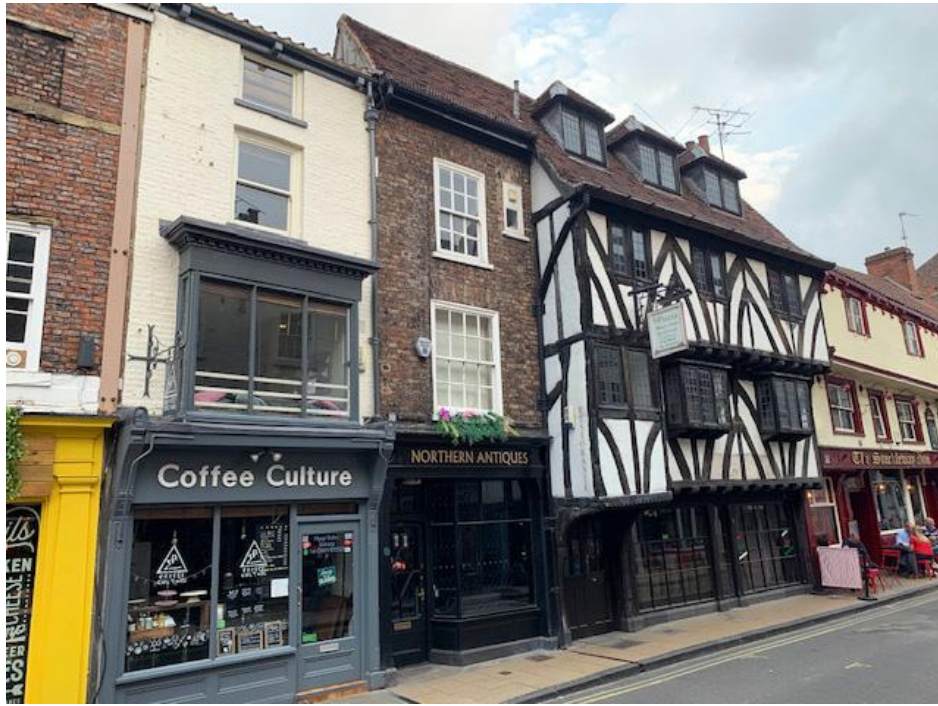
Fig. 5.2 No. 45 (timber framed) today with no. 41 (Coffee Culture) and no.43 (Northern Antiques) to the left. Although nos 41-43 are now cut back and re-fronted in brick, they are part of the same range (A).

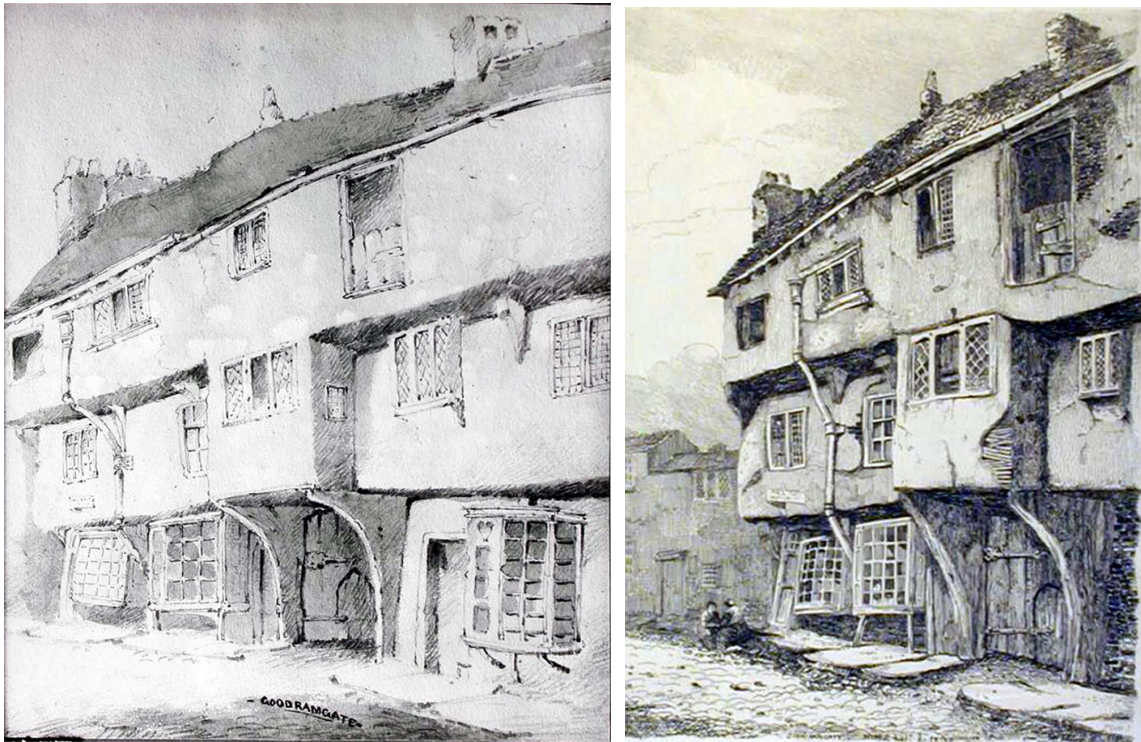
Fig. 5.3 Etchings of the site by an unknown author (left) and by Henry Cave (right) © YAYAS & York Museums Trust.

- The c.1800 etching depicts the whole of Range A, prior to the re-frontings of nos. 41 & 43 in brick (see fig. 5.2 for modern comparison). The range can be seen as a symmetrical five-bay structure with a narrow central bay which projects at the first floor over the passageway.
- Cave's etching focuses on the northern end of Range A, again showing nos. 41 & 43 prior to their re-frontings. The ground floor shops are shown with projecting Georgian bay windows, supported on either brackets or posts. A doorway can be seen to the immediate right of the passage.
- A wicket gate is shown within the large plank door of the central passageway. Possibly the original door, this is shown with large ironwork hinges set on the northern side of the opening. This doorway with its carved cheeks, can be seen a lovely 1832 etching (fig. 5.4).

- In places, and in particular to the right of the passageway door, Cave's etching appears to show brick or stone masonry infill.
- On the second floor, immediately to the south of the central projecting bay, what appears to be a loading bay is shown containing a Dutch or half timber door, although there is no hoist visible. This is indicative of the site being used as commercial premises, and likely that the upper floor was primarily used for storage. This was not uncommon; see for example Herbert House building B.

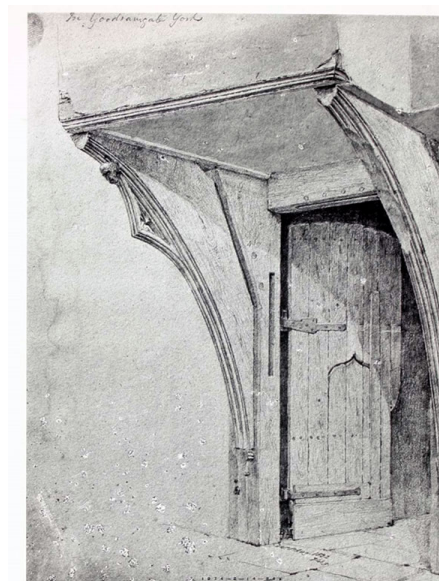
Fig. 5.4 1832 etching of the passageway entrance of no.45 - note the original mouldings on the projecting cheeks, which is now largely lost © YAYAS.

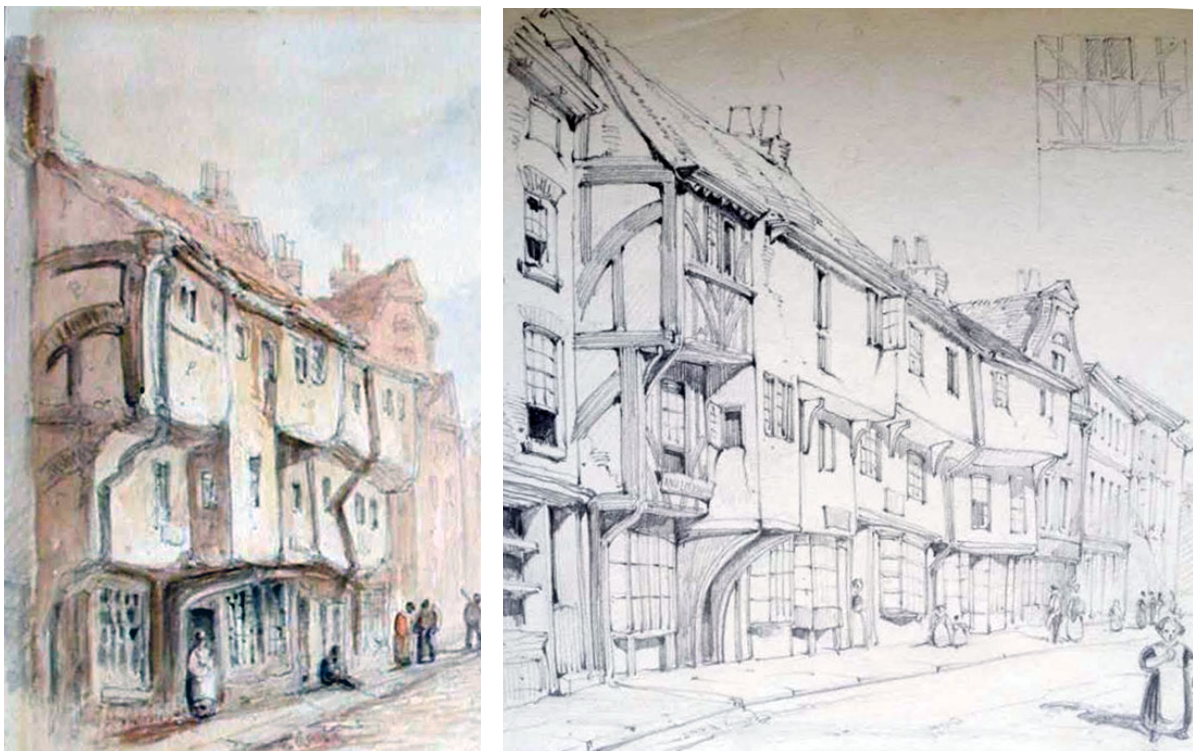
- Nicholson's and Harper's depictions of 1837 and 1840 (fig. 5.5) reveals that the northernmost bay (present no. 41) has by this stage been cut back and re-faced in brick with segmental-arched windows. At this point No. 43 retains its jettied-timber-frame, and between the two pictures (1837-1840) the external render was removed to reveal the timber framing to the front elevation.

Fig. 5.5 Left - watercolour by George Nicholson, dated 1837; right - sketch from April 1840 by John Harper, including a sketch of second-floor framing in the top right © York Museums Trust.

- In both images, the rest of No. 45 remains rendered, and is shown with small-paned casement windows on the upper floors, and with Georgian shop windows at ground floor. One of these windows is a projecting bay supported on small timber posts. A doorway appears to be located at the southern end of the range, past the projecting bay window. At first floor level a small casement window is shown on the northern side of the projecting bay over the (originally central) passageway.
- The central passageway can be seen on the 1852 first edition OS map (fig. 5.6), running through the present building and leading to Baker's Yard behind.

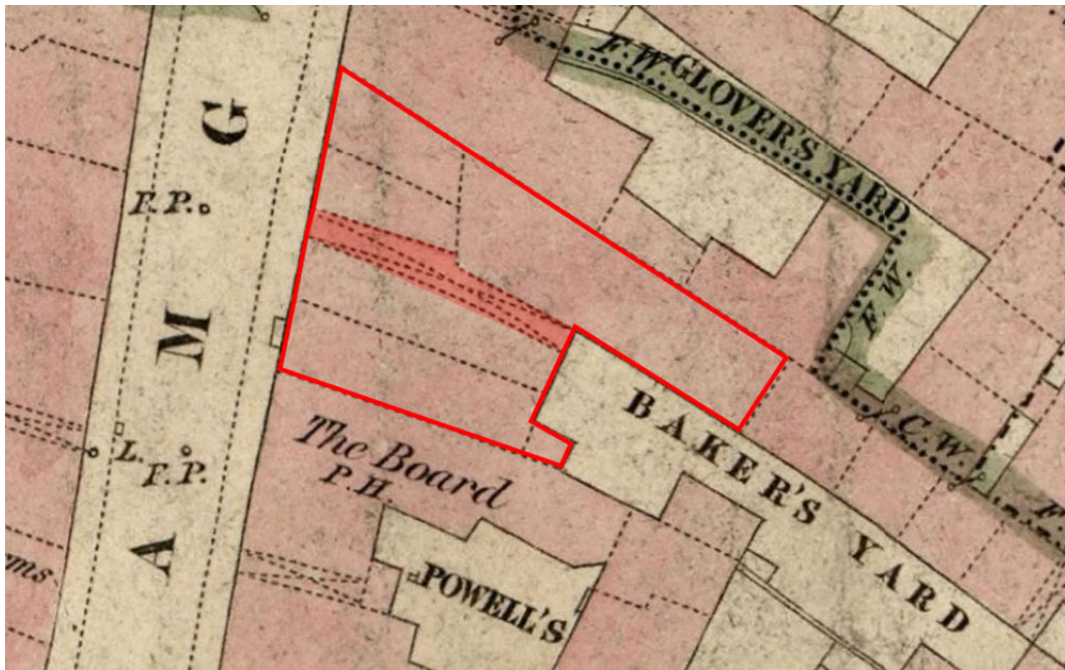
Fig. 5.6 Detail from the 1852 OS map, showing the internal divisions of the site and the central passageway (highlighted in red).

- The 1852 OS map also reveals that No. 45 was at this time subdivided into two premises, so the front range (A) represented two pairs of individual shops with the passageway in between. These were historically numbered nos. 31-32 to the north of the passage, and 33-34 to the south.

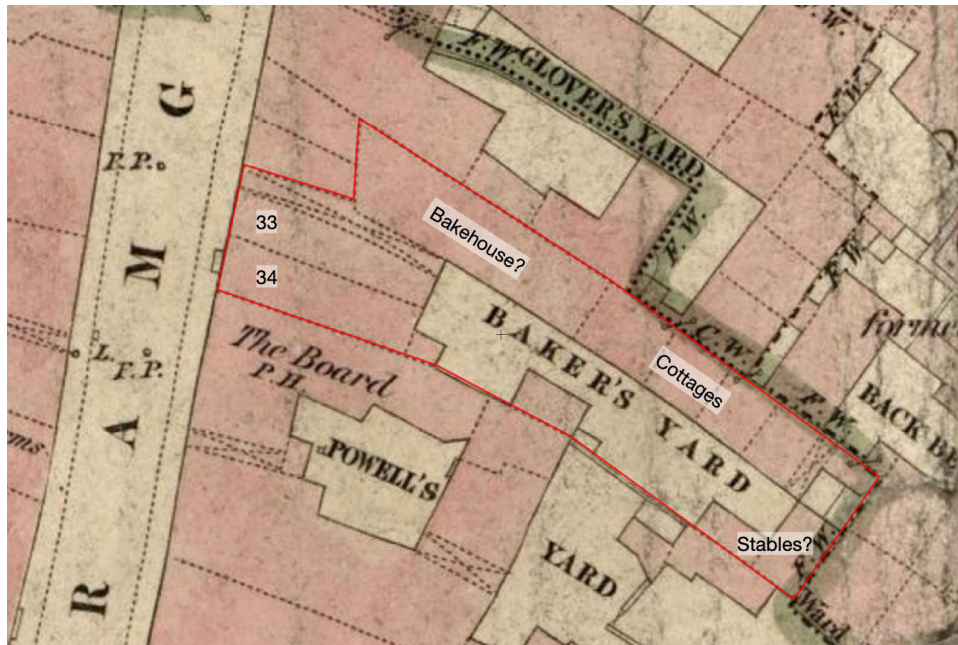
Fig. 5.8 Annotated 1852 OS Plan showing likely site outline at time of the 1890 sale with tentative labels.

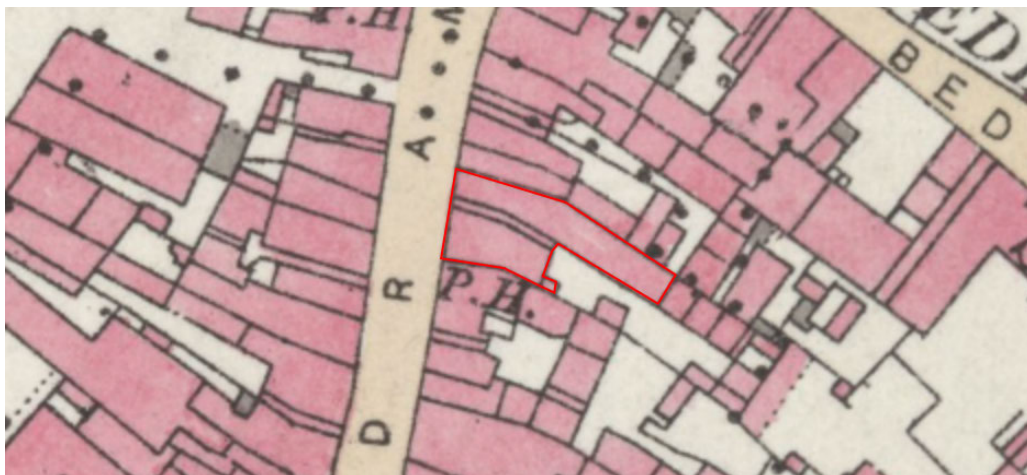
Fig. 5.9 Detail from the 1892 OS map with the wider site outlined in red. Note that nos 33-34 (below the passage) are now shown as a single unit.

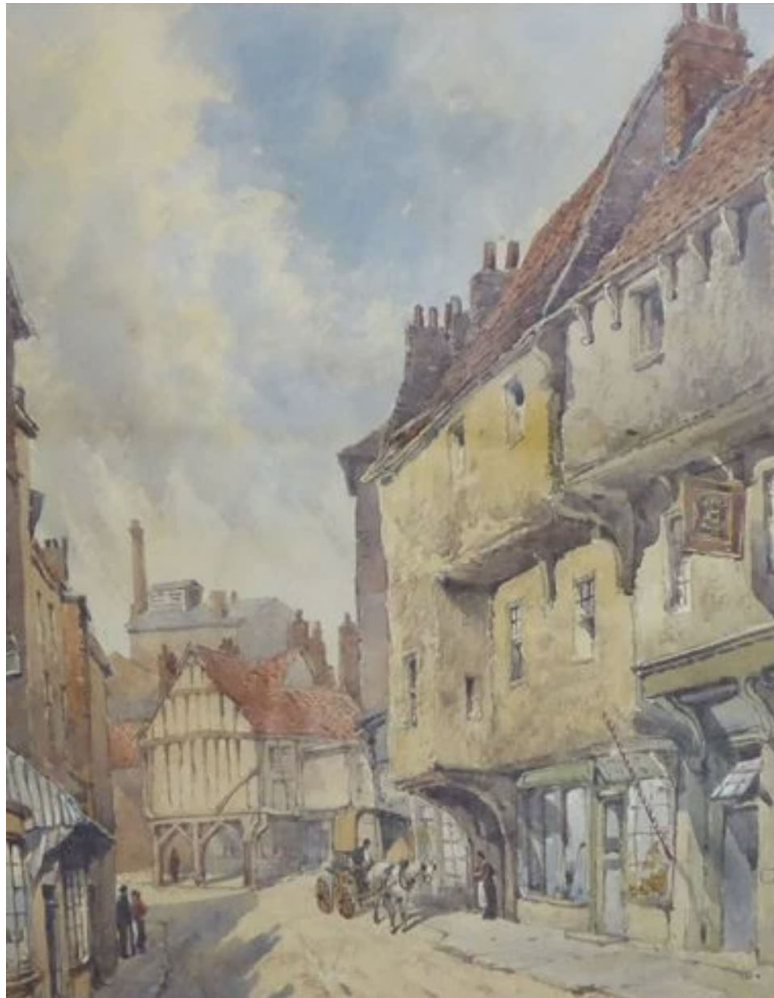
Fig. 5.10 1901 painting by William James Boddy - note the small window on the side of the projecting bay.

- More importantly, Broddy's painting shows that the Georgian shop front had been replaced. The projecting bay windows have made way for large plate glass windows and a central shop door.
- The first floor windows appear to have been replaced by sashes. The building can be seen in a streetscape photograph of c.1910 (fig. 5.11), confirming that the first floor windows had been changed to sashes. The window above the central passageway appears to be a sliding sash, and a large advertising board has been set immediately below.

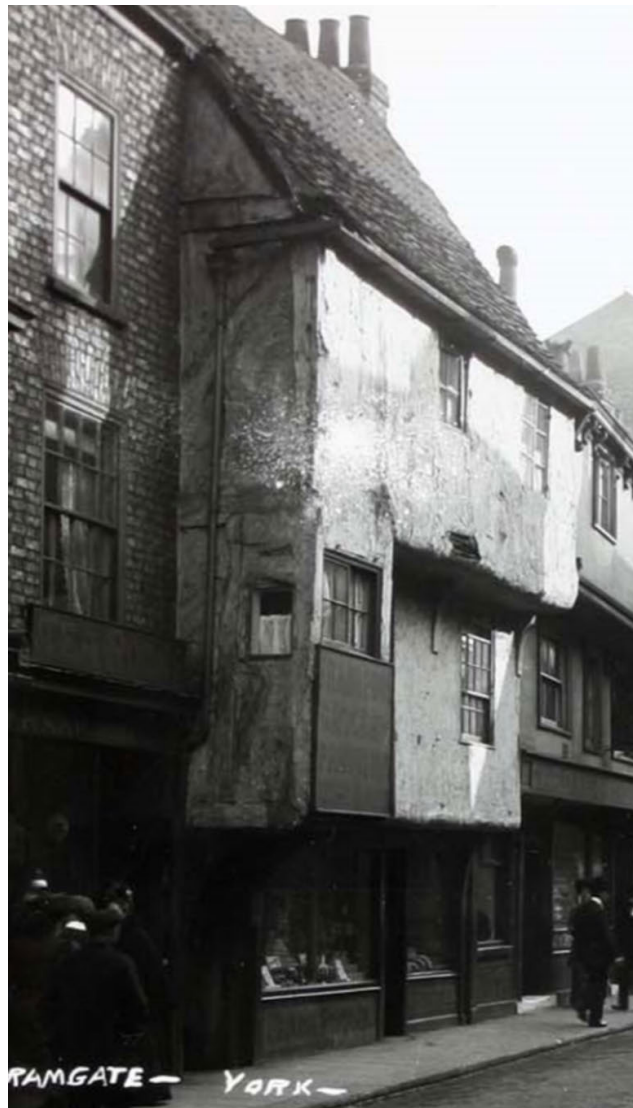
Fig. 5.11 Photograph of c.1910 © City of York Archives.

- It can be seen that the timber frame was exposed to the left. A partial lace curtain hangs in the first floor window, suggesting the upper floors remained in residential use.

- It is likely that these changes relate to a refurbishment of the property following its purchase by Frank Poole in 1890. The merging of the two different shops would likely necessitate change, particularly to the shop front. Advertisements by the Pooles for apprentices and servants in the 1890s suggest a level of comfortable wealth, and the change from tenants to owner / occupiers seems a likely moment for investment in the fabric.

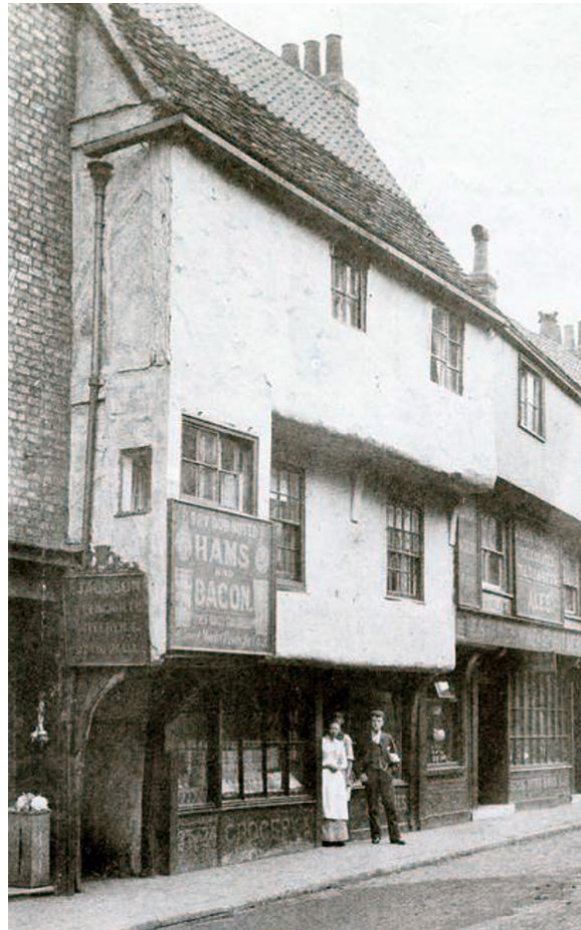
Fig. 5.12 An undated photo from the early 1900s presumably of the Poole family outside their grocers, bakers and confectionery shop © York Museums Trust.

- An undated early 1900s photograph (fig. 5.12) clearly shows the remodelled property, and may include proud owners Frank and Susannah M Poole along with one of their children or staff. In 1890 they occupied the site with their four children. By 1901, two children remained along with a live-in employee, and in 1911, their daughter, niece, and a servant lived at the property.

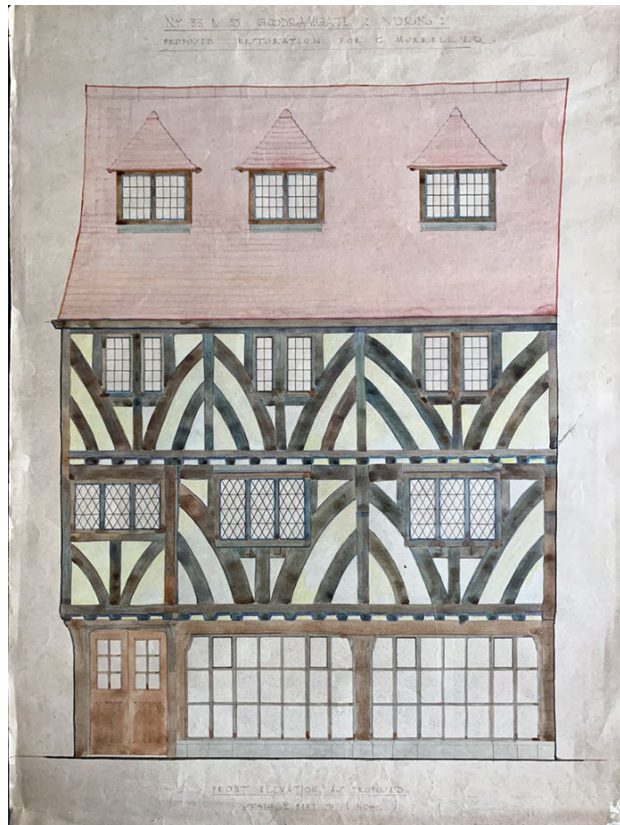
- Brierley & Rutherford's restoration of 1929-30 included the removal of the external render, repairs to the timber framing, and replacement of the windows (fig. 5.13). New shop windows were installed at ground floor, timber mullion windows were inserted upstairs - apparently in the original openings - and dormer windows were added to give the impression of an attic space.

Fig. 5.13 Proposed elevation design for Brierley and Rutherford © University of York.

- The front elevation as restored (fig. 5.14) does not entirely match with Brierley and Rutherford's proposed design. The first floor window was proposed as a three-lights, which would correspond to the window as depicted on the earliest etchings (fig. 5.3). However the window was instead restored as two-lights; it is not clear if this change was informed by evidence in the structure for an earlier window design.

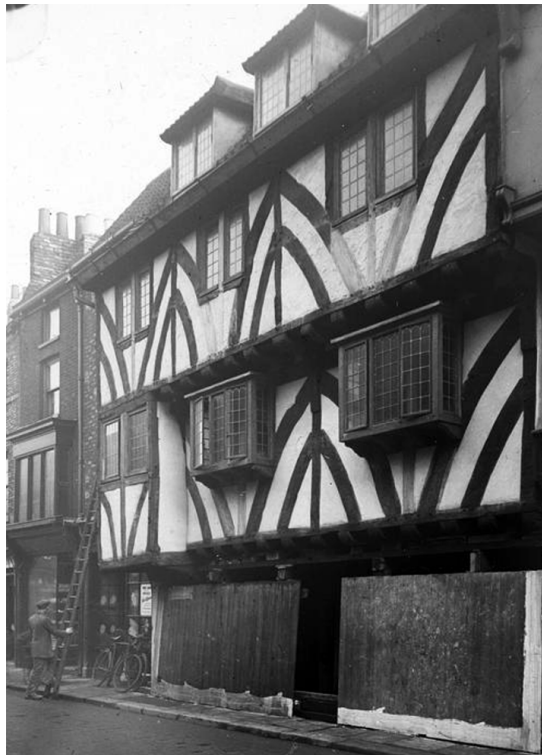
Fig. 5.14 Photograph of 1929 showing the restoration in progress. The pale replacement oak timbers can be clearly seen © City of York Archives.

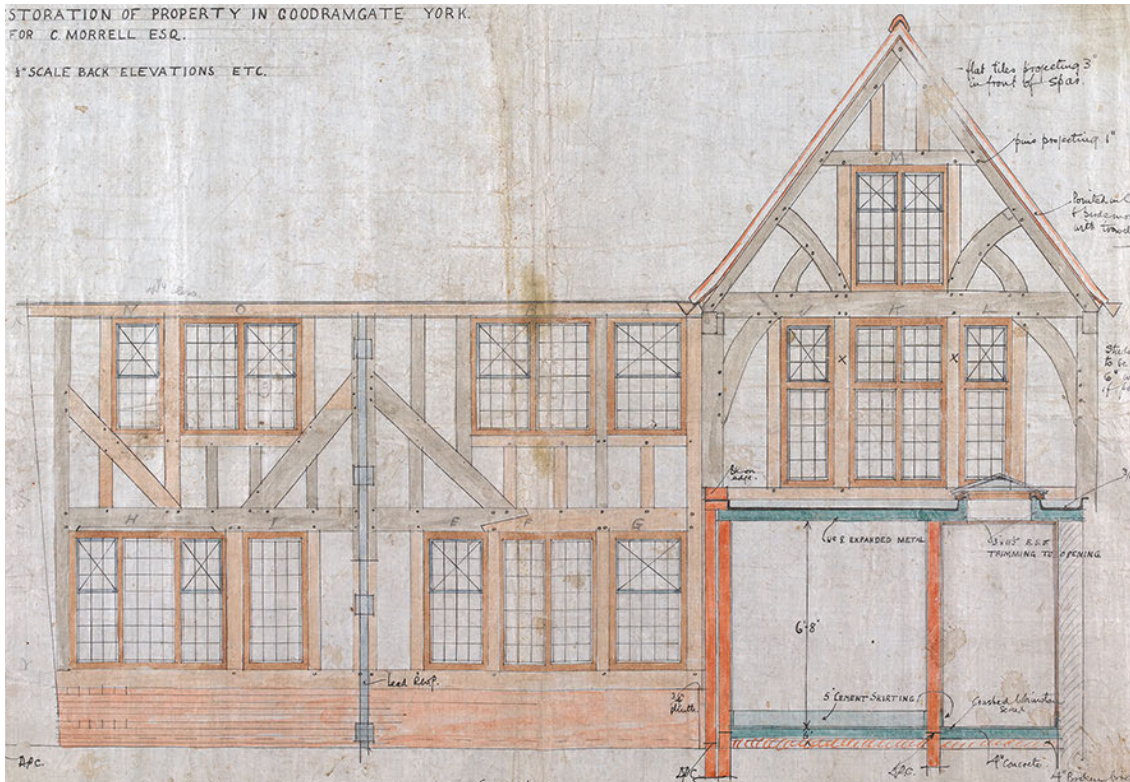
- The ground floor shop front was proposed with a single central pillar dividing the glazing, but today features a pair of posts. If the opening lights shown in the shop windows of the proposed elevation were installed, they have since been removed.
- While much of the front timber framing survives, on the rear of all three ranges, much of the studwork and infill was removed or replaced (fig. 5.15).

Fig. 5.15 The extent of proposed timberwork replacement to the rear of Ranges B & C (replacement timber in orange, retained timber in brown) © Borthwick Institute for Archives.

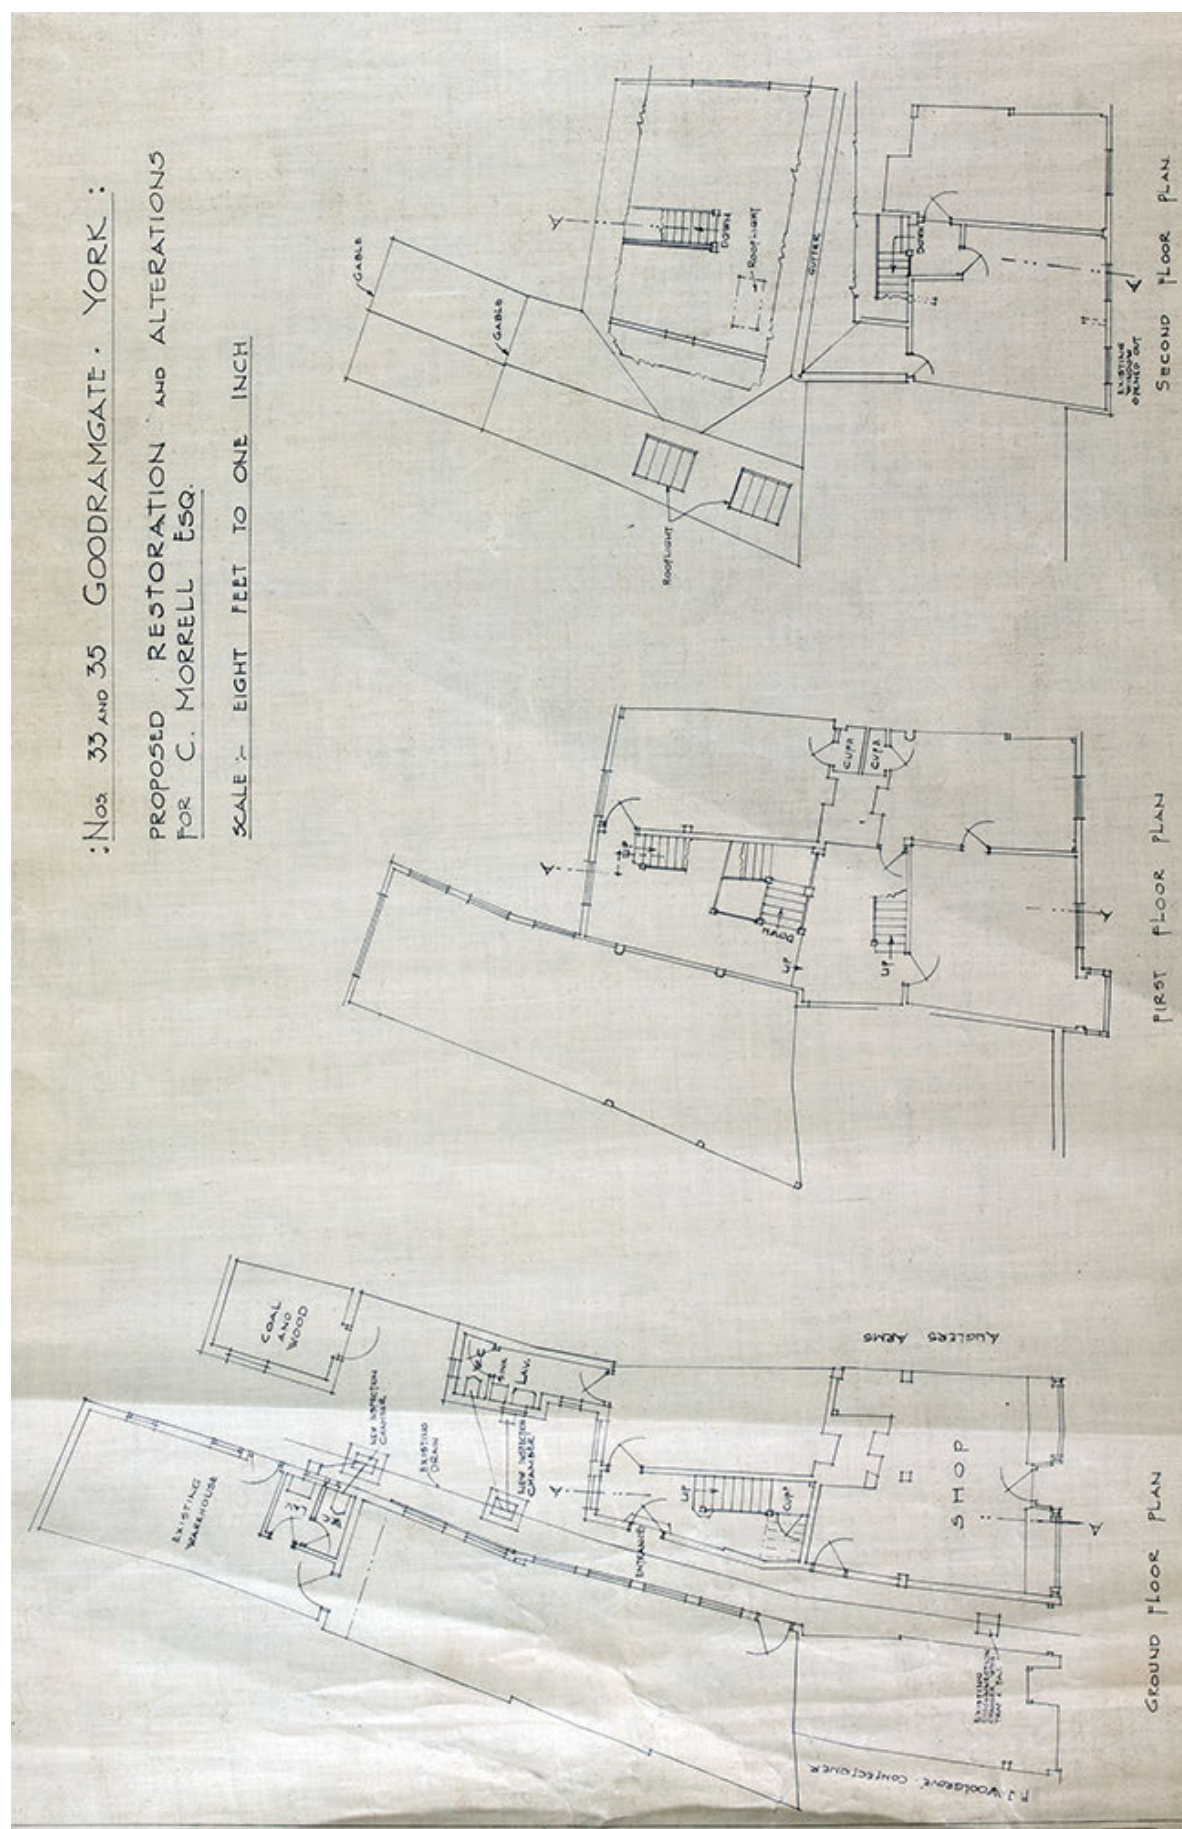
- No definitive floor plans exist for before Brierley & Rutherford's restoration, however early restoration scheme plans do provide a glimpse of the earlier internal arrangements (fig. 5.16).

Fig. 5.16 Undated proposed floor plans that appear to show the earlier internal layout © Borthwick Institute for Archives.

- These reveal that the shop was a single space with the rear infilled from Range A to incorporate the infill space.
- The Poole's residence was completely separate from the shop, and was accessed by a side door from the passage. The ground floor was arranged as a small hall with stairs, behind which was a single room, with a WC projecting into the rear courtyard.

- At first floor two separate staircases provided access to the second floor, one in the infill and the other in Range C. This presumably relates to the earlier subdivision of the property into two different premises, with a staircase serving each.

- Range C appears to be a single space of unknown purpose, while an "existing warehouse" with WCs sits immediately behind. This warehouse either replaced or was formed from the former cottages in Whiddop's Yard.

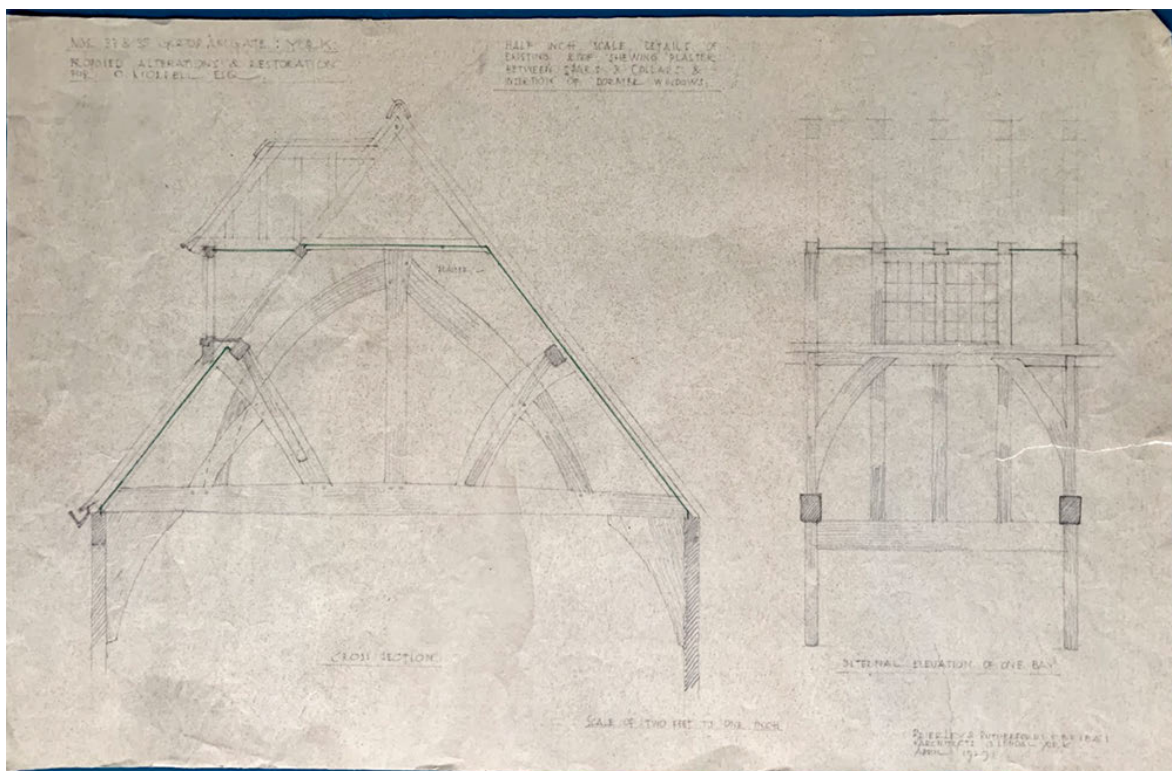
- As part of the restoration, all fittings not part of the original building were removed, resulting in the loss of much information about the historic use of the spaces. New plasterwork was installed (fig. 5.17) and the whole building was redecorated.

Fig. 5.17 Proposed pencil drawing, dated April 1929, showing the proposed new dormer windows and addition of internal plasterwork to the ceiling of the second storey © University of York.

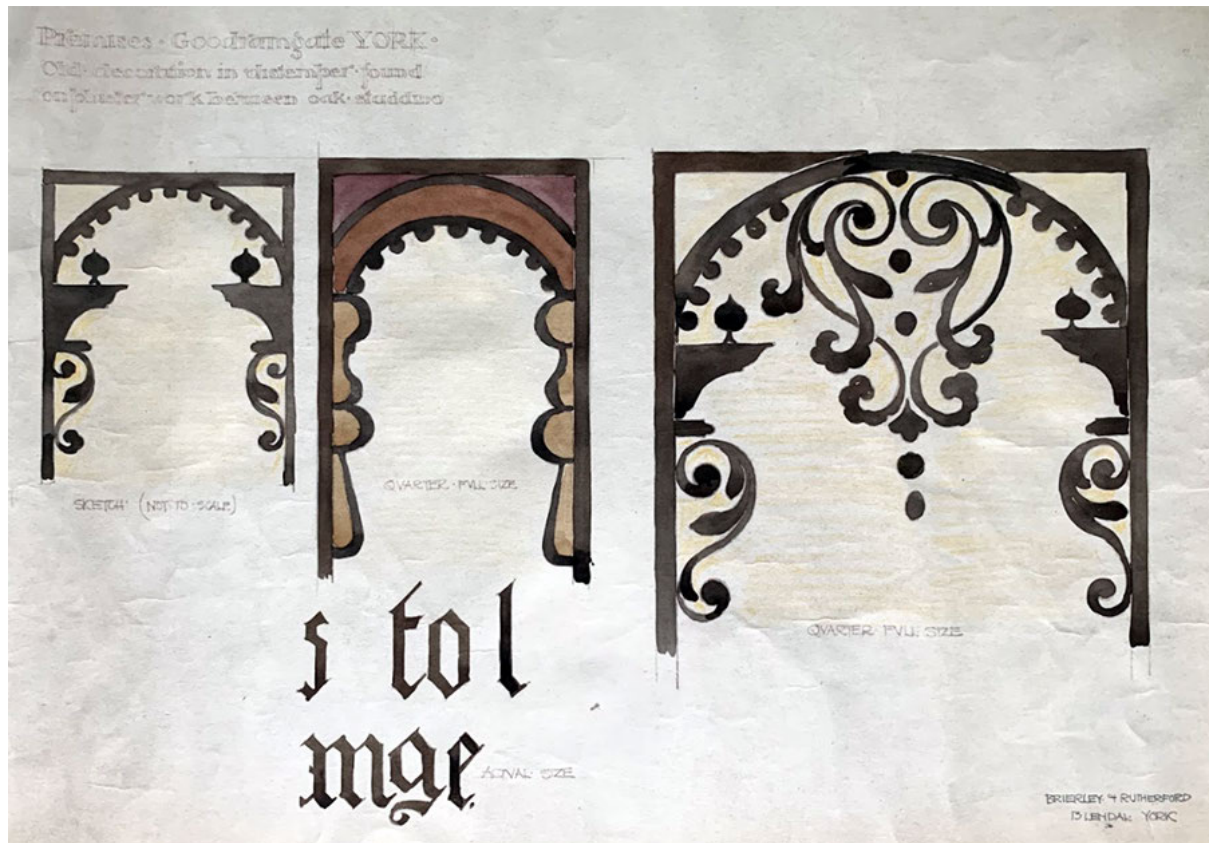
- It is possible that this heavy restoration caused the loss of some significant historic features. For example, an undated watercolour drawing (fig. 5.18) shows traces of post medieval distemper paintings found on infill panels discovered at “premises on Goodramgate”. Brierley and Rutherford were also working for Mr Morrell at no. 51 Goodramgate so it is not possible to definitively link these with no.45, however the original was found with a bundle with figs 5.13 and 5.17. If these were found in no. 45, their location is unknown and the paintings are presumed lost.

Fig. 5.18 Record watercolour drawings of C17th distemper wall paintings found on plasterwork between timber studs. Labelled only as “premises on Goodramgate” this likely relates to 45 Goodramgate, although the location and survival of these paintings is not known © University of York.

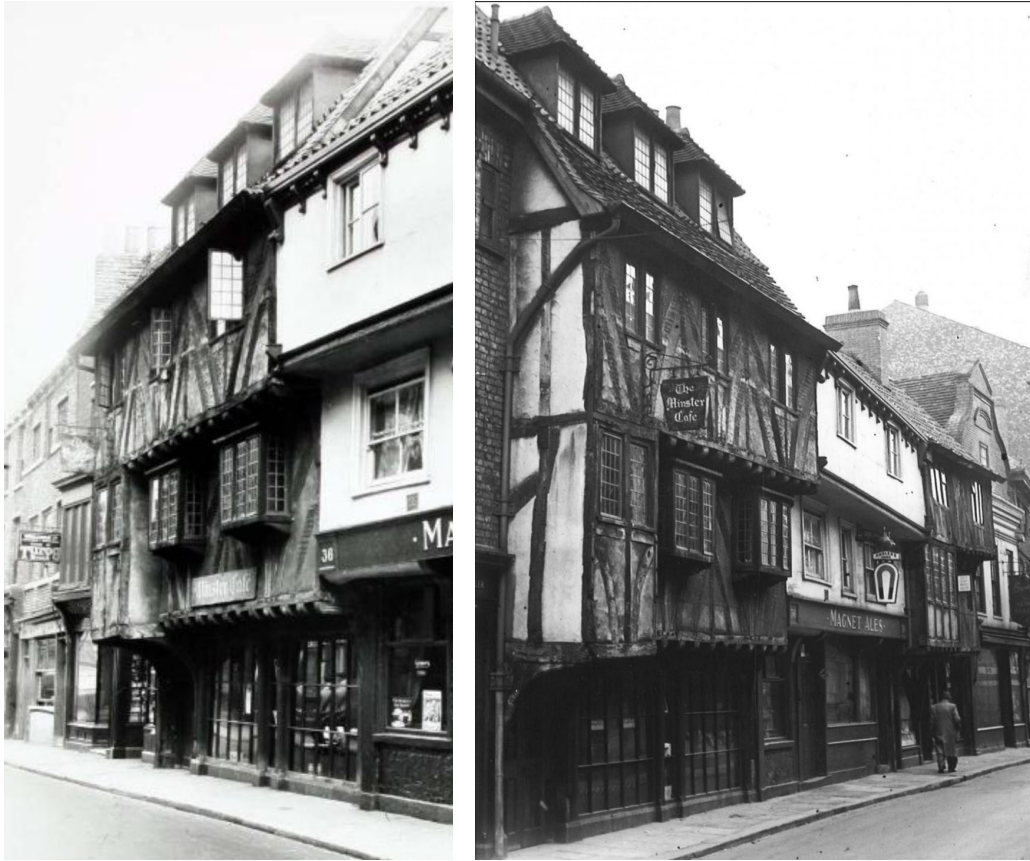
Fig. 5.19 1930s photographs of the Minster cafe occupying the restored building.

- Advertisements in the Yorkshire Evening Post in 1932-33 suggest the newly restored property was initially used as a showroom for the Waldenburg Brothers Furniture Factors of Leeds.
- However, by 1939 the site was occupied by Alfred Ellis, cafe proprietor, his wife Jessie, and a live-in confectionery assistant, Dorothy Scott. It has remained in use as a cafe restaurant throughout the C20th and into the C21st.
- For much of the C20th, the site operated as the Minster Cafe (fig. 5.19).

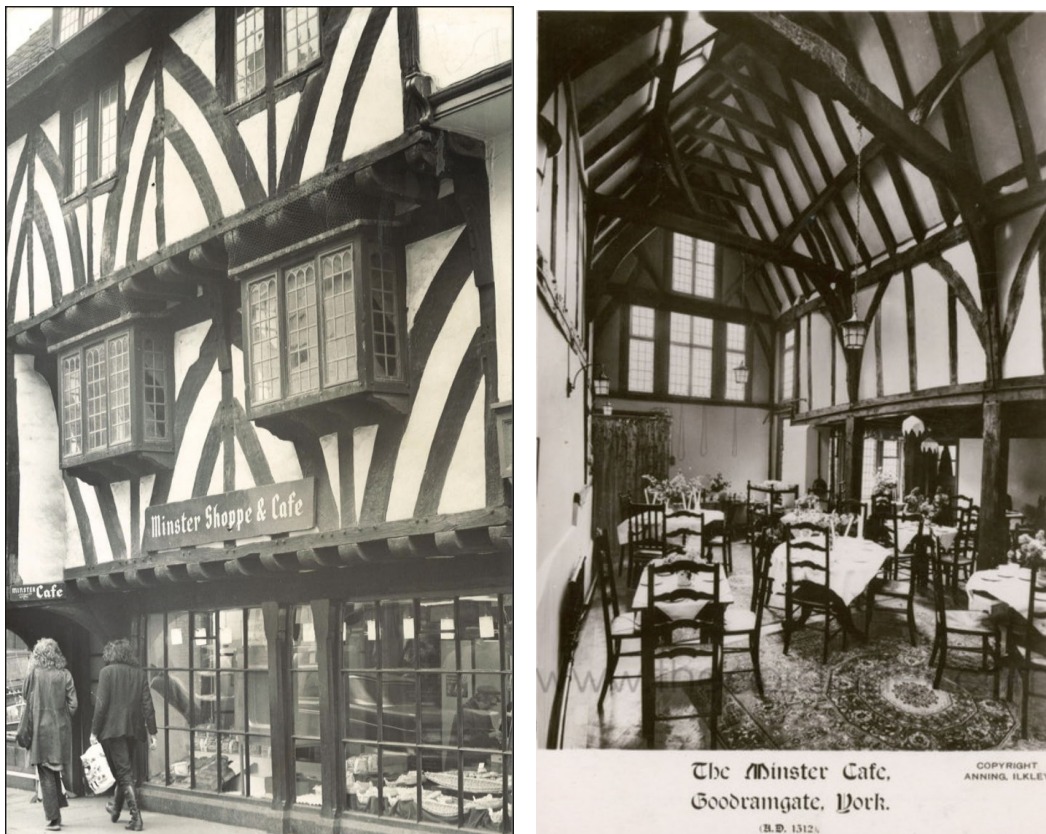
- Originally left unpainted, in the mid C20th, the infill panels were painted white (fig. 5.20).

Fig. 5.20 Left - mid C20th photograph, showing the white painted infill panels © City of York Archives; Right - postcard of the Minster Cafe from 1950, showing the restored interior. The claimed date of AD.1312 is erroneous.

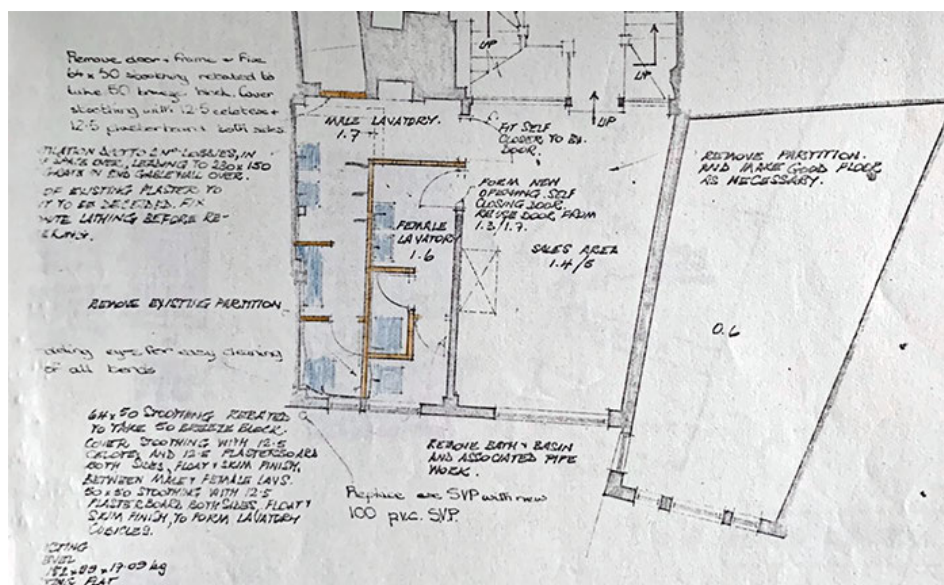
- Minor repairs and alterations took place in 1956, including the insertion of the present bolection-moulded brick fireplace on the ground floor of Range C into the earlier chimney stack.
- Further repairs and alterations occurred in the 1970s, including alterations to doors in the rear ranges, and the installation of new lavatories on the first floor of range C (fig. 5.21).

Fig. 5.21 Proposed plan for new lavatories in 1976.

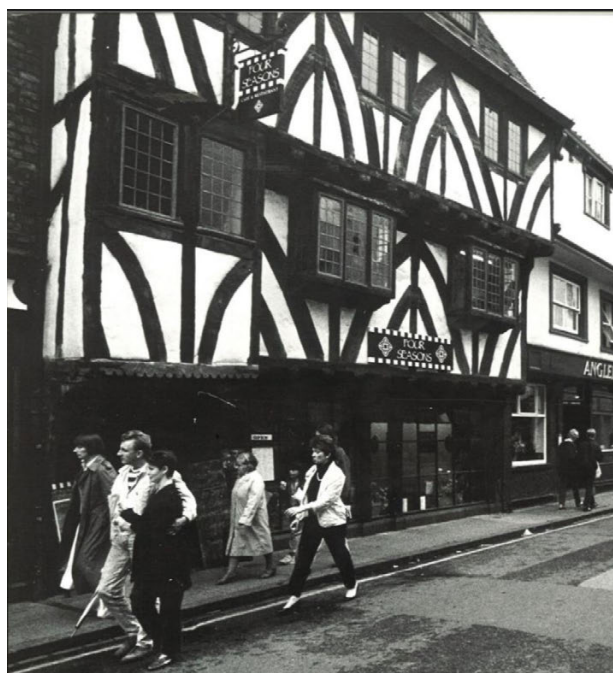
Fig. 5.22 Photo of the Four Seasons Cafe, likely from the late 1980s © City of York Archives.

- In the 1980s, the site became Marmaduke's Bistro and Coffee Bar (later Marmaduke's Licensed Restaurant), presumably named after it's most famous resident, Marmaduke Buckle.
- Following a grant from an Historic Buildings Preservation Grant Scheme, the roof was re-covered in 1986.
- In 1987, the site became the Four Seasons Cafe (fig. 5.22), which operated until 1995 before closing due to tough trading conditions.

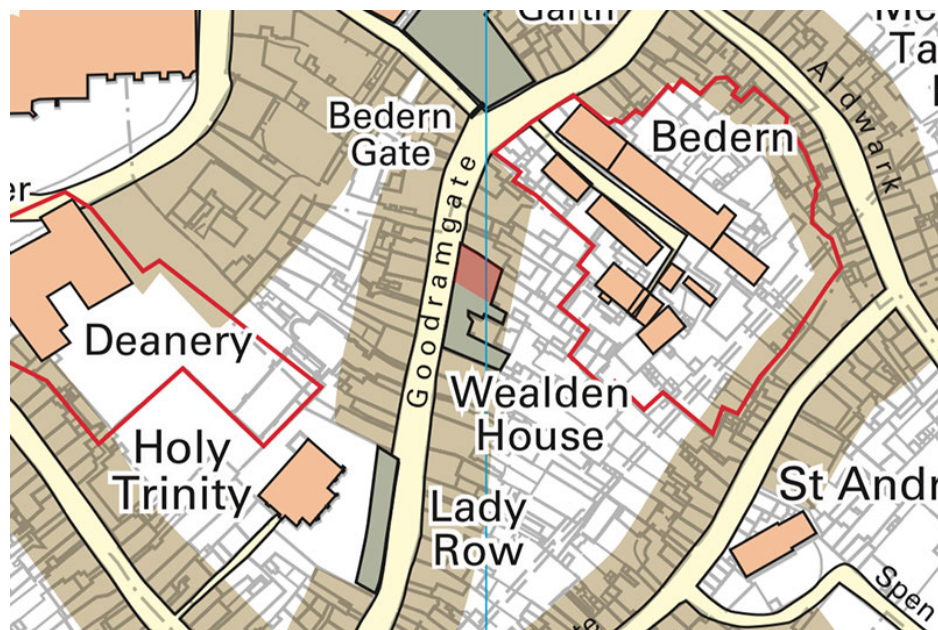
Fig. 6.1 Map of York c.1500 with major secular buildings on Goodramgate highlighted in blue (site in block red)
© Addyman 2015.

- Combined with the adjoining timber-framed ranges to the south-west (Snickelway's Inn and The Wealden Hall) no. 45 Goodramgate forms one of the largest surviving stretches of timber-framing in the city. Unlike other surviving groups, such as on the Shambles and Petergate, these properties have ranges running parallel to the street, demonstrating their framing to full effect. This grouping is identified on Addyman's 2015 map (along with Lady Row) as major secular buildings on late medieval Goodramgate (fig. 6.1)
